**Final Grant Report  
Tubmill Trout Club, Eleanor Clark Farm Phase- I  
August 04, 2017 completion**

**Project Name:** Eleanor Clark Farm, Phase – I  
**Project Address:** 298 Midget Camp Road, Bolivar Pa 15923  
**Project Location:** Westmoreland County, Fairfield Township  
**Project Description:** 1000 feet of habitat renewal within Hendricks Creek

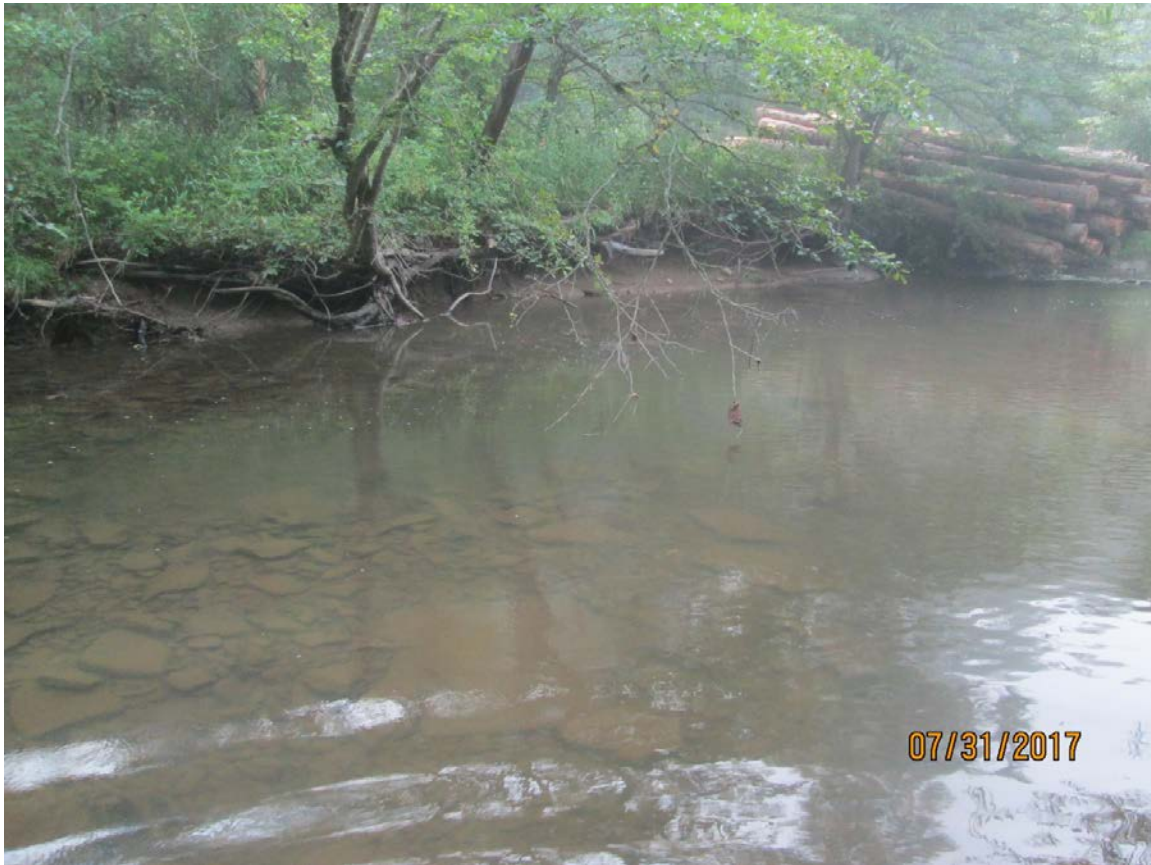
This series of preconstruction photos shows a desolate stream with highly eroded banks, a silt choked stream bottom devoid of suitable habitat for aquatic life. Notice the over widened stream channel resulting in shallow slow moving current.

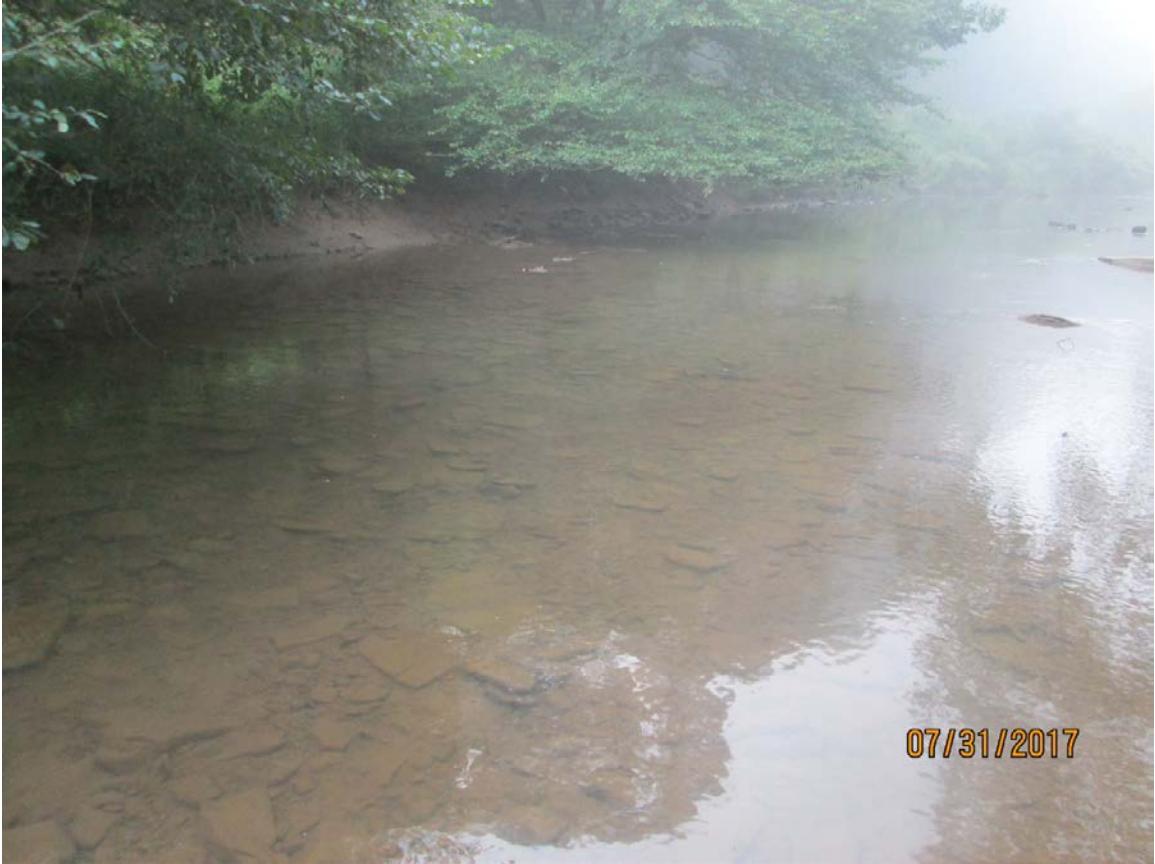
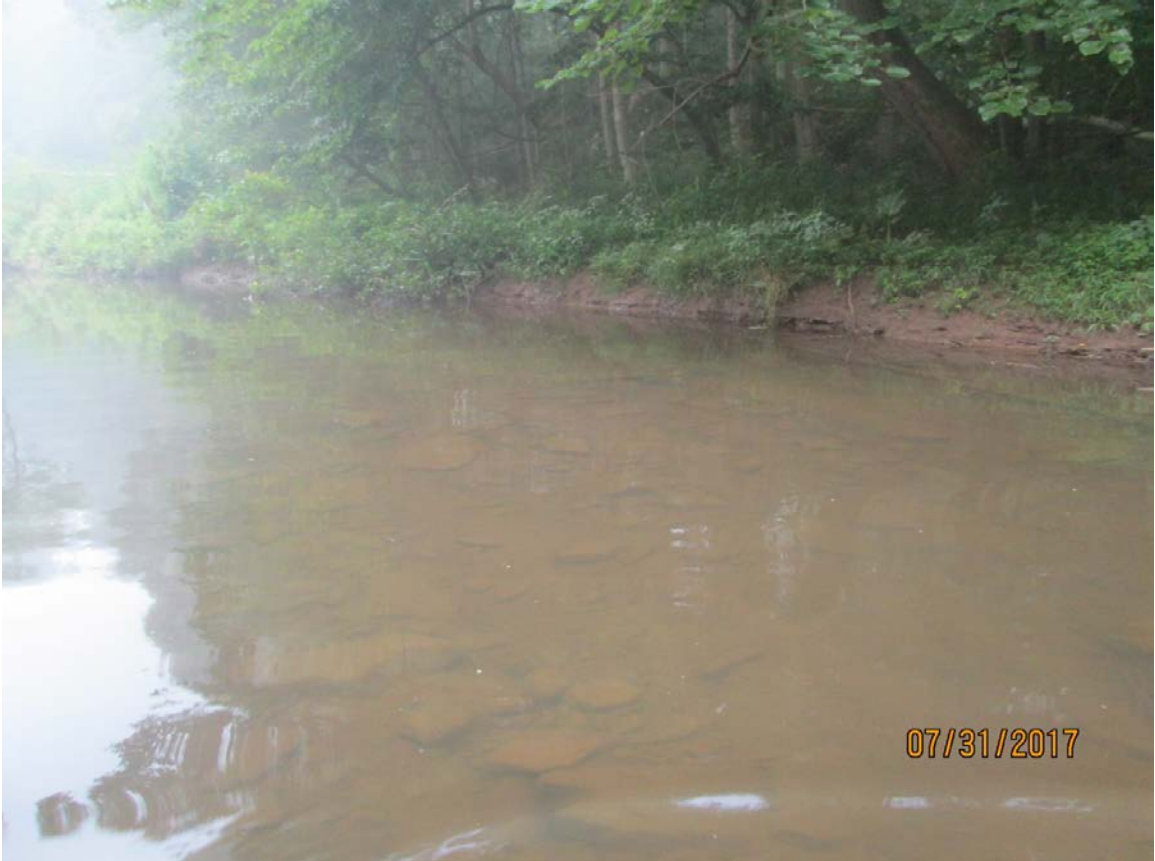
Ankle to knee deep slow moving water allows water temperatures to rise while offering no help with oxygenation. We found little minnow life but crayfish life seemed to abound with little to no insect life during preconstruction inspection. Tubmill Trout Club's habitat improvement initiative deemed this stream section to be a high priority concern. Hendricks Creek has been subject to decades of flooding, poor agricultural practices and most recently poor pipeline construction procedures resulting in sediment laden stream sections destroyed by these actions. Many future project are planned to bring this watershed back to a pristine stream to benefit and proliferate it's aquatic residents.

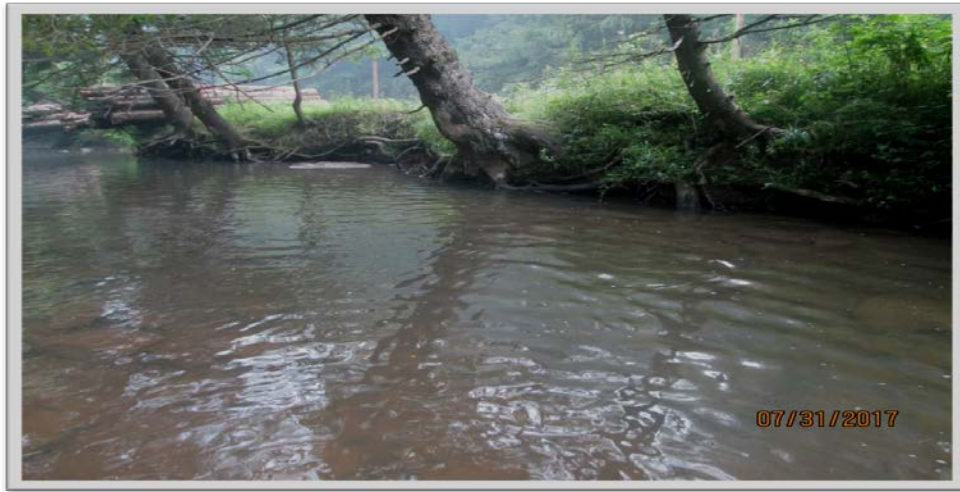
Above photo shows preconstruction location for device #46 a modified mudsill. Notice serious erosion between pine trees. Road right of way encroachment has occurred. The following pictures show a renewed stream vibrant and improving, providing suitable habitat and recreational opportunities for our community.

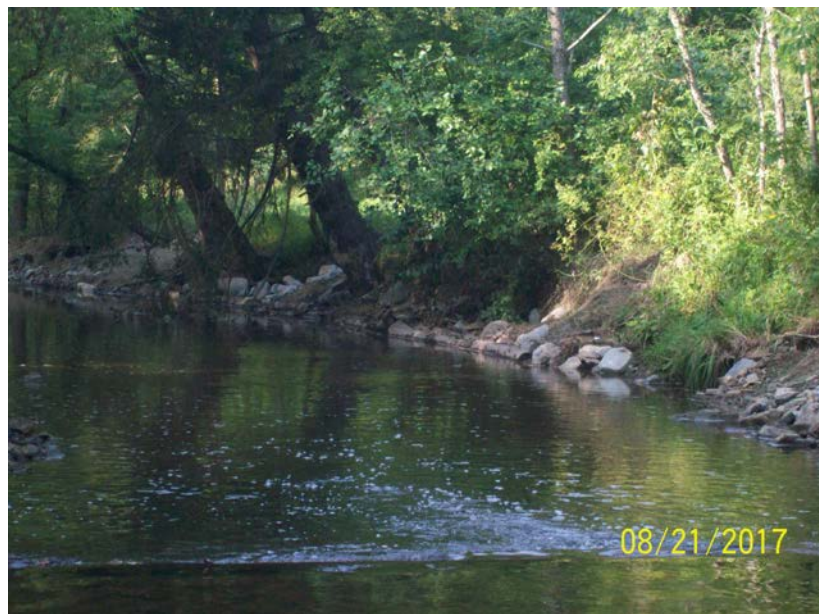
Same area after device #46 is in place. All eroded areas have been corrected with mudsill providing overhead cover for trout.

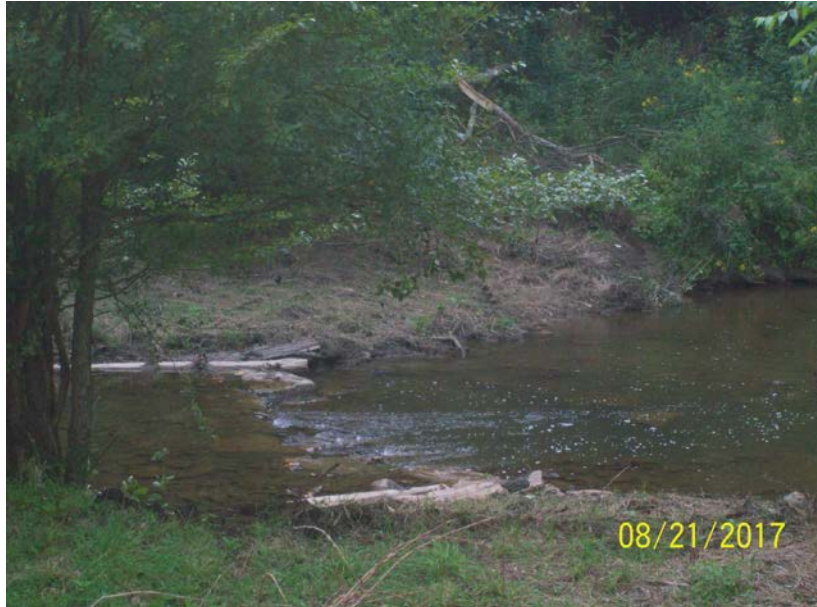
Plunge pool created from device # 17 with random boulders. This pool has acquired a depth of 4 feet where once no more than ankle deep water slowly flowed.

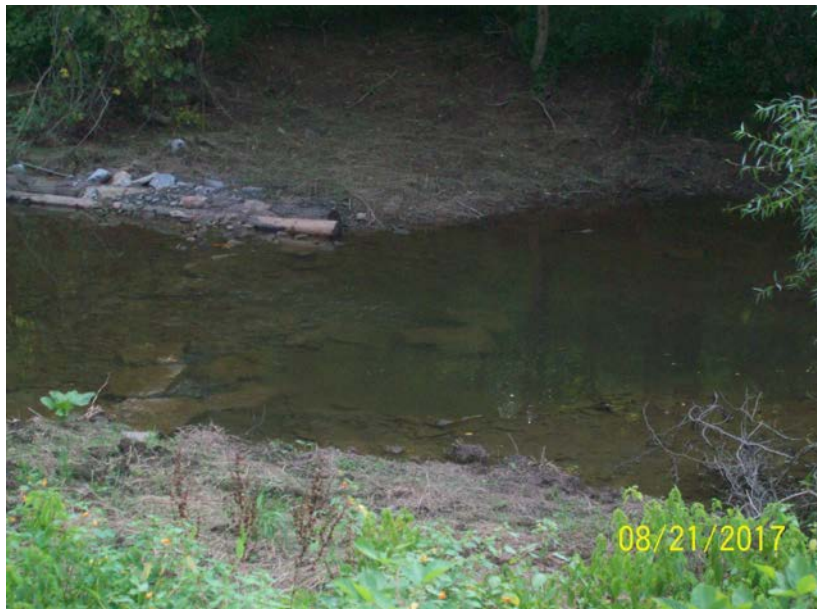
Above plunge pool was created by device #14. Notice the drastic 30 foot reduction in stream width. Again increased depth is gained below log framed cross vane rock throat.

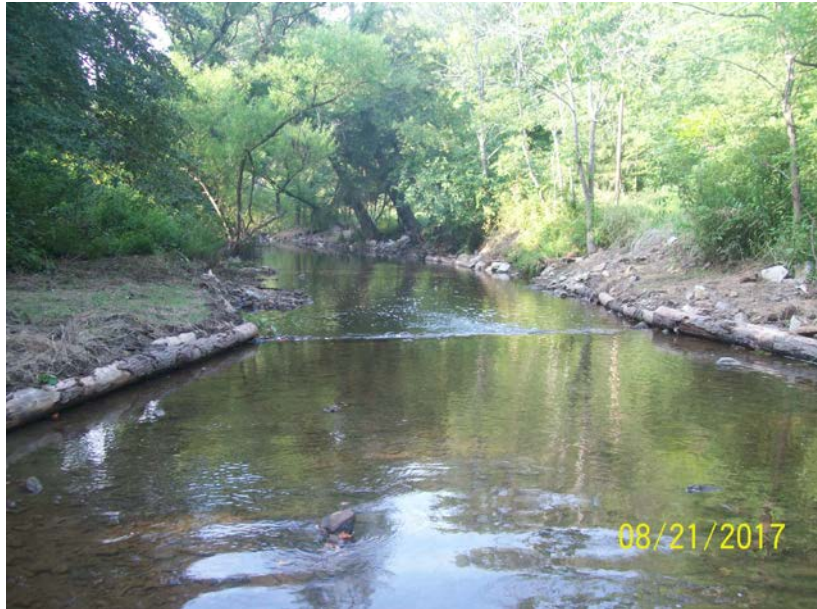
This view is taken from the project starting point device #01, one of six total cross vanes either rock throat or log framed located within this Clark Farm Phase-I project.

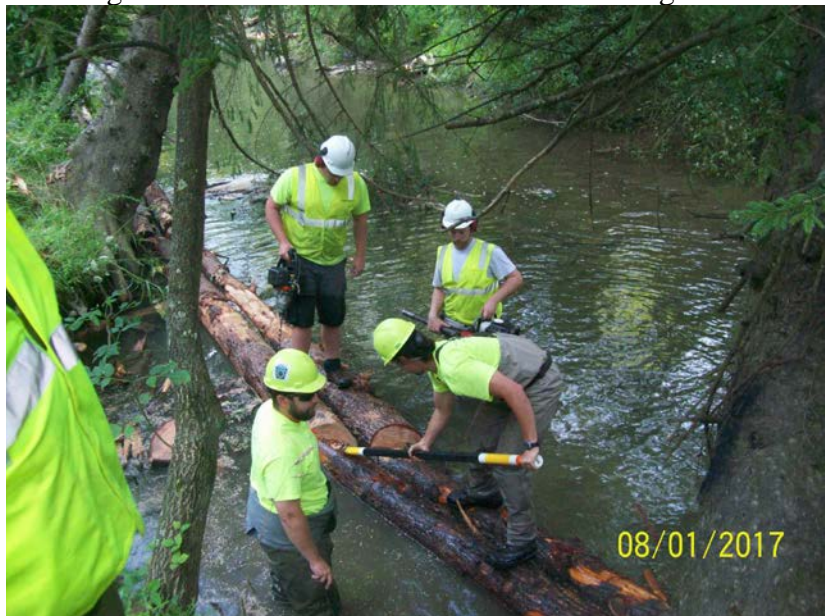
Mud sill #46 a very labor intensive area..

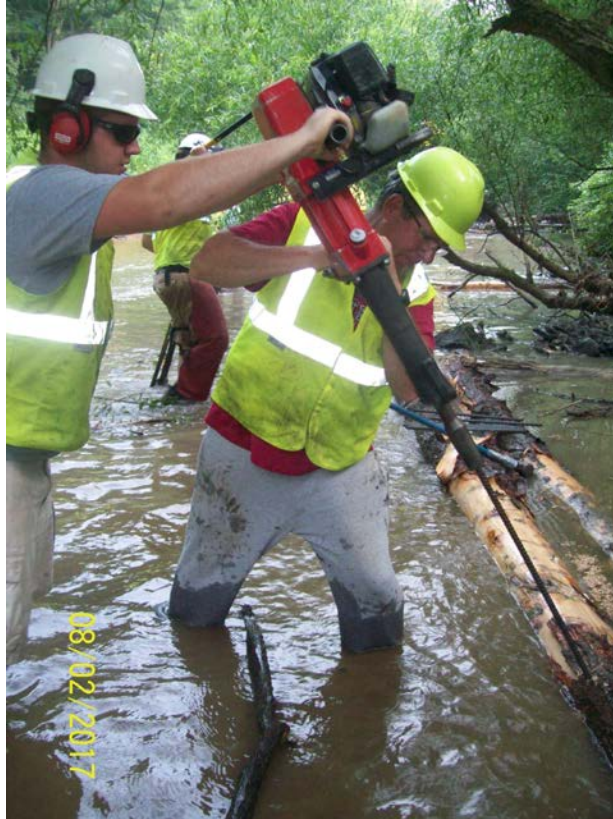
Unusual silt depth requires extra long 6 foot rods being used pinning logs into streambed.
