COLDWATER CONSERVATION PLAN

Clear Creek; Callen, Pine, and Leeper Runs

Jefferson County, Pennsylvania

Final September 2018

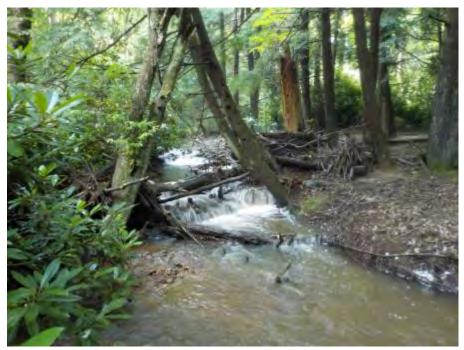
499: Large, stable wood pieces help sequester smaller pieces, scour pools, and assist the stream in accessing its floodplain during high water events. This section had a moderate amount of LWM.

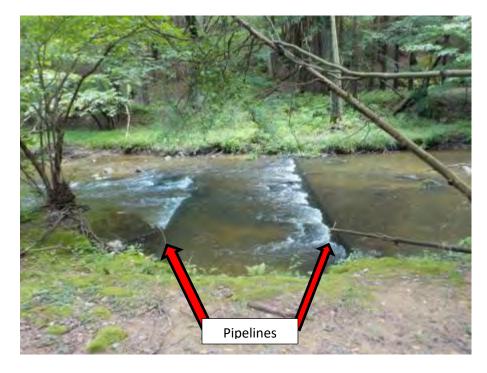
477: Stretches lacking an abundance of large, stable pieces allow smaller pieces to move more freely. Mobile pieces of wood in the channel may pose risks to exposed infrastructure, especially as they undercut and become more exposed. Note the absence of larger pieces of wood near these exposed pipelines on the streambed. LWM installations could be used here to control the grade of the streambed.

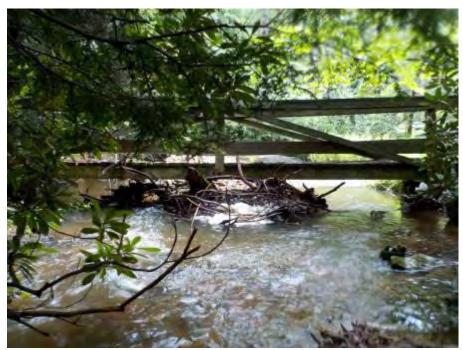
532: Smaller, mobile pieces of wood accumulating on the upstream side of this footbridge. A "catcher structure" may be a valuable upstream installation.

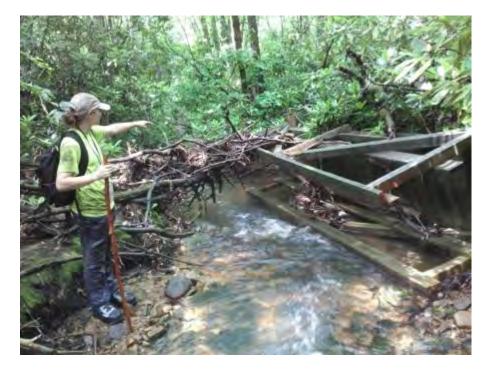
488: Not all wood in the channel is natural. This footbridge washed downstream in a flood, and is now creating its own debris jam and scour pool.

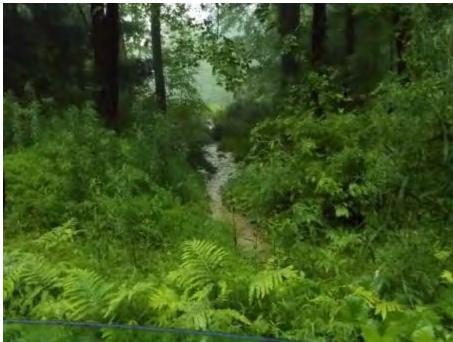
588: Dirt and gravel roads throughout this and other drainages contributed sediment during heavy precipitation or runoff events, at times even preventing accurate assessments.

588: Ephemeral tributary near the top of the watershed that captures all of the runoff in the previous photo.

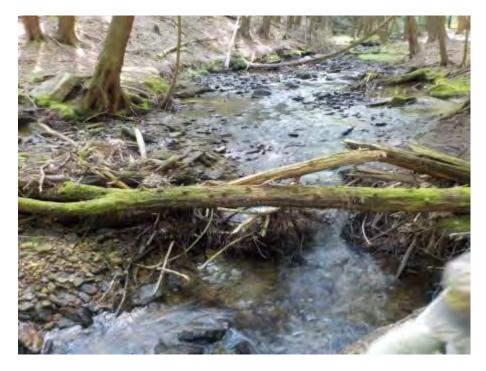
348: This segment is heavily fished. Improving habitat (increasing pools) through structures and LWM additions would prolong the holding time of stocked fish, as well as enhance the resiliency of wild fish.

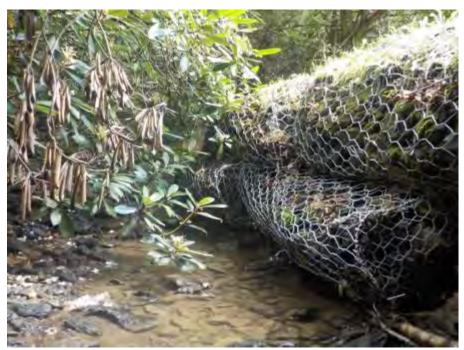
438: Gabions near the footbridge on Phyllis Run should be removed and replaced with log and stone habitat structures to stabilize the streambank and reduce the risk of scour associated gabion failure. The new structures will also have a more natural appearance that will blend in more with the natural environment.

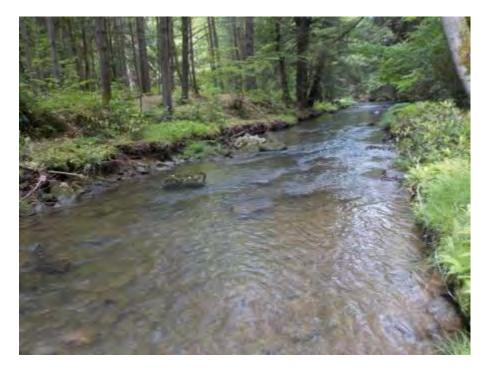
439: Though it may seem to be an attractive photograph of an idyllic section of stream, when viewed through "fish eyes," or those of an angler, one sees a lack of deep water habitat and cover. This stretch is a prime candidate for large woody materials additions.

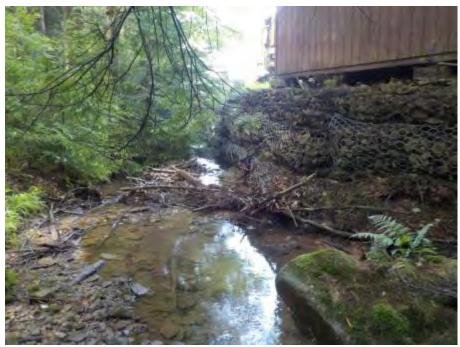
445: Gabions are used to stabilized part of the PA-DCNR BoF Maintenance yard and shed on the banks of Little Clear Creek. When possible, these should be replaced with a tree and boulder engineered log jam, for stability as well as habitat enhancement purposes. Additionally, buildings and parking lots should be situated 35 feet or more from the streambank.

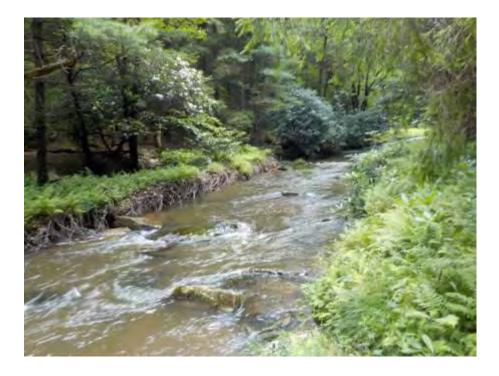
477: Long, straight stretches in this segment lack energy dissipating structure.

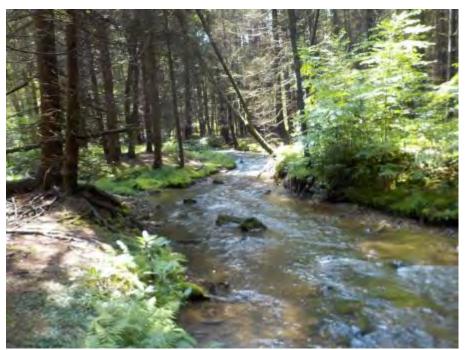
483: Shallow stretches in this segment would benefit from more deep-water habitat.

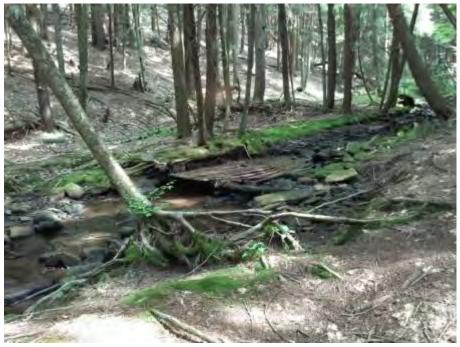
1561: In addition to removal of this mild AOP barrier, this heavily fished segment would benefit from additional deep-water habitats and LWM.

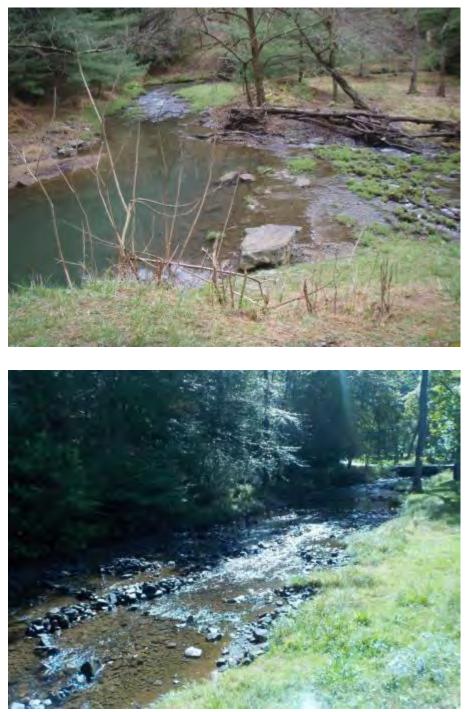
1581: This section is heavily used by both recreationists and migratory fishes. Habitat structures would be especially beneficial in the lower portion of the reach, where recreationists often create "hand dams"

and runs that negatively impact the fish and macroinvertebrate communities (bottom). Educational signage may also be advisable. Gabions are present in the upper reaches of this segment near the tail out of a relic log/mill dam (top). It is recommended to remove the gabions, and replace with habitat structures.

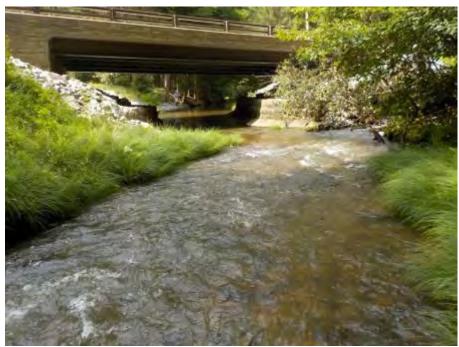
1586: Gabions upstream of the swimming dam should be replaced with log and stone stabilization structures. Habitat structures throughout this reach would benefit recreationists and migrating fishes as well.

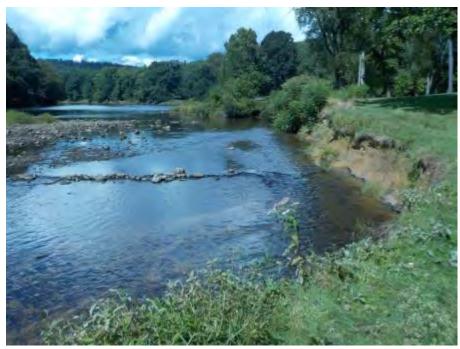
Clarion River at the confluence with Clear Creek: Though not technically one of the streams assessed in the Coldwater Conservation Plan, the Clarion River immediately downstream of the mouth of Clear Creek has been experiencing significant erosion for several years. Note the constructed riffle or "hand dam" directing flow toward the eroding bank, which is a part of Clear Creek State Park.

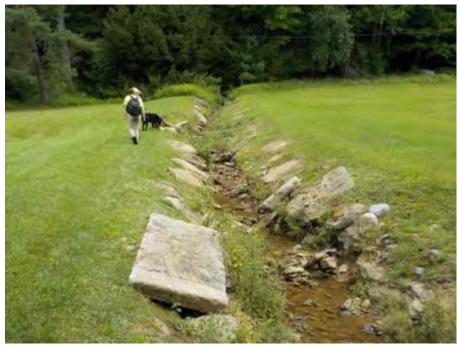
1559: This segment traverses a portion of the old Heath Pump Station grounds. It was kept straight, mowed and cleaned by National Fuel Gas.

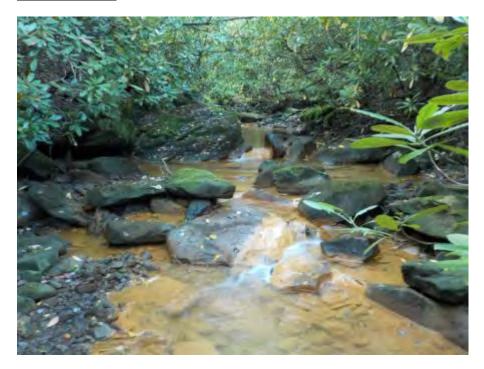
510: Several measurements of specific conductivity were taken upstream of, downstream of, and throughout this area of seeming ferric deposition on Truby Run.

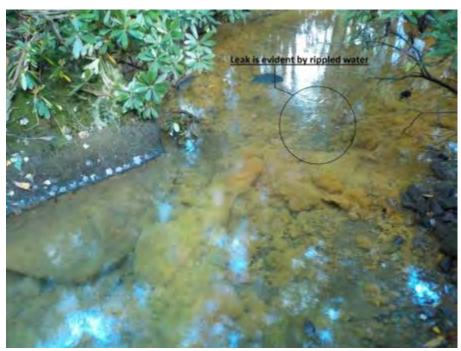
510: The ferric deposition and a sulphurous odor originate at a seep that bubbles up through the stream gravel.

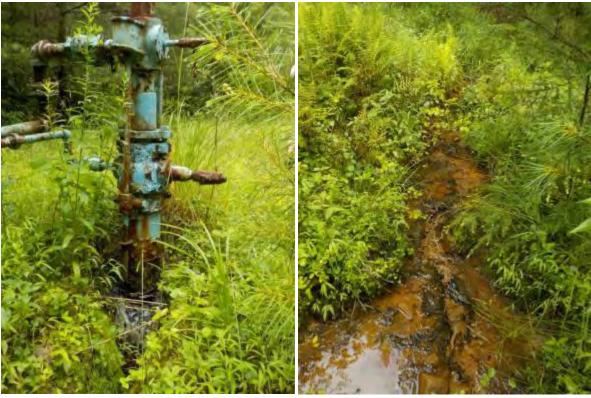
499: A gas well near the top of this segment on the right descending bank leaks discolored, Sulphursmelling water that is 9.5° C, pH 7.88, and 297μ s/cm. The stream does not appear to be mortally impaired from this source, but the water leak is recommended to be plugged in the event that the outflow changes in volume or chemistry.

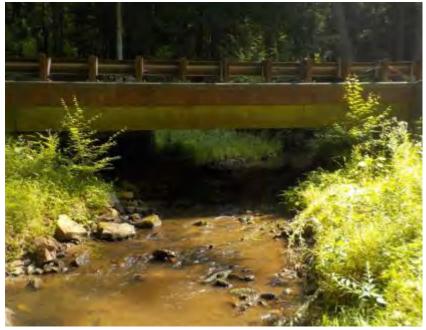
348: The Callen Run Road bridge crossing Callen Run is not a barrier to Aquatic Organism Passage. It is noted here only because it does cause a slight constriction of the floodplain, thus influencing natural stream flows in a small way.

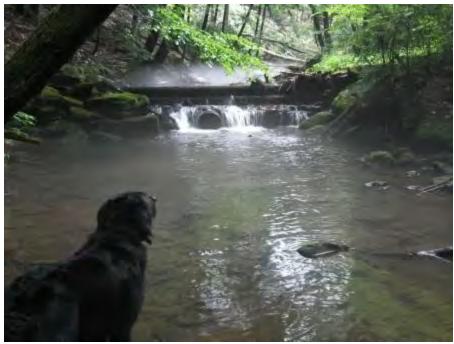
377: The relic dam on Johns Run at low flow.

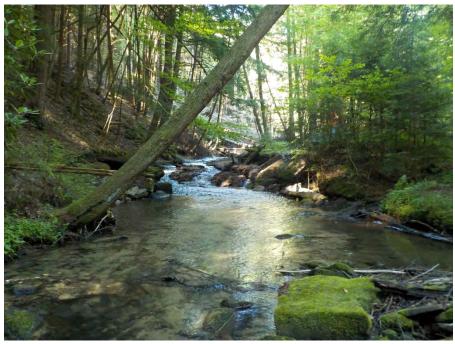
377: This dam was removed on July 9th, 2018, by the Western Pennsylvania Conservancy, Jefferson County Conservation District, Heath Township Sportsmans Club, and other volunteers through a generous grant from the Coldwater Heritage Partnership. Its Removal restored aquatic connectivity to approximately 4.75 miles of upstream habitat for native coldwater fishes.

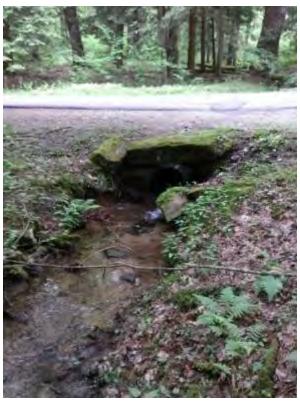
408: Culvert on Clear Creek Park Road is perched and undersized.

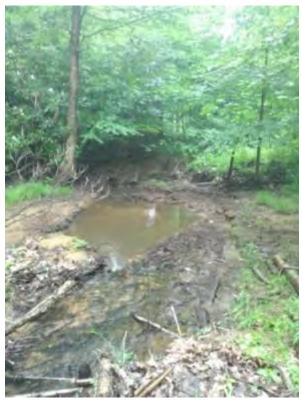
431: A relic dam (partially breached) with an old road grade on the breastworks forms a partial AOP barrier. A large sediment slug exists upstream of the breast in the former impoundment.

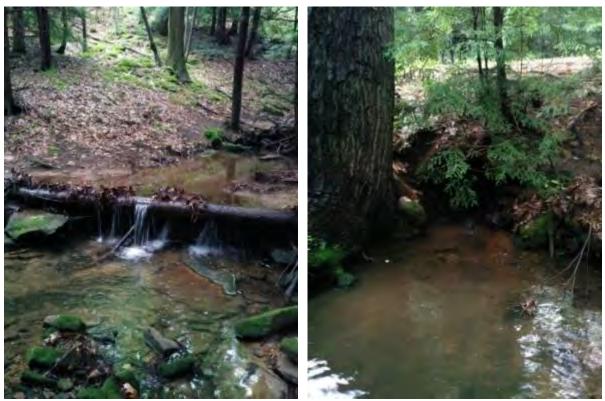
437: An exposed gas pipeline (left) as well as an undersized culvert on a timber haul road (right) form 2 AOP barriers on this segment.

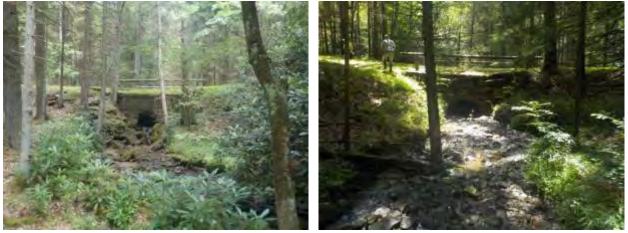
438: This undersized culvert where Clear Creek State Park Road crosses Phyllis Run prevents Aquatic organism passage from Clear Creek. The outlet is perched (left), with a large sediment slug upstream of inlet (right).

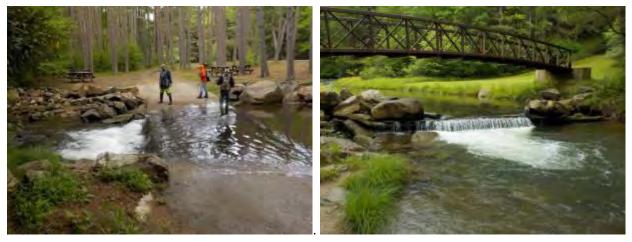
439: Two barriers to fish passage on Clear Creek main stem include a vehicle ford to a picnic area and a jack dam.

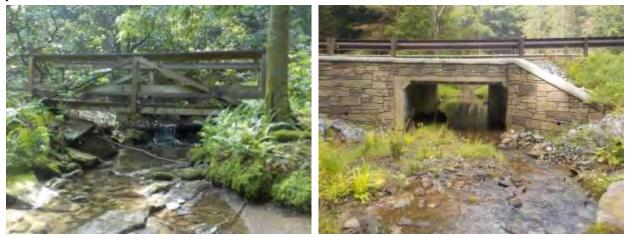
445: Several footbridges for the hiking trail in the Little Clear Creek watershed cross the stream, forming little if any AOP barrier, but still create a minor restriction on natural stream flow (left). The vehicle bridge for Corbett Road (right) is a more substantial barrier to passage for terrestrial and riparian animals, as no floodplains (dry passage) are present within the crossing structure. Crossings like these may increase animal/motorist collisions.

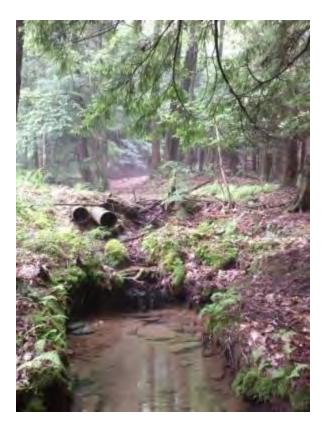
457: An ATV bridge/ford crosses this segment near its confluence. This was a short segment and most of the channel was dry above this crossing.

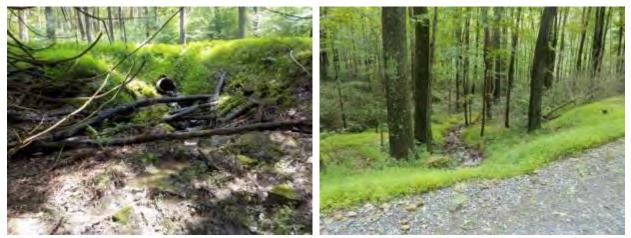
476: Two undersized culverts form AOP barriers on this stream. One is on Corbett Road (left), and the other is on Little Clear Creek Road (right). Both are perched at the outlet. Copious Japanese stiltgrass is in evidence in both of these photos.

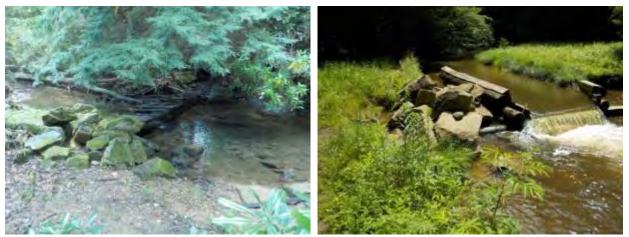
477: Two water jacks form partial to full AOP barriers at varying flow levels. The older jack (left) is falling apart. A side channel is developing to the river right of the newer jack (right), and, if properly constructed and secured, may provide passage around the jack during all flow levels.

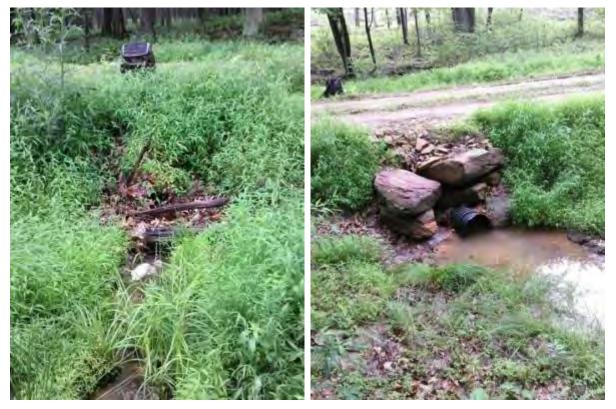
479: This crossing on a logging road in the headwaters is undersized, and therefore an AOP barrier. It is also clogged at the inlet (left). Road ditches enter directly into the stream in this area, further reducing the efficacy of the crossing structure, as well as it's passability during flood flows. If the road is to continue to see use, the culvert should be replaced and DGR improvements made to reduce sedimentation to the creek.

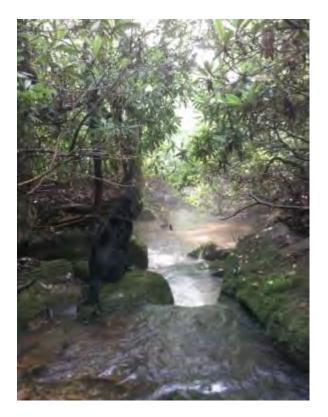
488: This waterfall, approximately three feet high, may prove a natural barrier to upstream aquatic organism passage at most flows.

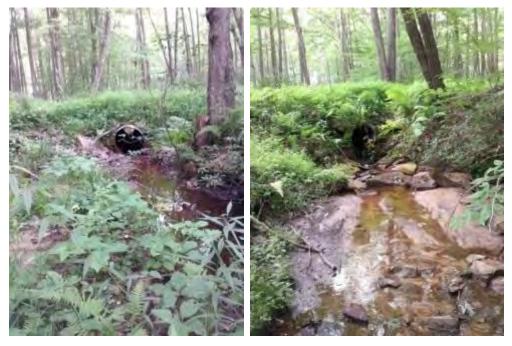
490: The culvert on Callen Run Road, where it crosses Callen Run in the headwaters, is undersized. A sediment wedge is forming upstream of the inlet (left), and the outlet is perched (right). Downstream of the outlet's primary scour area, sediment from the dirt and gravel road has begun to accumulate.

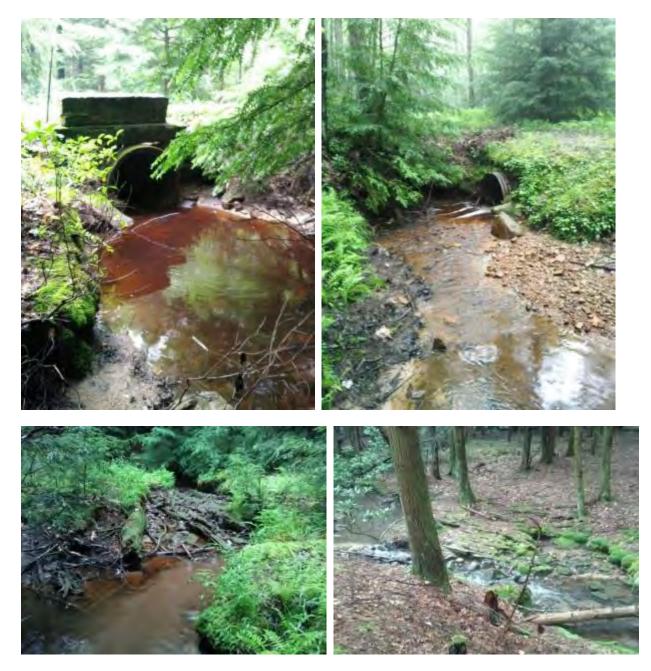
500: The culvert at the Pine Run Road crossing (top left), as well as on a private dirt and gravel road (top right) are undersized for this watershed. Several relic logging road corduroys also exist on this segment (bottom photos), and may form partial AOP barriers in lower flows.

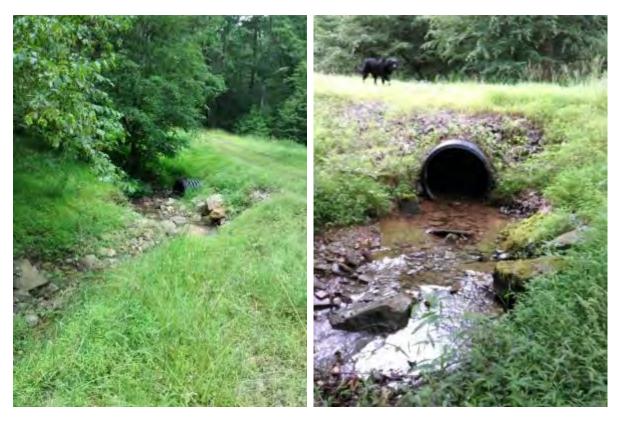
535: Culvert on a State Forest road is undersized and poorly aligned. Inlet with sediment wedge (left) and outlet with scour pool (right).

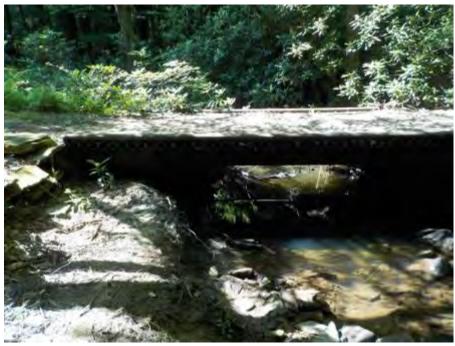
547: While not much of an AOP barrier, this small bridge over Trap Run does constrict the natural stream channel during high flow.

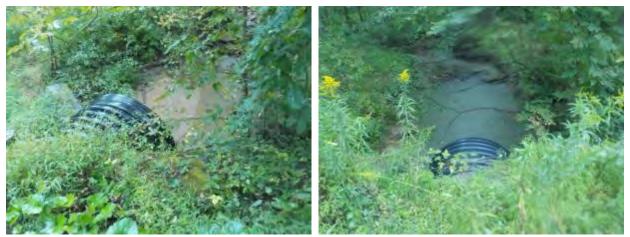
570: Shaffer Road Culvert. Inlet with sediment slug (left), Outlet with scour pool (right).

As in the case of segment 570, the culvert crossing under Shaffer Road is undersized, putting the stream and roadway at risk. This structure should be replaced with a larger one, be it a squashed pipe, bottomless arch, or bridge. Structure type and installation will vary by site based on the stream, landowner, and roadway needs, as well as available funding. The structure should be sized to one hundred and twenty percent (120%) of the stream's current bankfull width that is out of the "zone of influence" of the existing crossing structure. A substrate/bedload mix comparable to that present naturally in the stream channel should be used to simulate it through the crossing. Floodplains should be built inside the crossing structure to facilitate higher flows expected to be associated with climate change trends (thus reducing future maintenance), as well as assist non-fish species in utilizing the waterway for travel. The photo below, taken in the East Branch Tionesta Creek drainage in McKean County, poignantly illustrates the importance of a properly sized crossing structure. Had she been able to traverse the stream and floodplain through the culvert, the smashed, gravid female snapping turtle would not have been hit by a vehicle. She, as well as the eggs she was carrying, represent a rare source of energy traveling upstream. Not only has the culvert impacted the turtle population, but the energy cycle of the entire ecosystem.

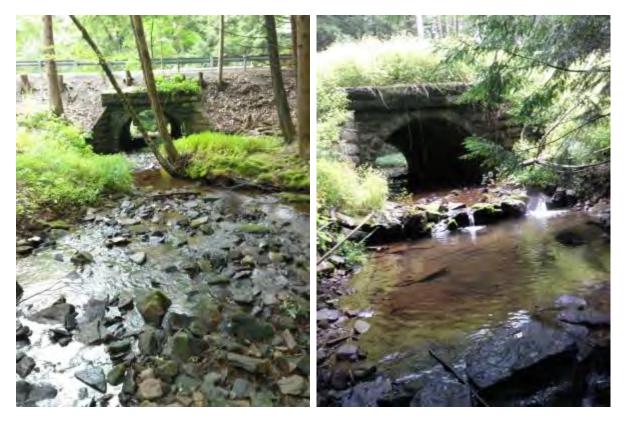
1551: Leeper Run crossing through State Route 949. Inlet (left) and outlet (right) with scour pool.

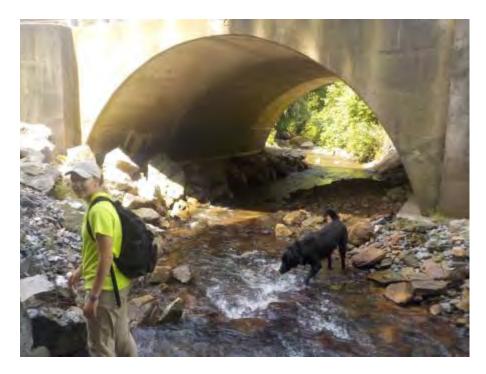
1557: The State Route 949 bridge over Callen Run is not an AOP barrier. While it does provide a slight constriction of natural streamflow, natural and semi-natural dry passage is present through both sides of the structure, as well as a semi-natural stream substrate in the channel.

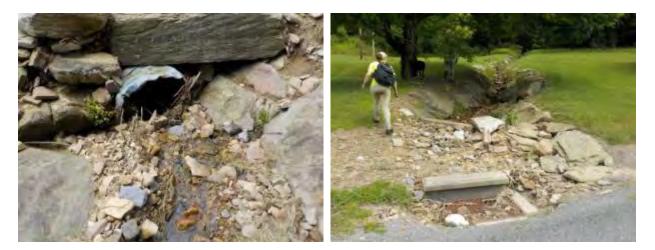
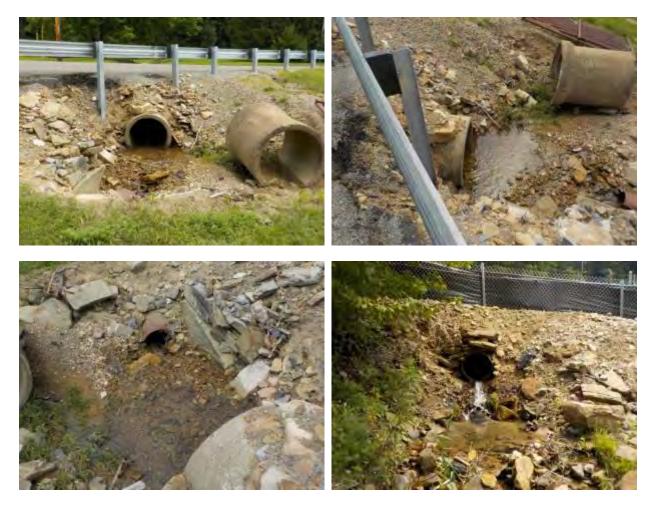
1559: Two culverts reduce connectivity on this segment. The most permanent is that which crosses under State Route 949. Its inlet (top photos) is undersized and clogged. Its outlet (middle photos) exhibits the scour pool typical of undersized crossings. Just downstream of that scour pool is the inlet to a temporary culvert (bottom left) which provides access for trucks and equipment decommissioning the Heath Pump Station. It will be removed, and this area re-contoured, at the completion of that removal and restoration project. Its outlet is perched (bottom right).

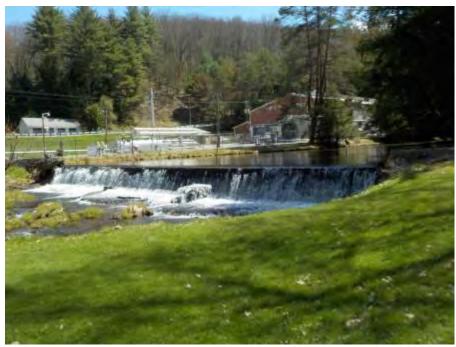
1561: Callen Run Dam during a high water event.

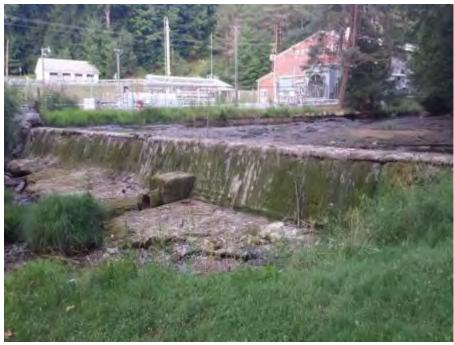
1561: Callen Run Dam during a low water event.

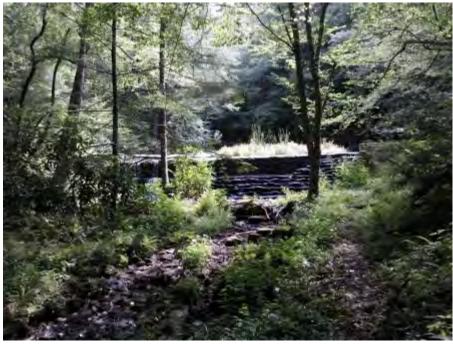
1567: Breastworks (from downstream, a migrating fish's perspective) of the "upper dam" on Callen Run. It is upstream of the bridge where Callen Run Road crosses this segment.

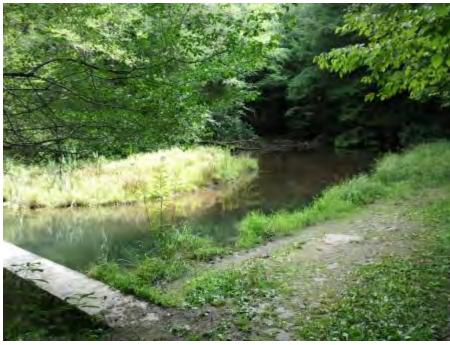
1567: Impoundment with sediment upstream of the upper dam on Callen.

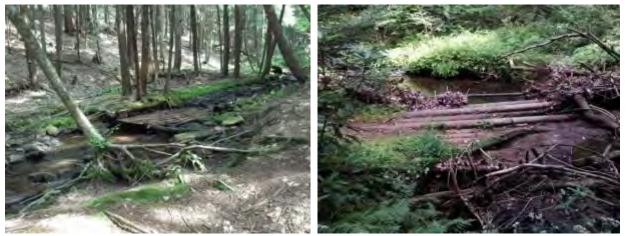
1567: A breached splash dam (left) downstream of the "upper dam" on Callen Run provides a low water AOP barrier. It is a low priority to remove, as it will likely fail on its own. A set of well casings (right) used as a foot and atv bridge has fallen into the stream, and serves as a low-water AOP barrier.

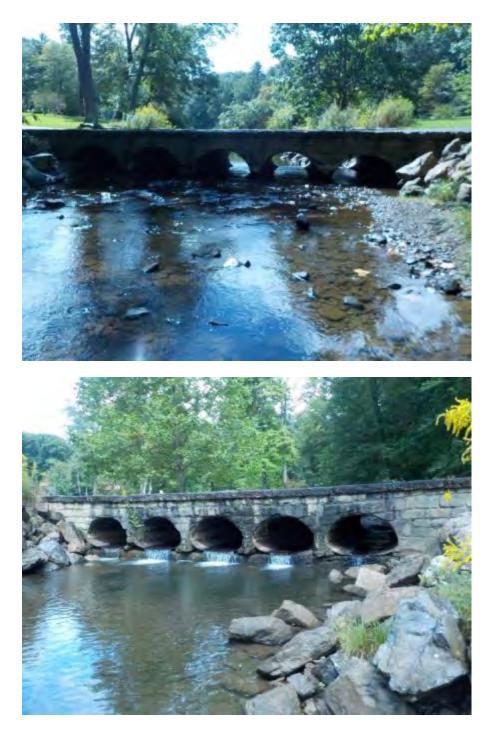
1581: Clear Creek mainstem has several AOP barriers. One of the most impactful is the set of culverts near the mouth. They are part of a bridge that aggrades sediment upstream (top), and forms a large scour pool downstream (bottom). The bridge is designed to be overtopped during high flood flows, which may create a public safety risk to people on the left bank during those events. Additionally, by impacting the natural sediment regime the structure may be exacerbating the erosion problem at the confluence with the Clarion River.

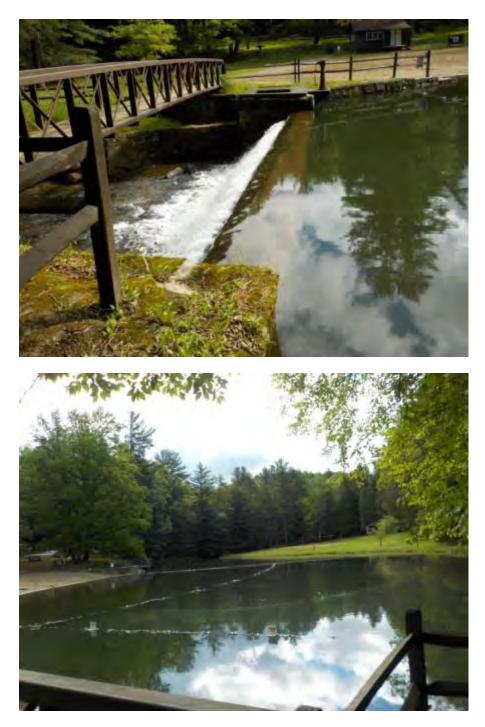
1586: One of the most noticeable AOP barriers on Clear Creek main stem is the "Swimming Dam" (above). Its high breast is a complete passage barrier to fish.

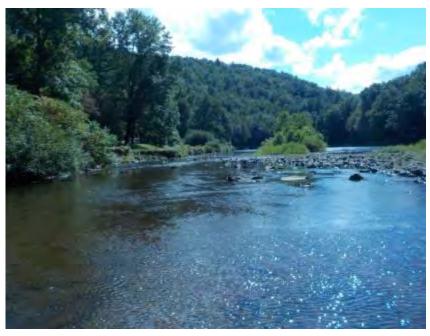
Clarion River, at the confluence with Clear Creek exhibits eroding banks approximately 6 feet tall in the left side of the photo.

Soil bioengineering will be necessary to stabilize the eroding bank of the Clarion River, at the confluence with Clear Creek. Since this location is a direct connection to the larger ecosystem, this stabilization project is included in this plan. The Clarion River is federally designated as a Wild and Scenic River in the reach adjacent to Clear Creek State Park, and as such is under a stricter set of regulations for activities that may or may not occur within and along its banks. This includes methods and rational for bank stabilization and instream habitat improvements. Utilizing a soil bioengineering approach coupled with naturally inspired and implemented large wood structures for toe stabilization will protect this popular recreation spot, and enhance the
