Coldwater Heritage Partnership Final Report

Project Title: Beaverdam Run Habitat Improvement and Sediment Reduction Phase II

Beaverdam Run Stabilization/Large Wood Addition Project Beaverdam Run, Clinton County

Final Report for Technical Assistance Provided through Trout Unlimited's Nonpoint Source Technical Assistance Program

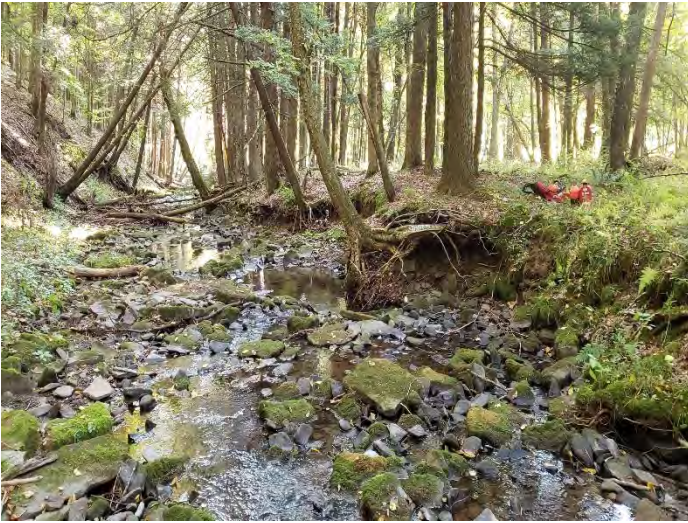
Photo 1: Pre-construction view of eroding stream bank

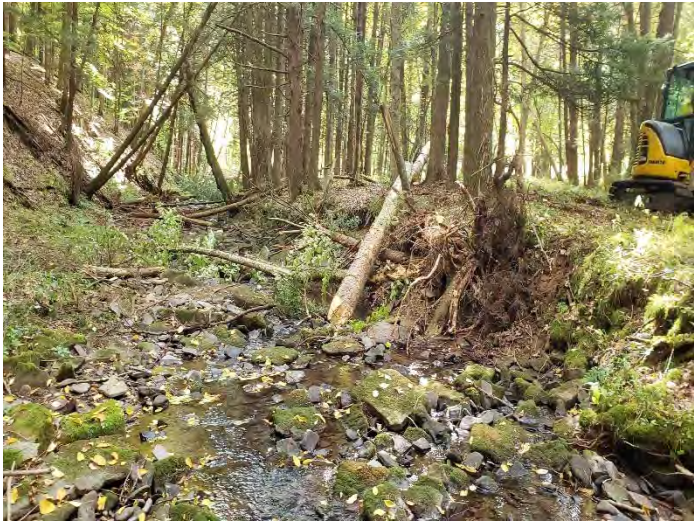
Photo 2: Post-construction view of Toe Wood Structure (Post Photo 1)

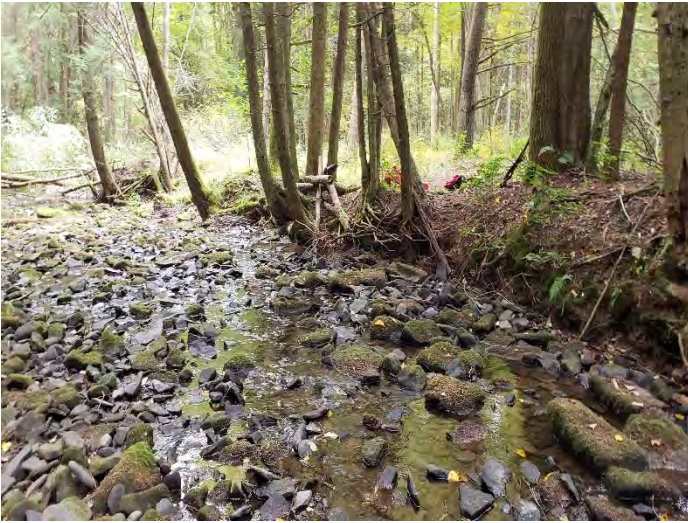
Photo 3: Pre-construction view of eroding stream bank

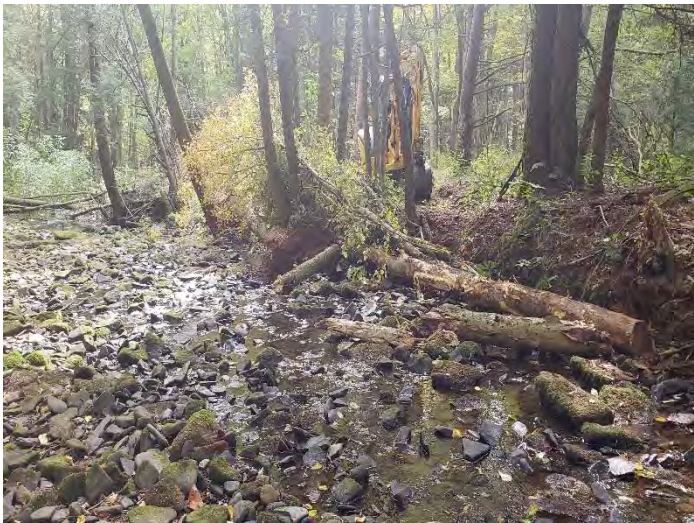
Photo 4: Post-construction view of Toe Wood Structure (Post Photo 3)

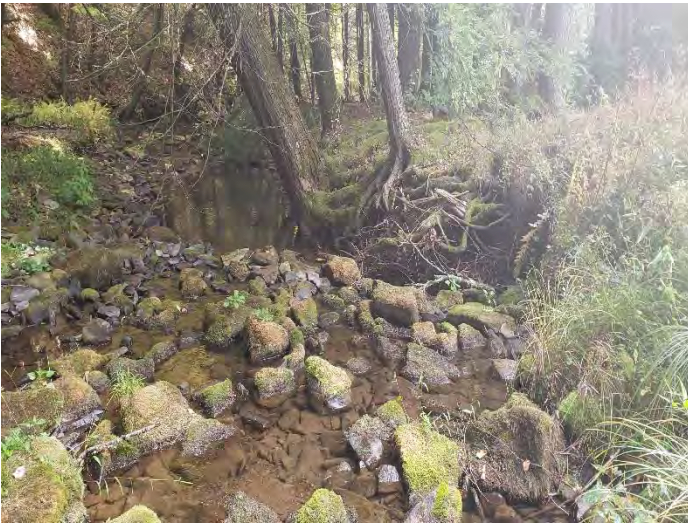
Photo 5: Pre-construction view of eroding stream bank

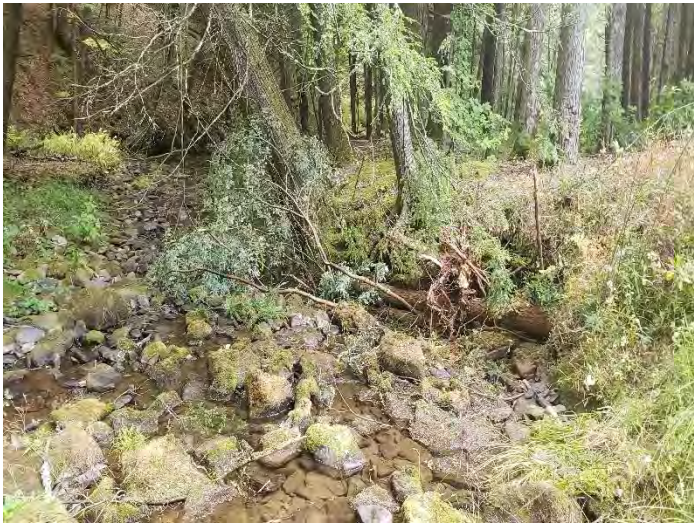
Photo 6: Post-construction view of Toe Wood Structure (Post Photo 5)

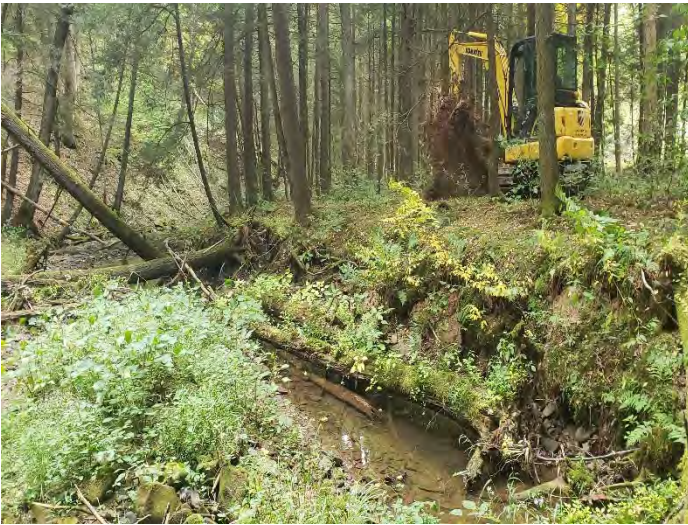
Photo 7: Pre-construction view of eroding stream bank

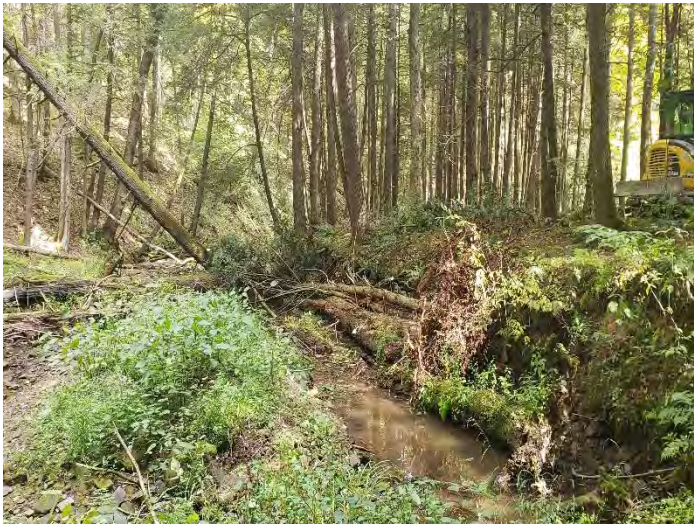
Photo 8: Post-construction view of Toe Wood Structure (Post Photo 7)

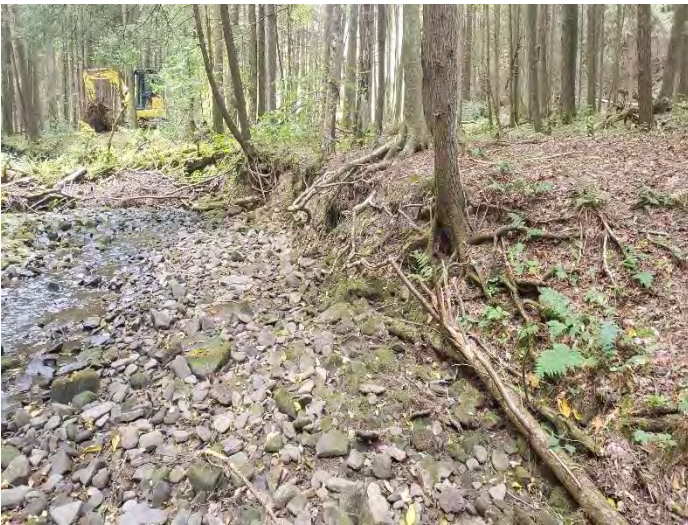
Photo 9: Pre-construction view of eroding stream bank

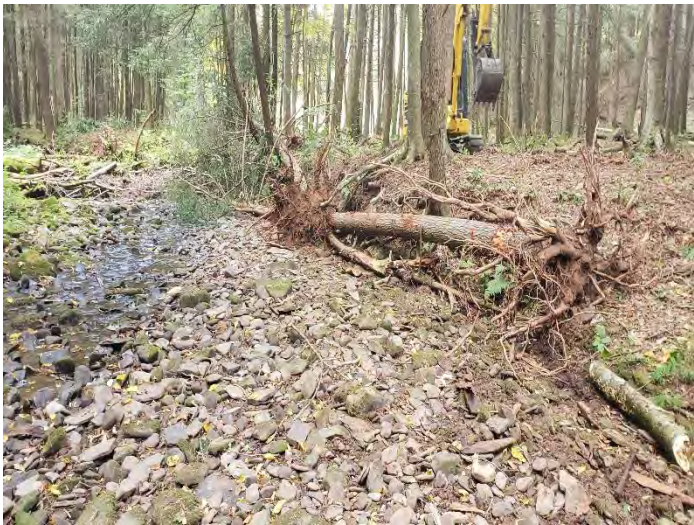
Photo 10: Post-construction view of Toe Wood Structure (Post Photo 9)

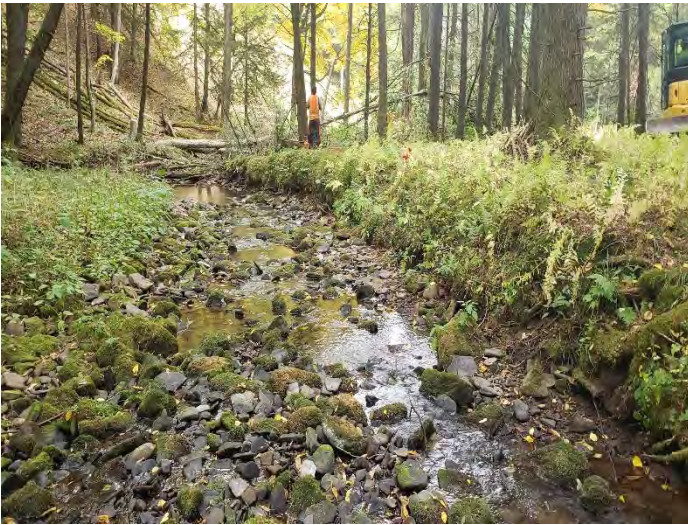
Photo 11: Pre-construction view of eroding stream bank

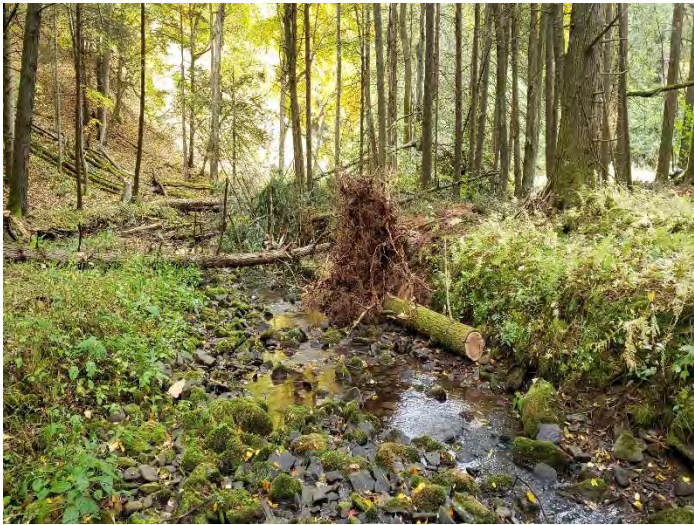
Photo 12: Post-construction view of Toe Wood Structure (Post Photo 11)

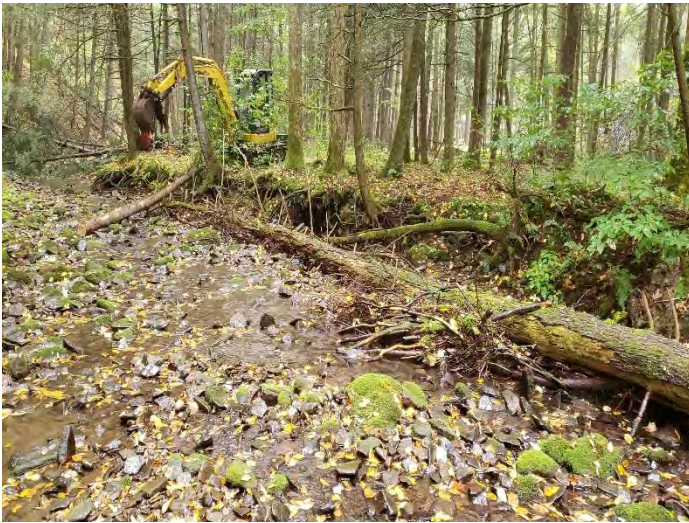
Photo 13: Pre-construction view of eroding stream bank

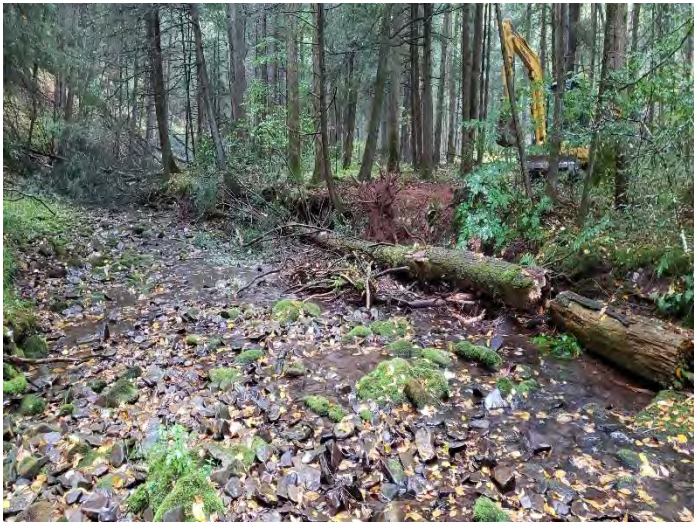
**Photo 14: Post-construction view of Toe Wood Structure
(Post Photo 13)**
