Letort Spring Run Coldwater Conservation Plan Route 34 to Interstate-81

Plan Prepared by: Cumberland Valley Trout Unlimited

Cumberland County Conservation District

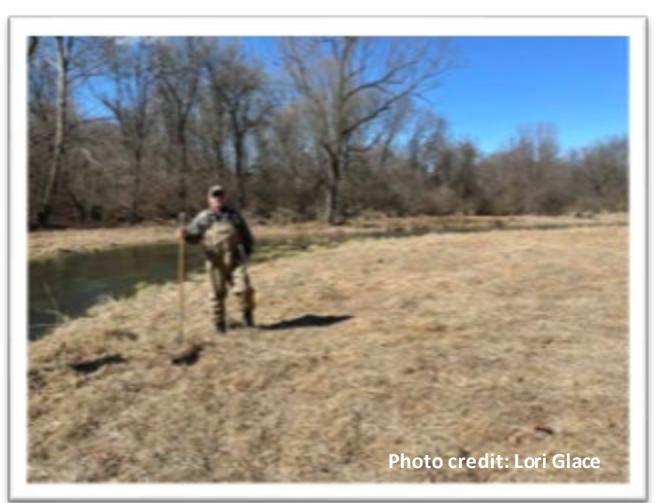
**Figure 5:** Photo of Robert Schott during habitat assessment at the Frey/Tiley Tract. Historically this a rea had two sink holes repairs in the last 15 years.

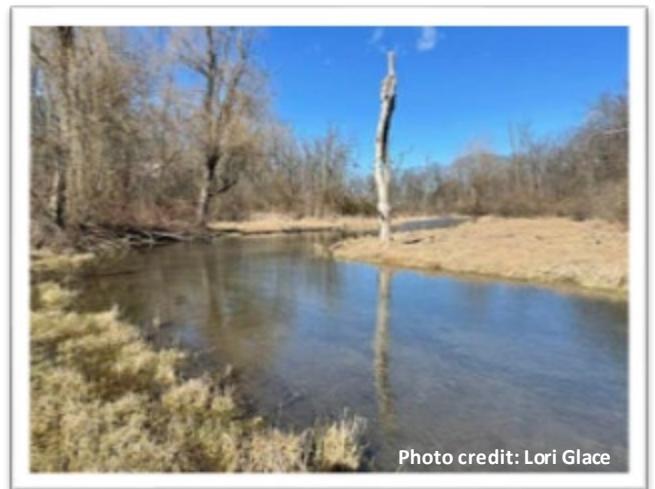
**Figure 6**: Upstream of Vince's Meadow. This area is loaded with sediment and has reed canary grass growing into the stream corridor.

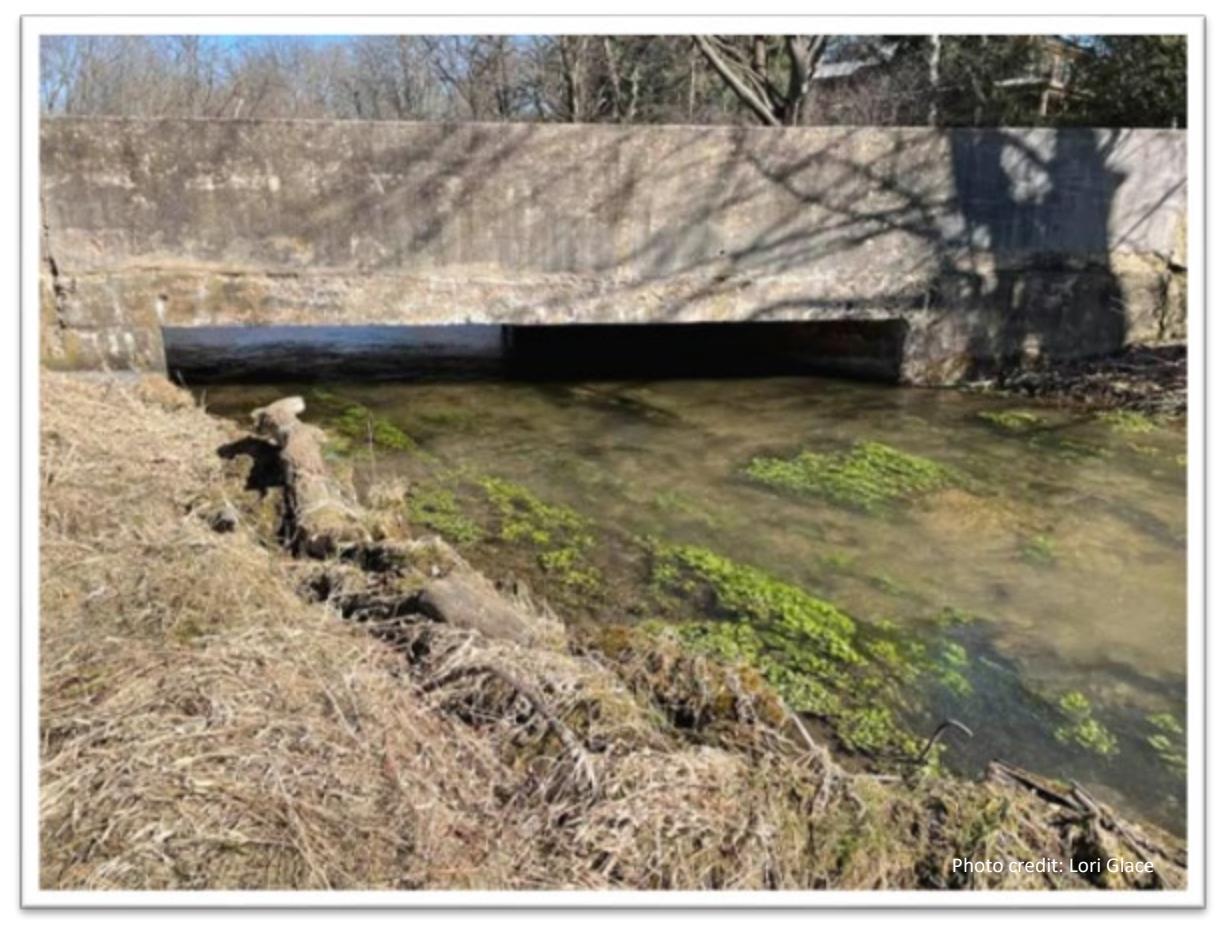
**Figure 8:** Bonny Brook Road bridge downstream of Trego's meadow. The bridge narrows the stream corridor here but still allows aquatic passage and cover for fish. The constricted flow increases velocity under the bridge which could be a be nefit downstream by exposing stream bed gravel.

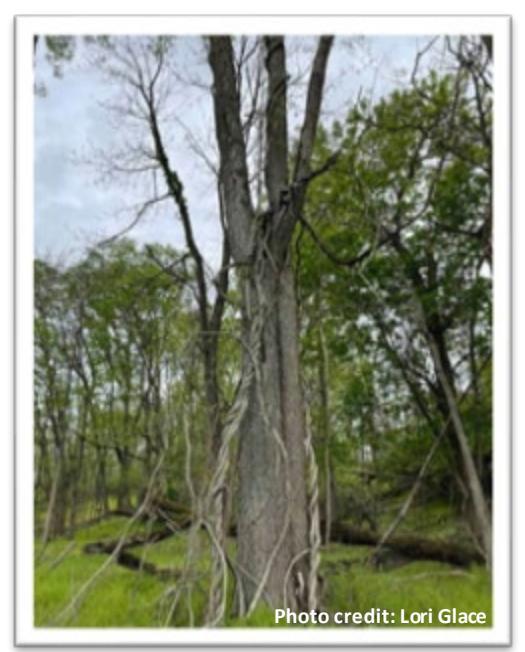
Figure 12: Oriental bittersweet damaging a native hackberry tree.

the spotted lanternfly. Other high ranking common species include honeysuckle (*Lonicera spp.*), multiflora rose (*Rosa multiflora*), autumn olive (*Elaeagnus umbellate*), garlic mustard (*Alliaria petiolate*), and Oriental bittersweet (*Celastrus orbiculatus*). Other general recommendations: start with invasive tree removal, then shrubs, then undergrowth. Recommend planting native plants where invasive plants are removed. This treatment will take several years to fully become successful and will have to be spot treated continuously.

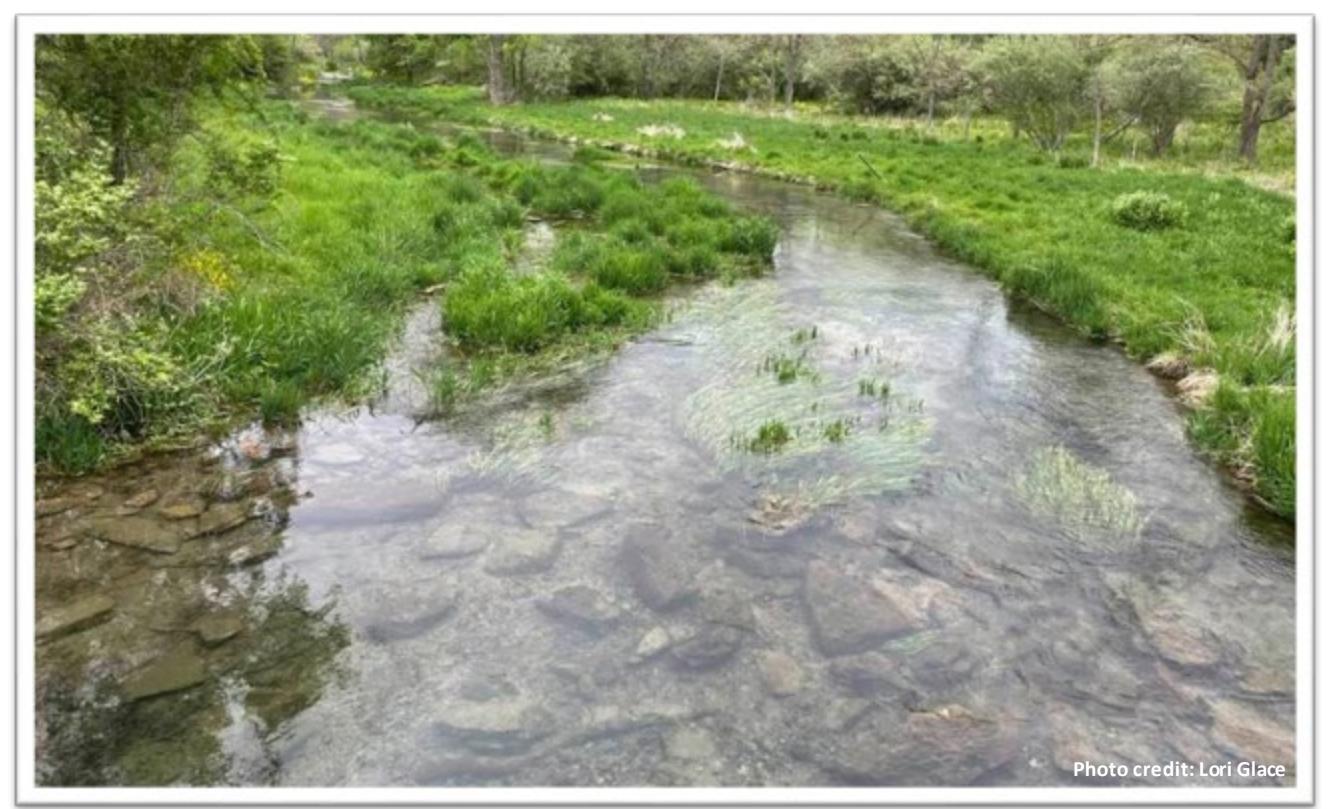
**Figure 13:** Reed canary grass growing into the main corridor of the Letort. View is downstream of the railroad bridge on the Letort Nature Trail by Otto's Meadow.

Located between Otto's Meadow and I-81, this section of stream is choked with sediment which has allowed reed canary grass to encroach on the stream. This section of stream also has several Willow trees that are dying. Remediation opportunities include installation of trout habitat structures to help increase the flow of water to help reveal gravel substrate. Recommend to replant trees where large willow trees have died.

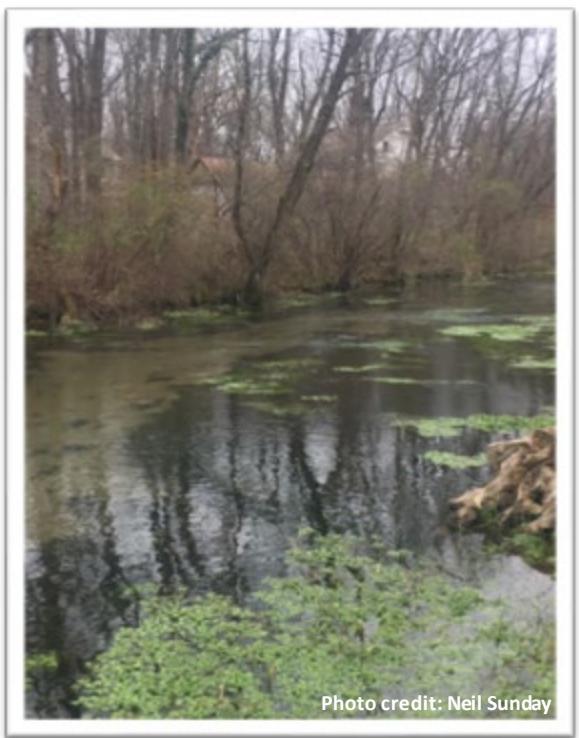
**Figure 16:** Over-widened section of Trego's Meadow upstream of Bonny Brook Road.

Over-widening of the channel causes water to spread out over a larger area. This causes the water velocity to slow down. As water flow slows down, sediment will drop out of the water column. Over time, sediment bars and wedges form, which will allow for plants to colonize the area. These plants will trap additional sediment and cause more water displacement into the riparian zones. Slowing water and encroachment into the bank margins will cause warmer temperatures which will deplete the available dissolved oxygen that is

Located upstream of Bonny Brook Road, this section is over-widened, bank failure, and stream banks are turning marshy. Remediation opportunities include fish habitat structures to stabilize the bank and direct water back into the center of the stream. This will also help to keep the gravel clear in this section. Random boulder placement will help to create diversity in the stream channel and will create pockets of water where trout can rest and hide.

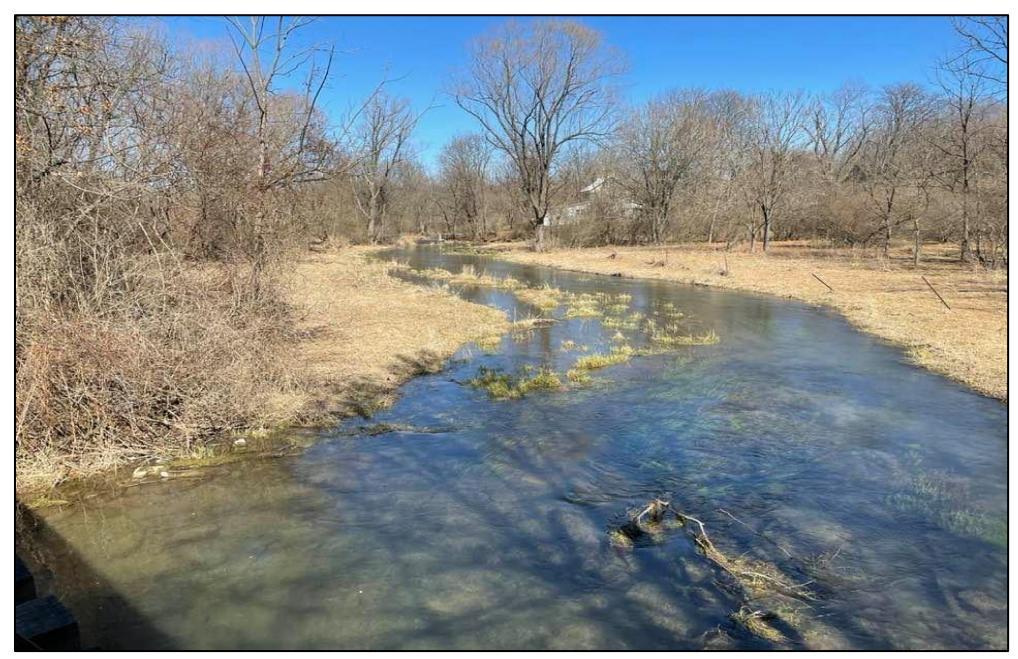
This reach begins at the Letort Rail Trail bridge and continues downstream to the I-81 bridge (Figure 3). It is a meandering stretch of stream with optimal stream-side habitat. For the vast majority of the reach the stream banks are well vegetated and stable. The riparian zone is wide and fairly diverse providing the stream good buffering from overland runoff. Just downstream from the Letort Rail Trail bridge sections of gravel substrate can be seen in deeper runs cut between the vegetation providing deep water and overhead cover for fish. The vegetation and gravel provide good habitat and substrate for insects and crustaceans. Unfortunately, in-stream habitat for fish and macroinvertebrates is sub-optimal for the reach overall due to sediment deposition.

Figure 3. Main Letort Spring Run, Reach 2, looking downstream from the Letort Rail Trail bridge which is located downstream from Union Quarries.

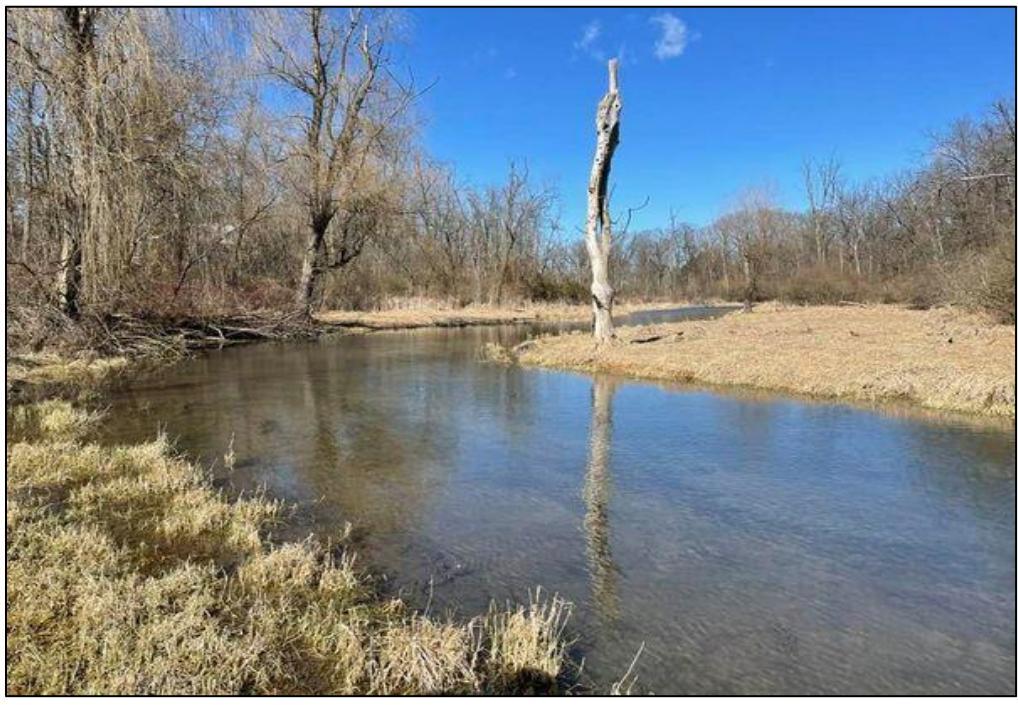
Further downstream a couple hundred meters the stream is virtually devoid of all submerged vegetation (Figure 4). The substrate consists of a thick layer of silt from bank to bank rendering this section mostly uninhabitable for a good fish and macroinvertebrate community. The exact upstream and downstream extent of this non-vegetated reach should be further documented. The cause of the condition is presently unknown.

Figure 4. Main Letort Spring Run, Reach 2, looking downstream. Location is approximately 200 meters downstream from Letort Rail Trail bridge.

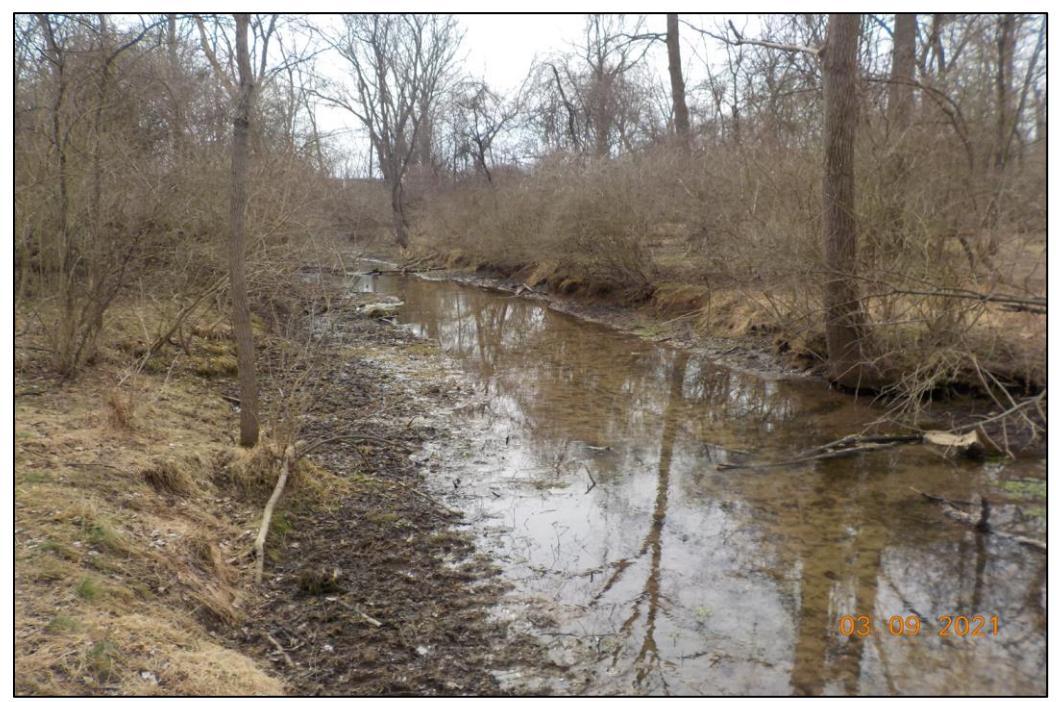
The upper limit of this reach starts at the Rt. 34 bridge and ends at the confluence with the large spring-fed flow on the east side of the Capone property. This area was formerly known as the Spott's Dam portion of the B&W Quality Growers watercress farm. Over half of this reach is bordered on both sides by property owned by Hempt Brothers, Inc. which is wooded. The lower portion is bordered on the northwest side by residential land that for the most part is partially wooded along the stream corridor. The southeast side of the lower portion is the former watercress farm property which is wooded along the stream corridor. There were no signs of significant overland sediment input along the entire reach. Nonetheless, the entire streambed is laden with a thick layer of sediment and minimal vegetation (Figure 6).

Figure 6. Bonny Brook Branch of Letort Spring Run, Reach 1, looking upstream. Location is approximately 250 meters downstream from Rt. 34.

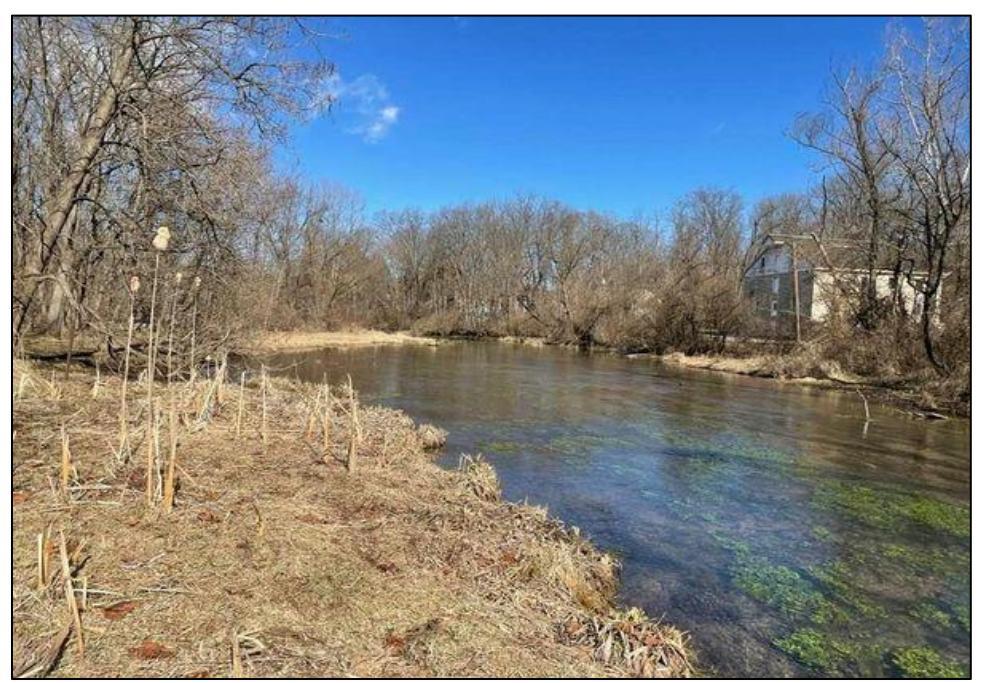
Further downstream the stream widens (Figure 11). This is especially significant along the stretch owned by the Cumberland Valley Chapter of Trout Unlimited. This area is known as Trego's Meadow.

Figure 11. Bonny Brook Branch, Letort Spring Run, Reach 2, looking downstream. The left side of the frame is the property owned by the Cumberland Valley Chapter of Trout Unlimited.
