Bullion Run Conservation Plan

Plan was prepared by the Venango Conservation District

December 2020

Addendum to Coldwater Heritage Partnership Planning Grant

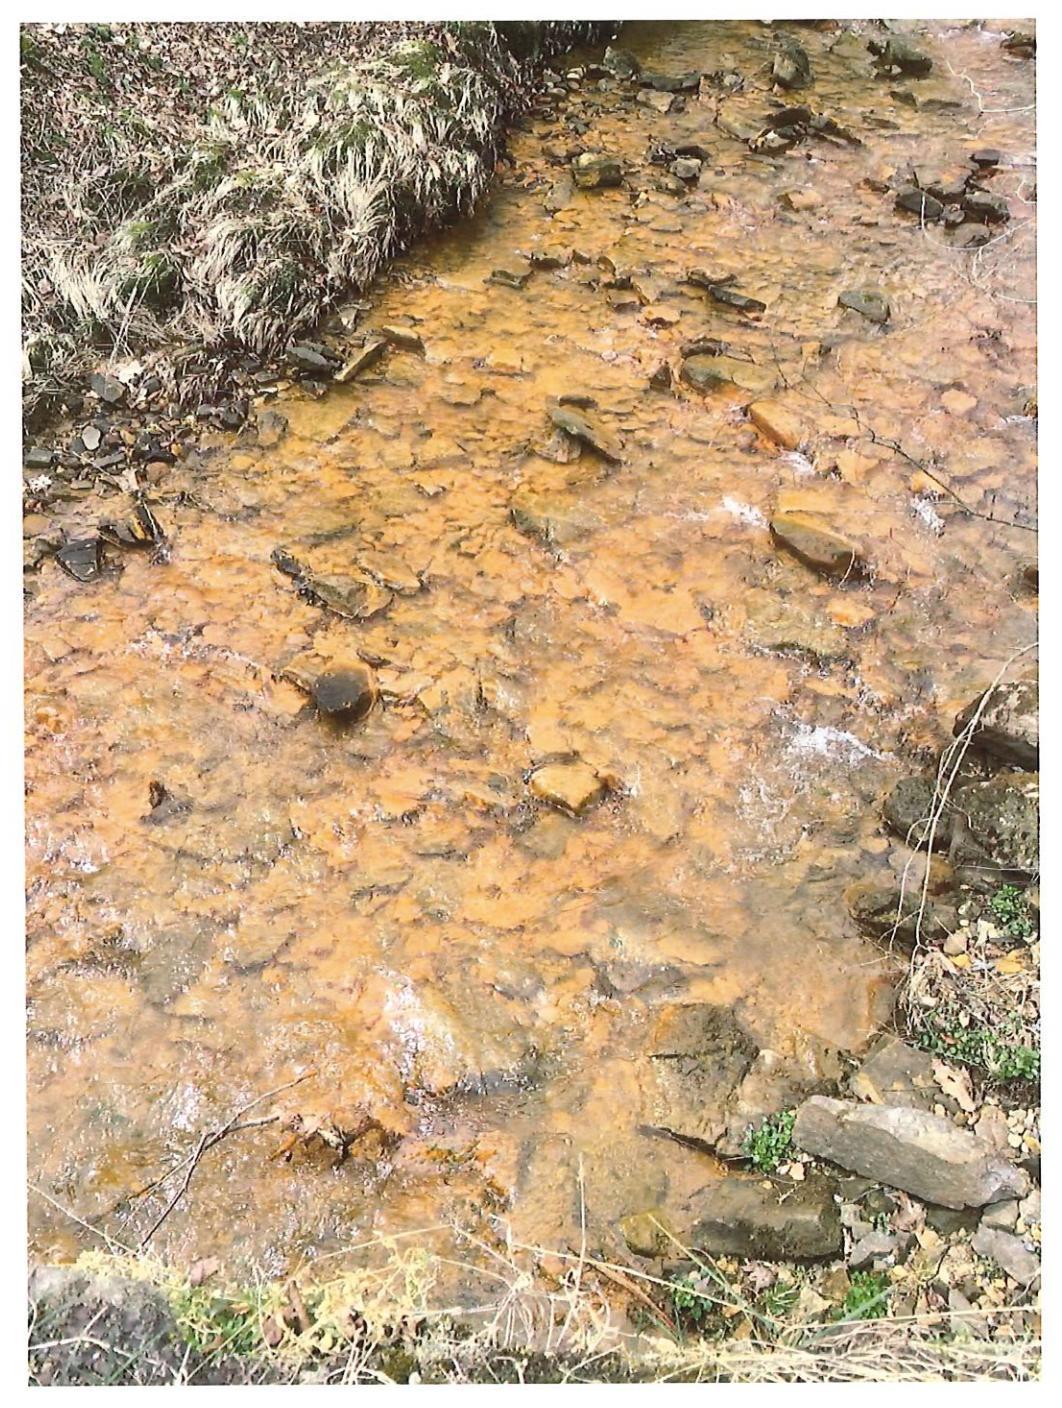
Lastly, Station #7, which contained no species of fish can believed to be the result of the data collected on the impaired streams in Bullion. Station #7 stream section is considered to be impaired by heavy metals, which was evident during sampling of severe iron deposition. Station #8 did contain fish species, but no trout. This was in the headwaters of Bullion and was severely filled with sediment and little habitat. Most of surrounding landscape is agriculture and also road stormwater run-off is common in this stretch from both local and state highways. Even though these two stations lack trout and fish species, at Station #6, we documented a very healthy population of trout species, predominantly Brook Trout, which was never documented by Pennsylvania Fish and Boat Commission. That stream section is now considered a reproductive trout stream section.

Picture 4. Iron deposition at Station #7.

2.1) Possibly try to determine source of pollution and seek grant funding to potentially correct impairment. This could allow for fish and macroinvertebrate communities to re-establish in this section.

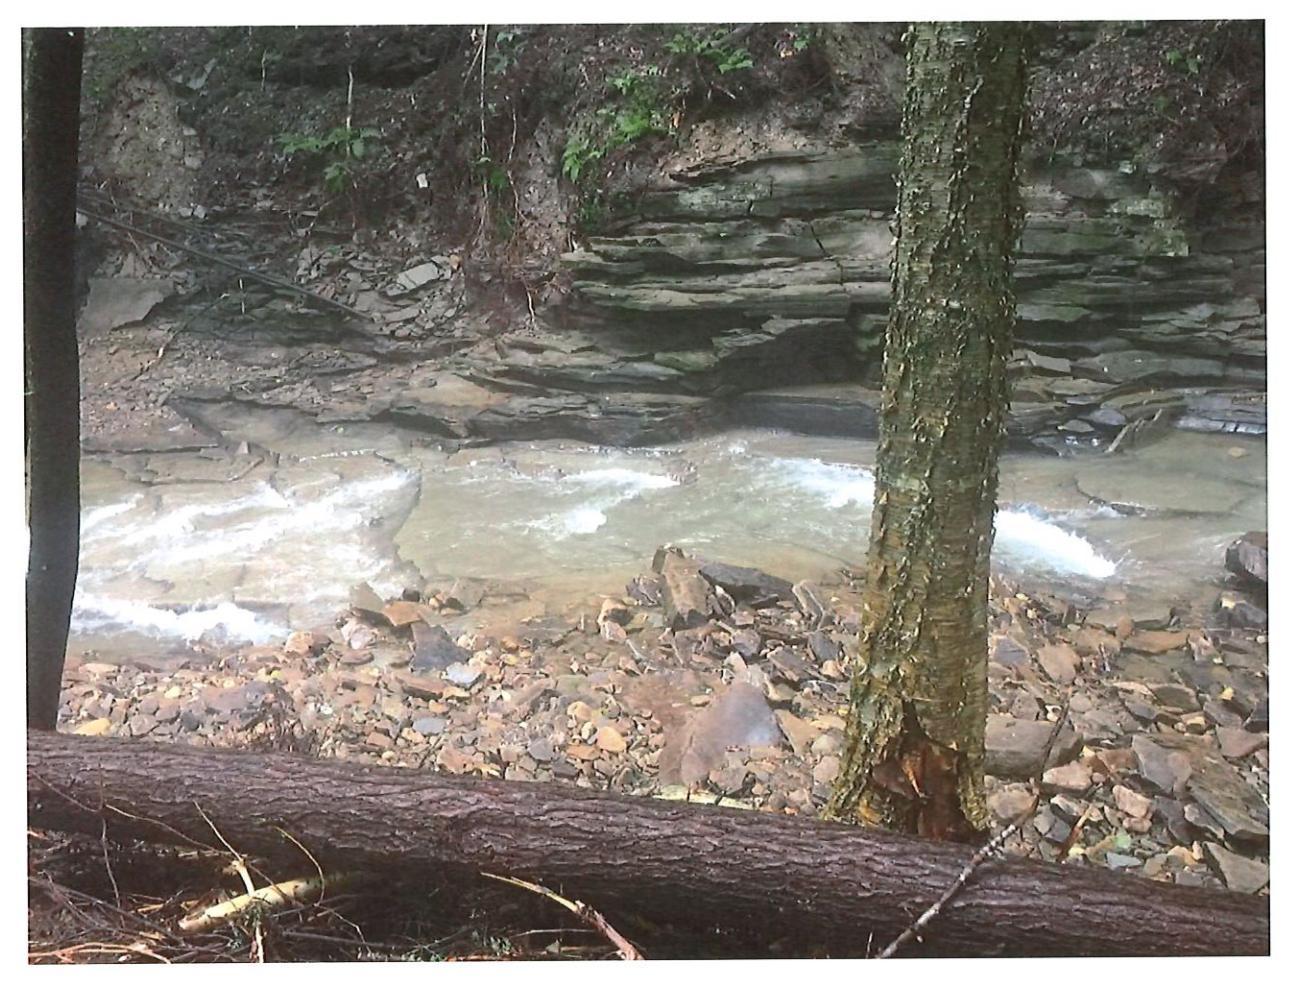
Picture 5. Bedrock substrate noted during habitat assessment.

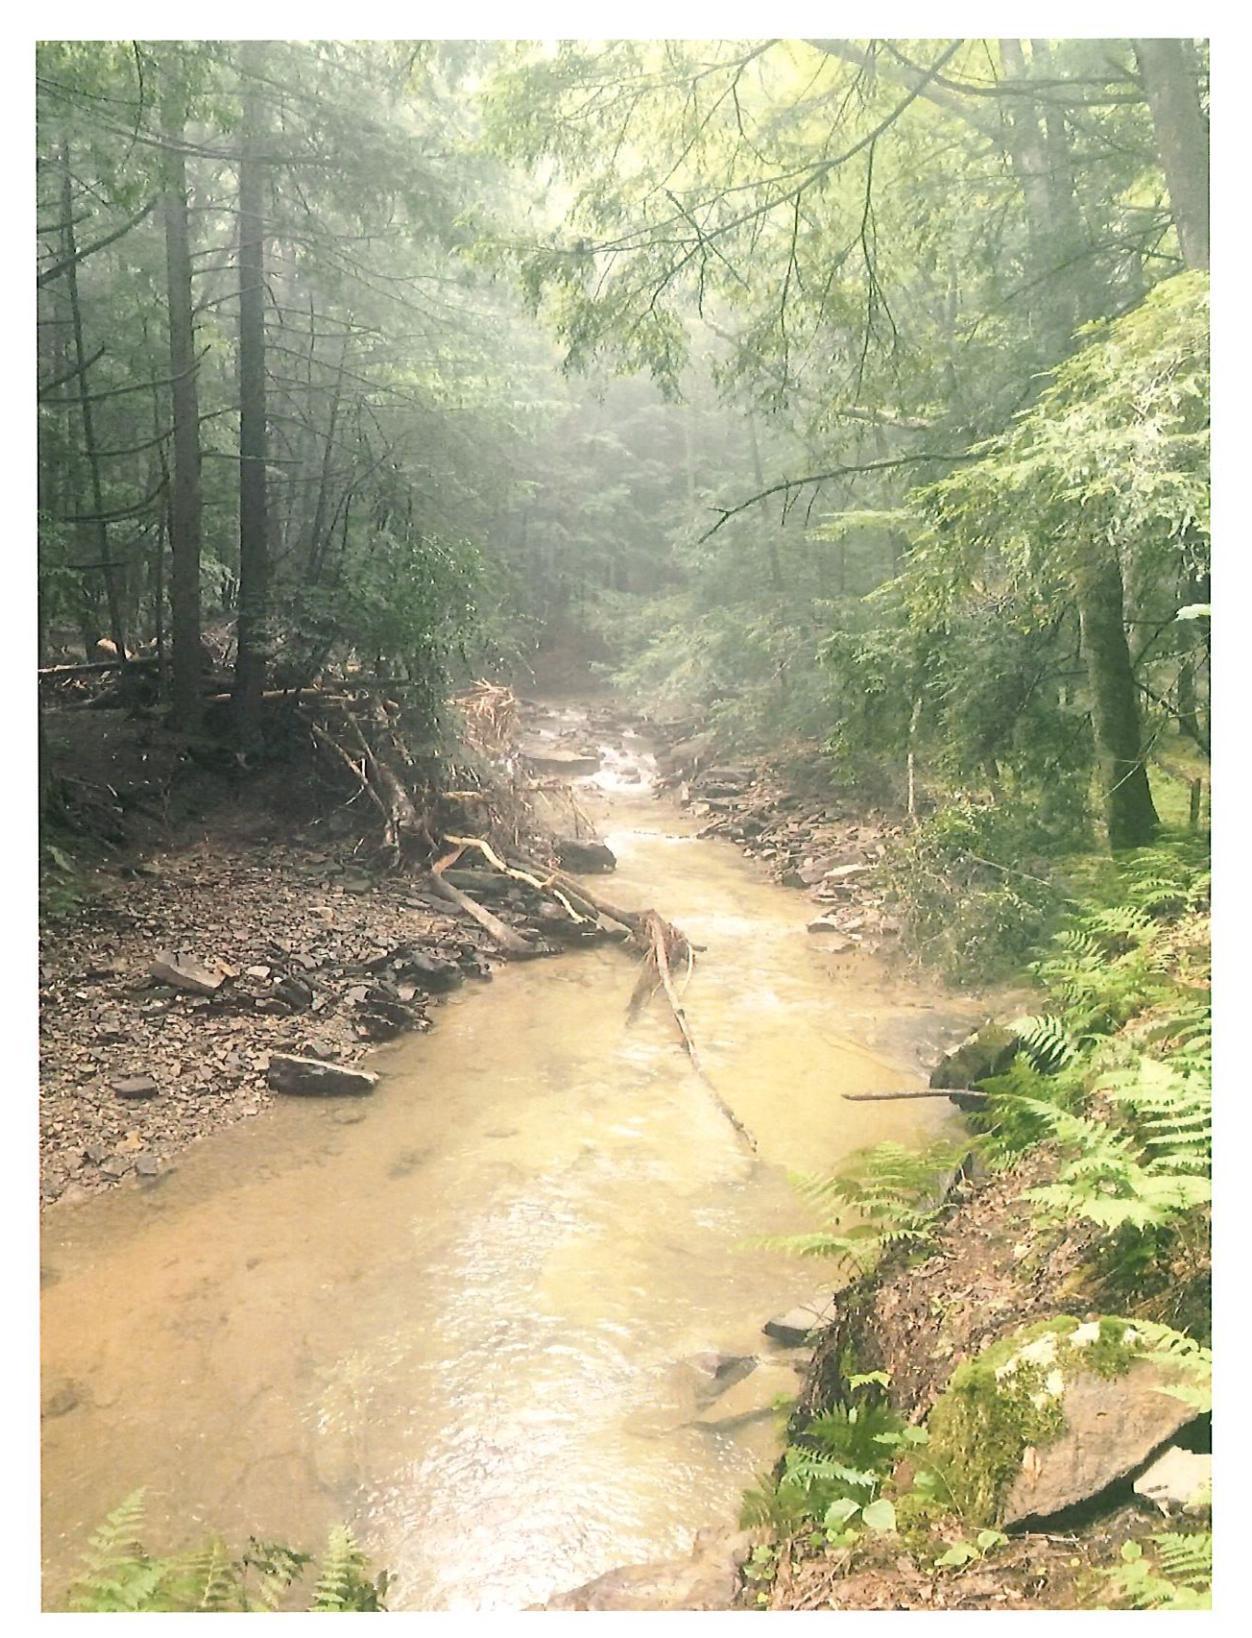
Picture 6. Severe embeddedness during habitat assessment. This was after major rainfall event noted.

- Further fish habitat enhancement/streambank stabilization devices should be implemented throughout watershed. This will address the habitat assessment reported by offering additional habitat while destressing scoured banks documented throughout watershed.
- Detailed chemical sampling throughout the watershed, but specifically at Station #7 where the Department of Environmental Protection has listed as impaired by heavy metals.

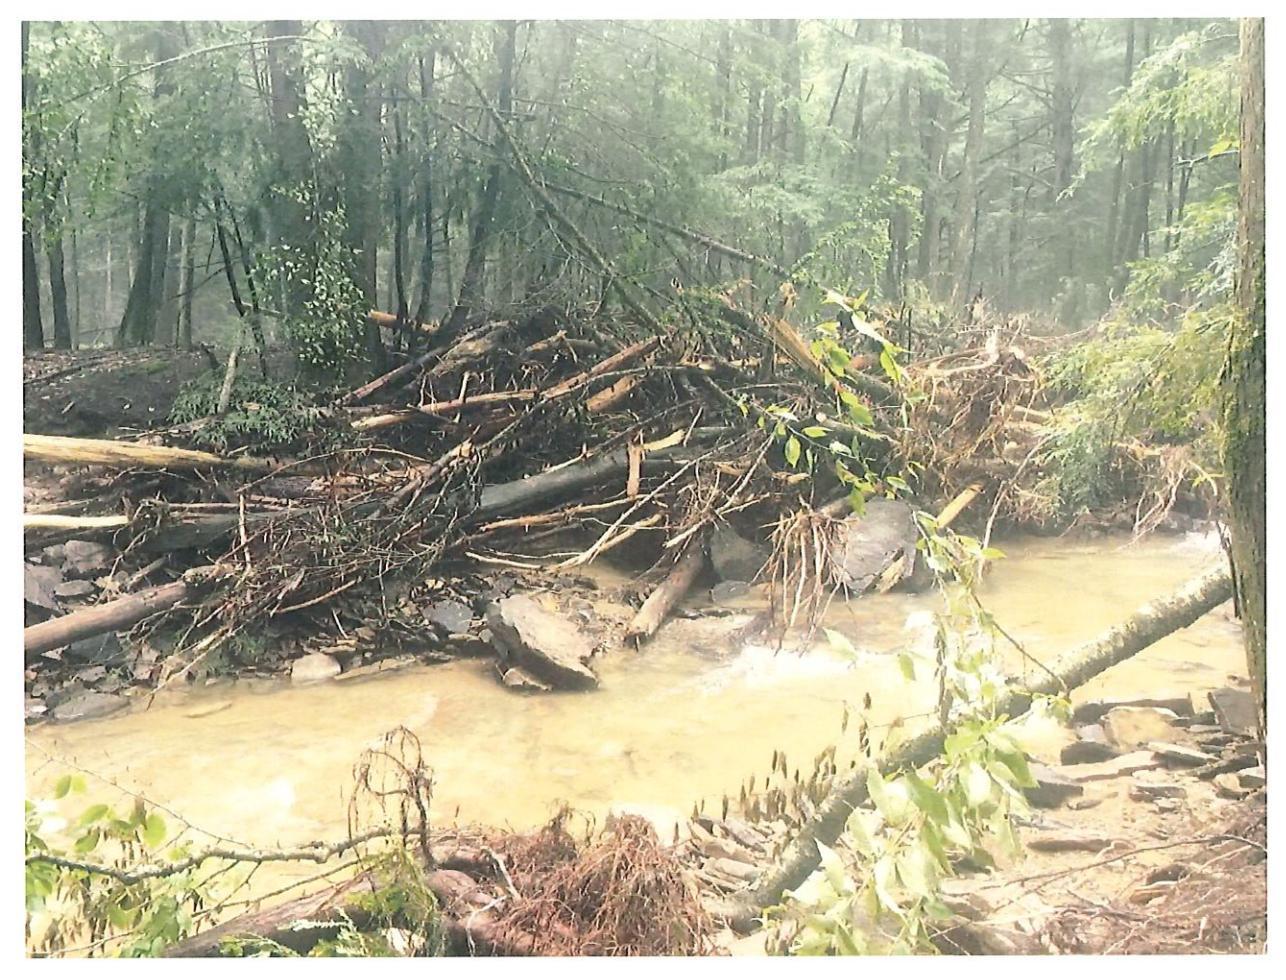
Picture 7. Large amount of debris from severe flooding during rainfall of 2017.

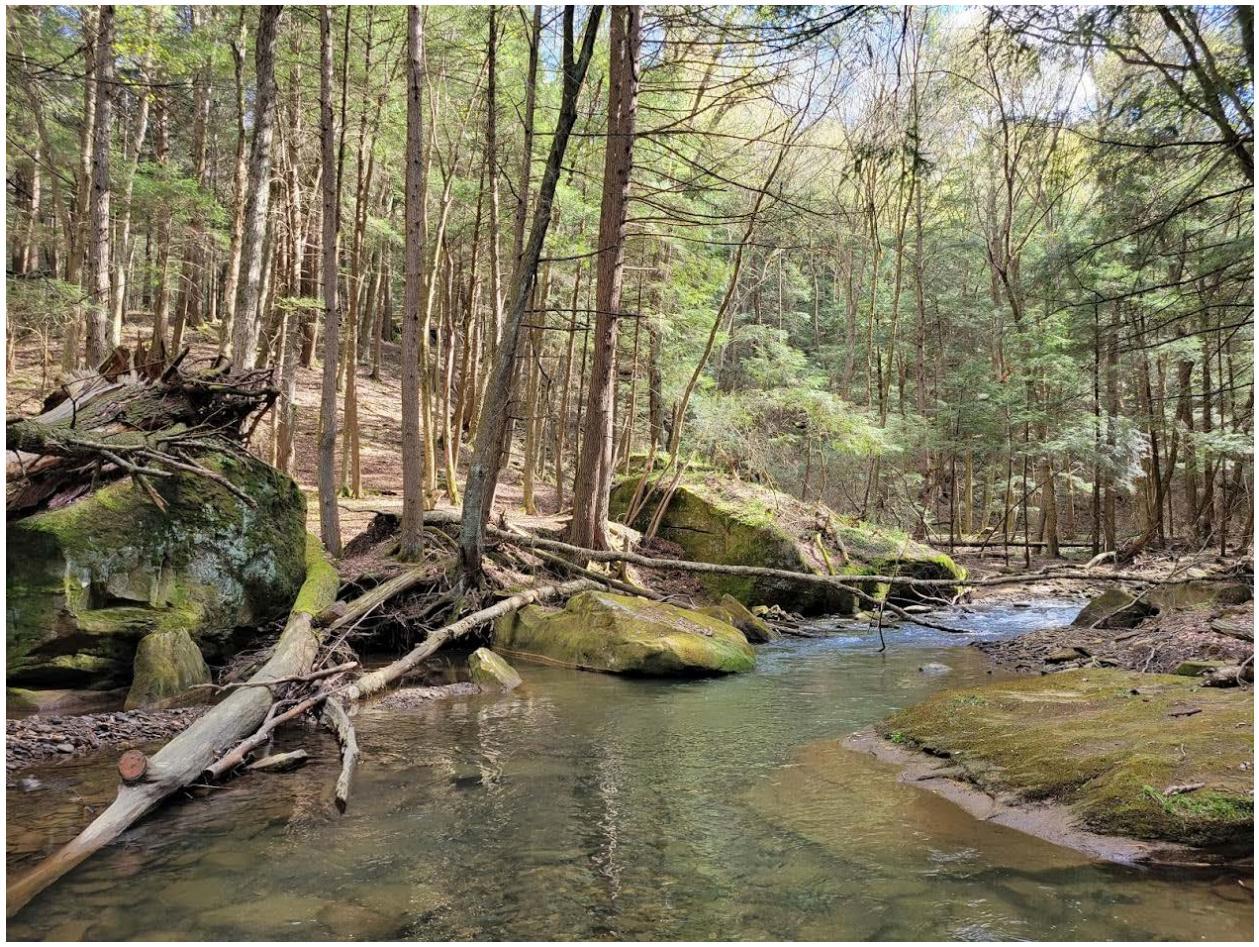
Site BR2 is located upstream of site BR1 on Bullion Run and upstream of a small tributary that is not listed as impaired by DEP. BR2 had adequate instream habitat (Figure 2). Chemical conditions here were similar to that at site BR1, having low or non-measurable concentrations of metals at these sites.

Figure 2. Example of good instream habitat at site BR2.

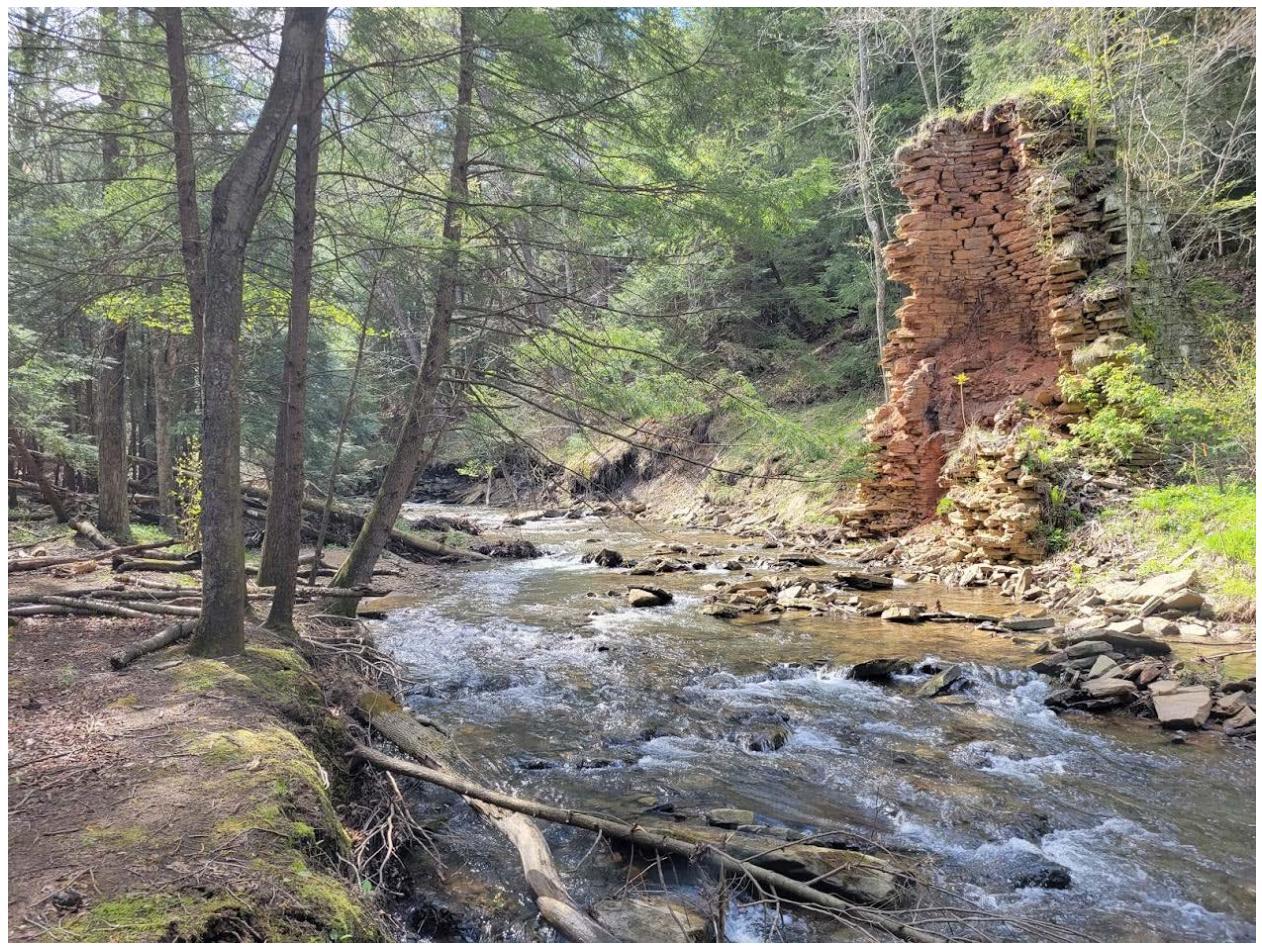
Figure 3. Bullion Run Iron Furnace Ruins located immediately downstream of site BR3. Bank erosion evident in photo is prevalent in this reach.

Bank erosion and sediment loss were noted at multiple sites during this study in addition to the fish habitat and bank stabilization work already being completed. Bullion Run would benefit from additional bank stabilization. The section downstream of site BR5 had notable barren banks that would benefit from bank stabilization (Figure 4).

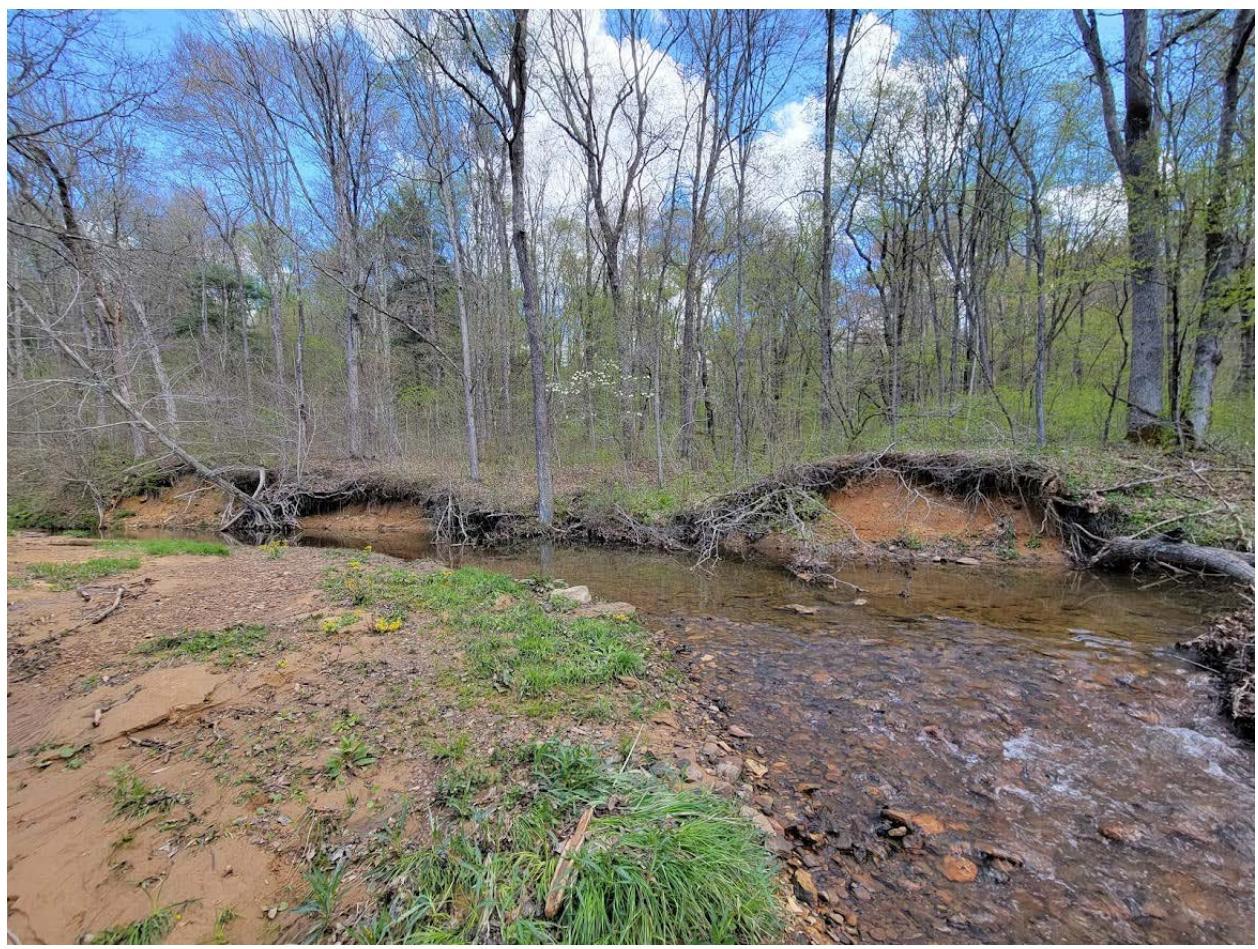
Figure 4. Eroding banks at site BR5.

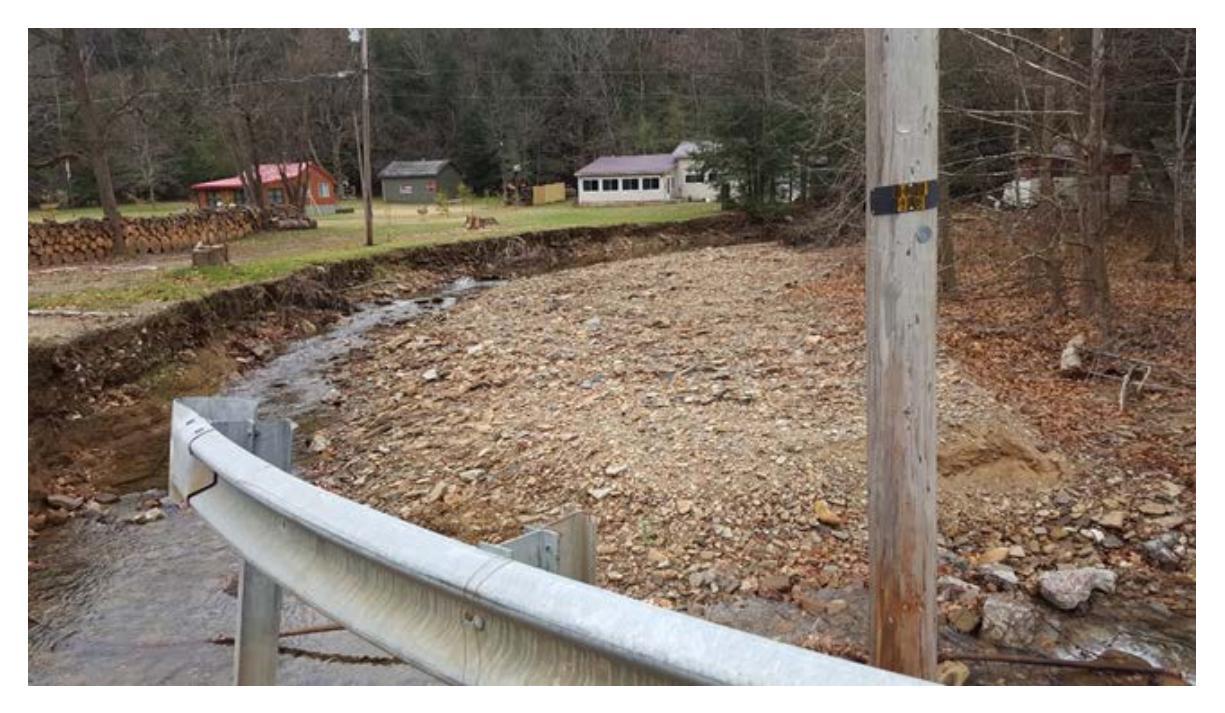
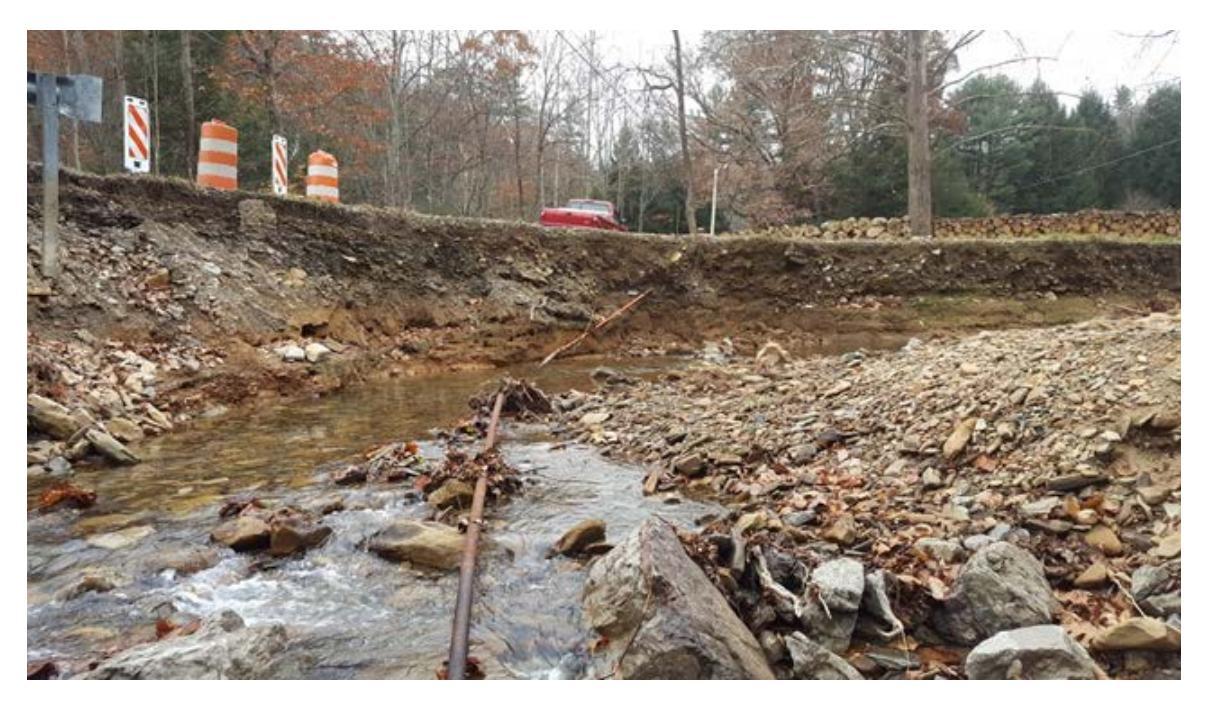
According to watershed members and local landowners, this site had been experiencing bank loss during high flow or rain events over decades that had recently increased in severity. Heavy rain events over a short duration prior to macroinvertebrate sampling caused the movement of many tons of material and the stream channel to move roughly 60 feet from its original channel, taking with it the bank and much of the adjacent property (Figure 6a and 6b). Because of the stream channel movement and weak banks, this site received a marginal habitat score of 107, the lowest habitat score of all sites assessed for this report. Nearly all parameters were negatively affected by the habitat impairments and channel movement. The parameters that received the lowest scores were condition of banks, bank vegetative protection, and disruptive pressure which all scored poor.

Figure 6a. Bullion Run near mouth pre-construction with fresh flood damage.

Figure 6b. Bullion Run near mouth pre-construction with fresh flood damage.

Following documentation of the stream impairments and sediment movement near the mouth of Bullion Run (BR02/2019, BR1/2021) TU coordinated with SCWA, PennDOT, and landowners to facilitate restoration of this site by moving the stream back into it's channel, protecting the banks and road, and adding instream fish habitat (Figure 7a and 7b).

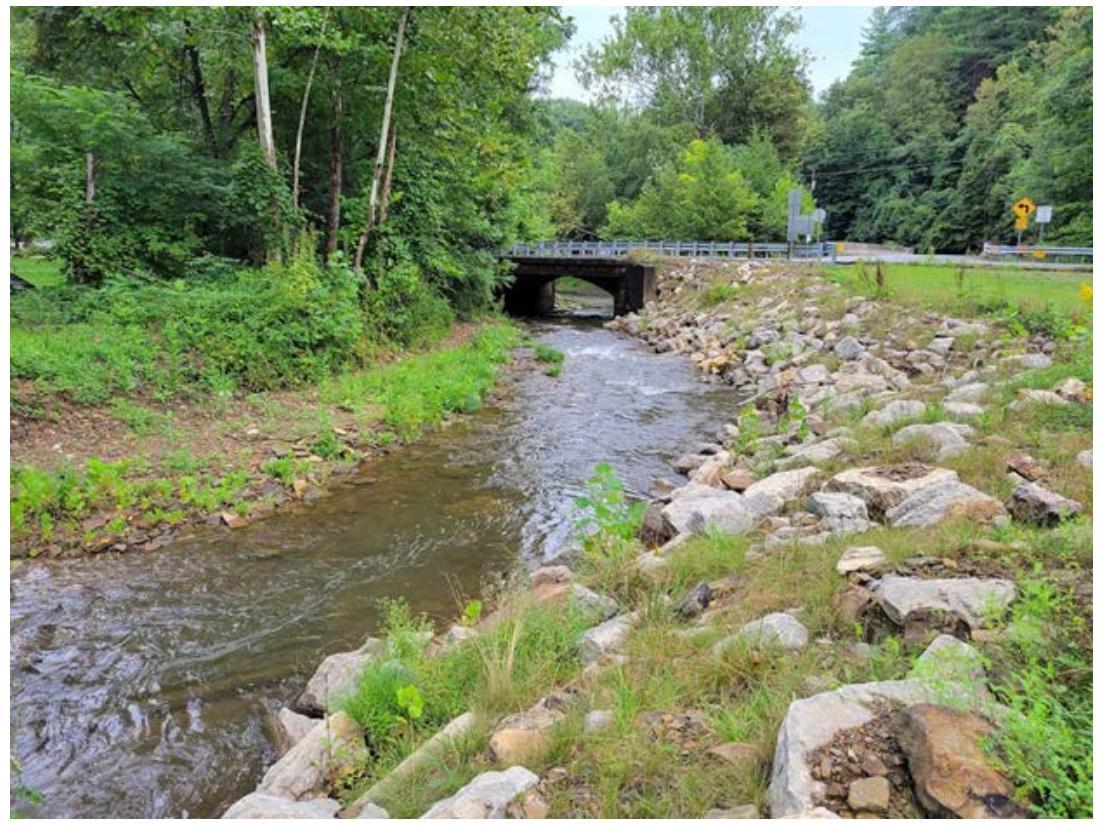
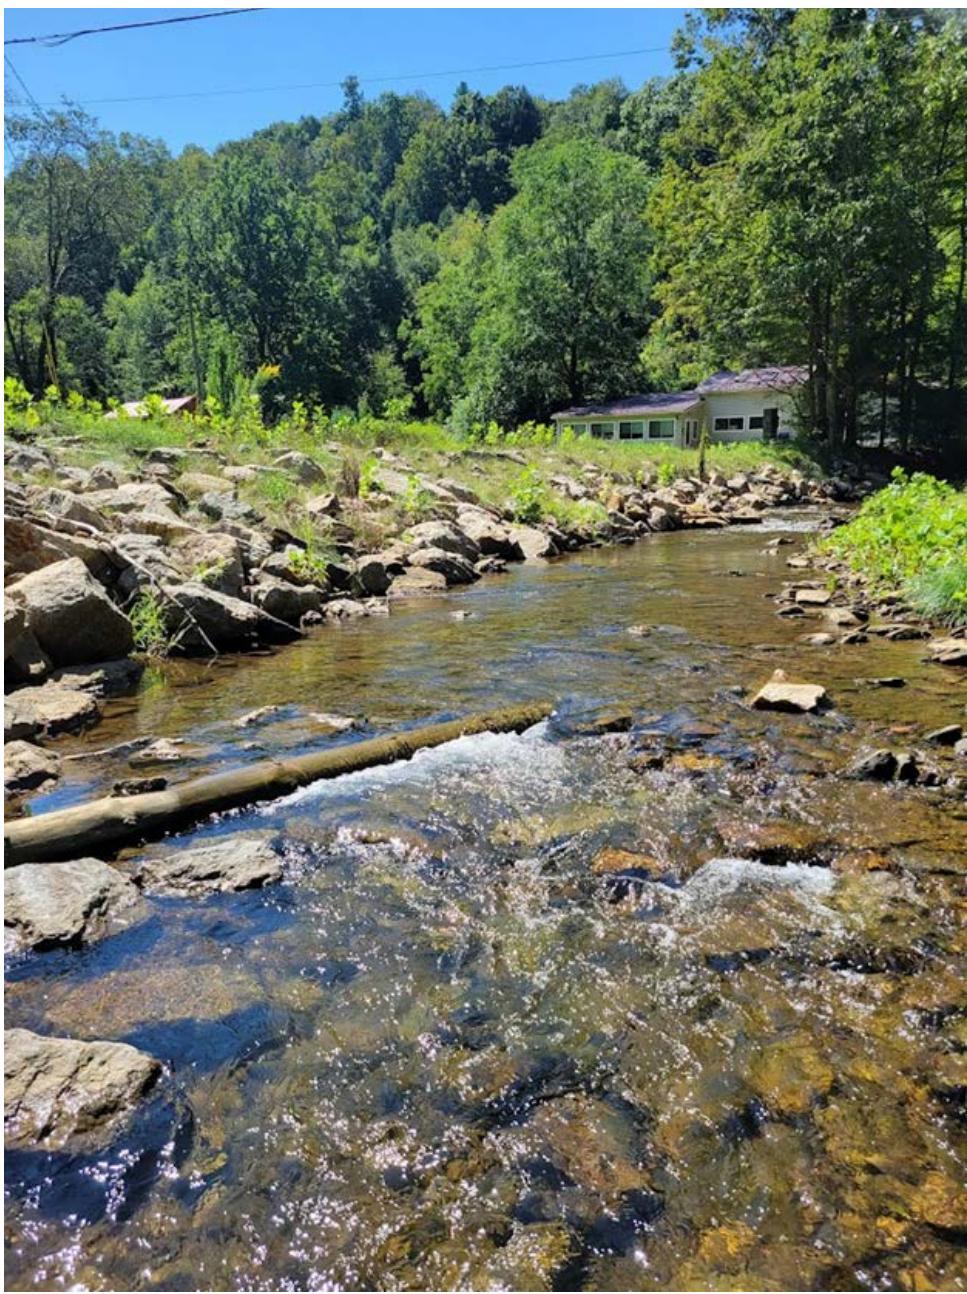
Figure 7a. Bullion Run near mouth post construction (looking downstream).

Figure 7b. Bullion Run near mouth post construction (looking upstream).

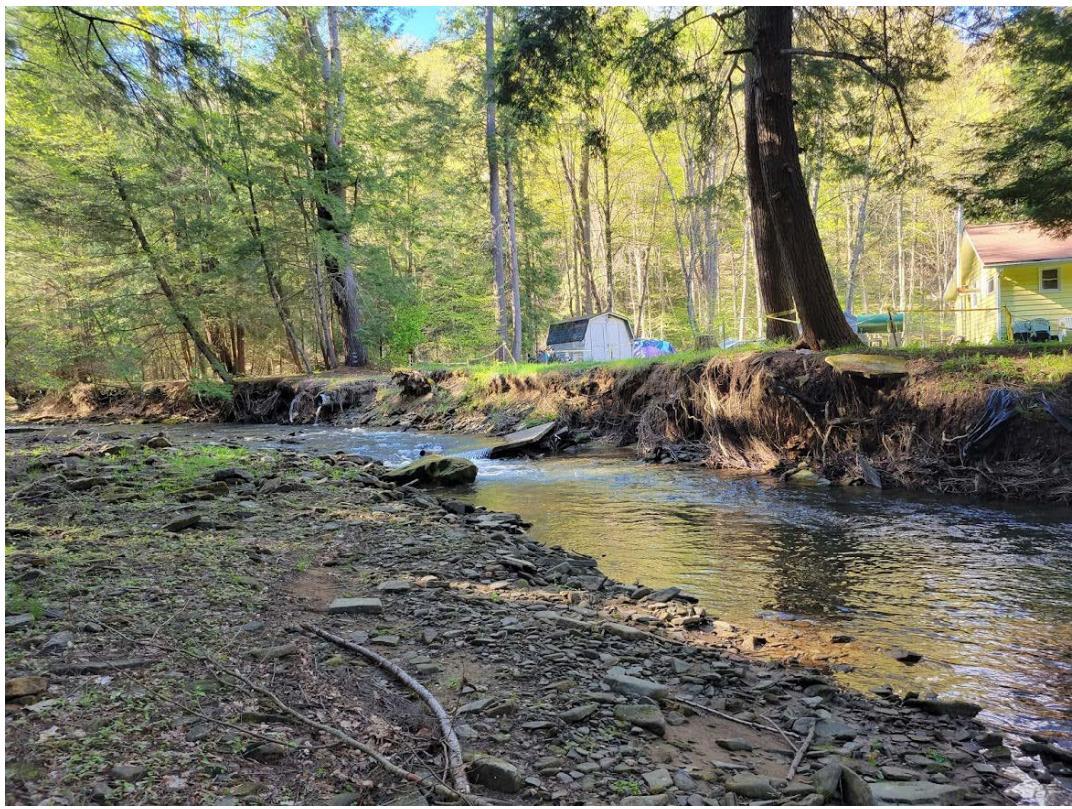
Figure 8. 2021 Habitat site pre-construction.

In 2020 and 2021, additional instream habitat was completed by TU and the SCWA moving upstream from the site near the mouth that was initially restored. Bullion Run flows past a small neighborhood of homes on the left bank and erosion was evident throughout. Figures and show before (Figure 8) and after (Figure 9) the most recent habitat work was completed to stabilize banks and create instream fish habitat.

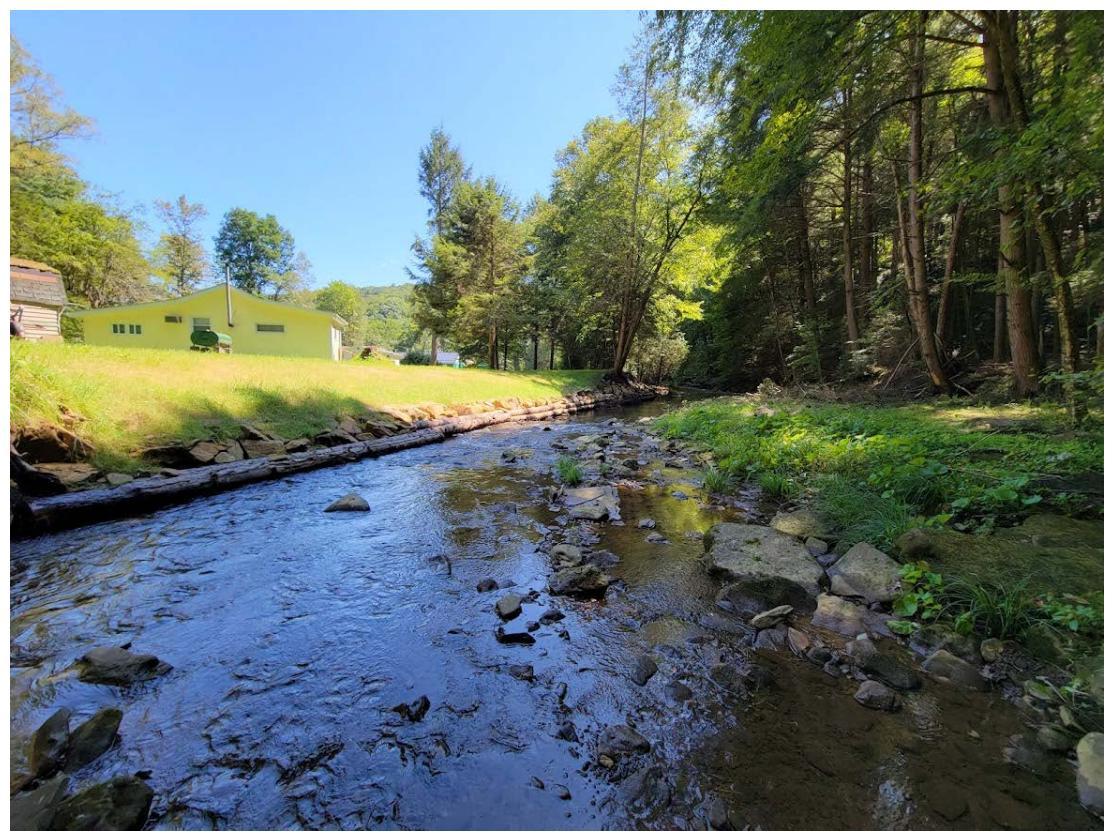
Figure 9. 2021 Habitat site post construction.
