Farnsworth Branch COLDWATER CONSERVATION PLAN Warren County

July 2021

Warren County Conservation District

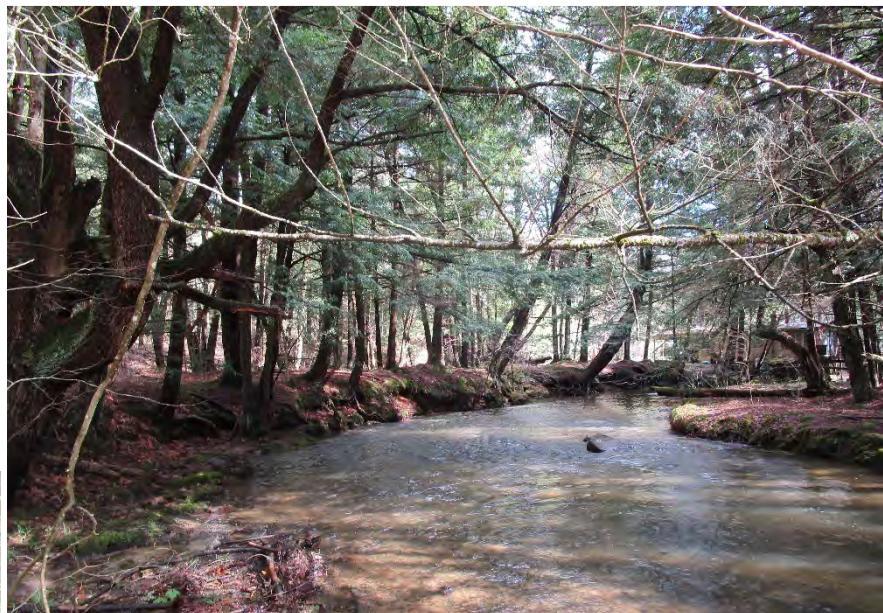
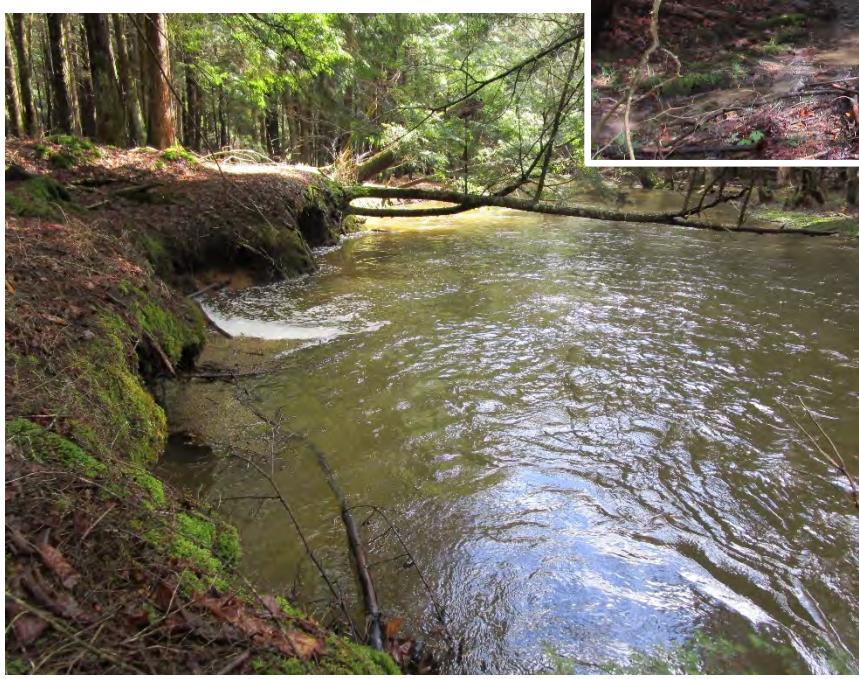
Segment 5522b	N 41.75414, W -79.11969
	N 41.755788, W -79.117730
Description: Erosion on left descending bank (LDB)	
Recommendation: Modified mud sills or root wads in both locations.

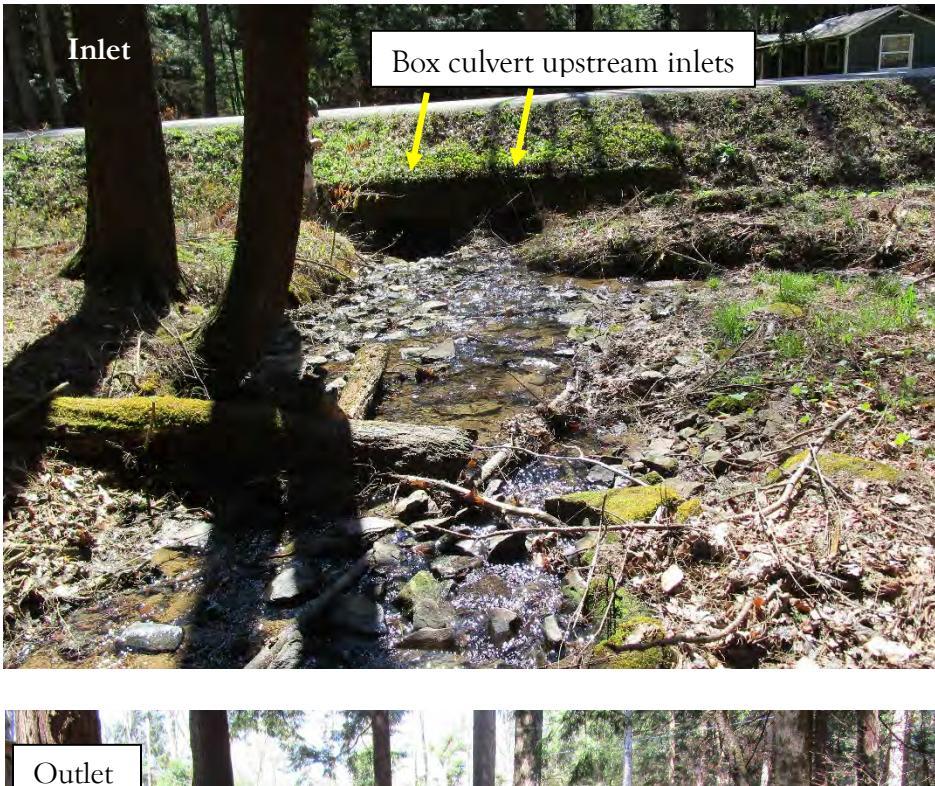
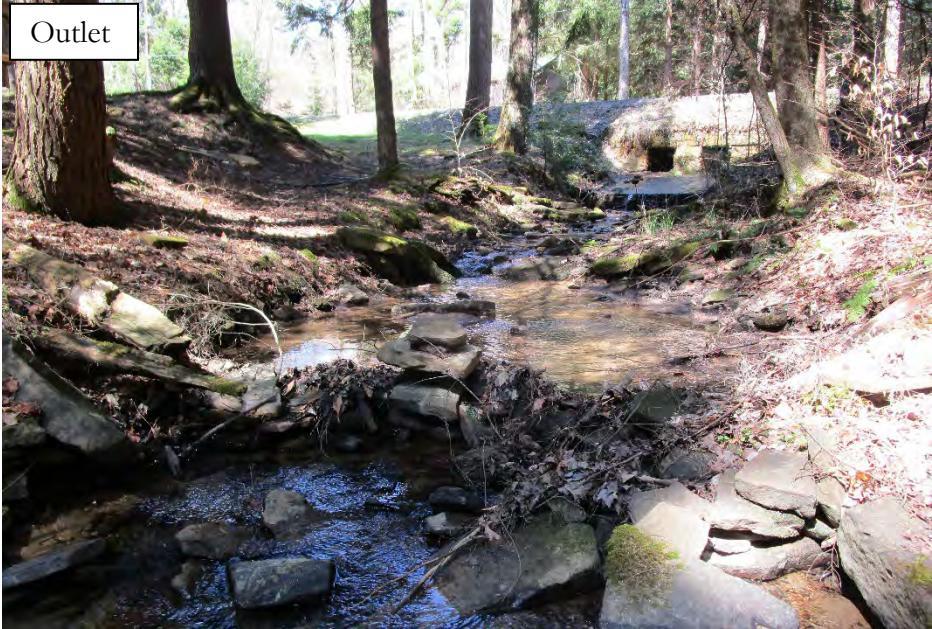
Segment 5523	N 41.75230, W 79.12473
0	,

<u>Description</u>: Concrete box culvert across FR 154 is creating a large pool downstream and there is a debris jam at the upstream side of the culvert which inhibits flow. Manmade hand dam downstream of box culvert also causes AOP blockage.

Recommendation: Resize culvert or replace with bridge. Remove manmade hand dam.

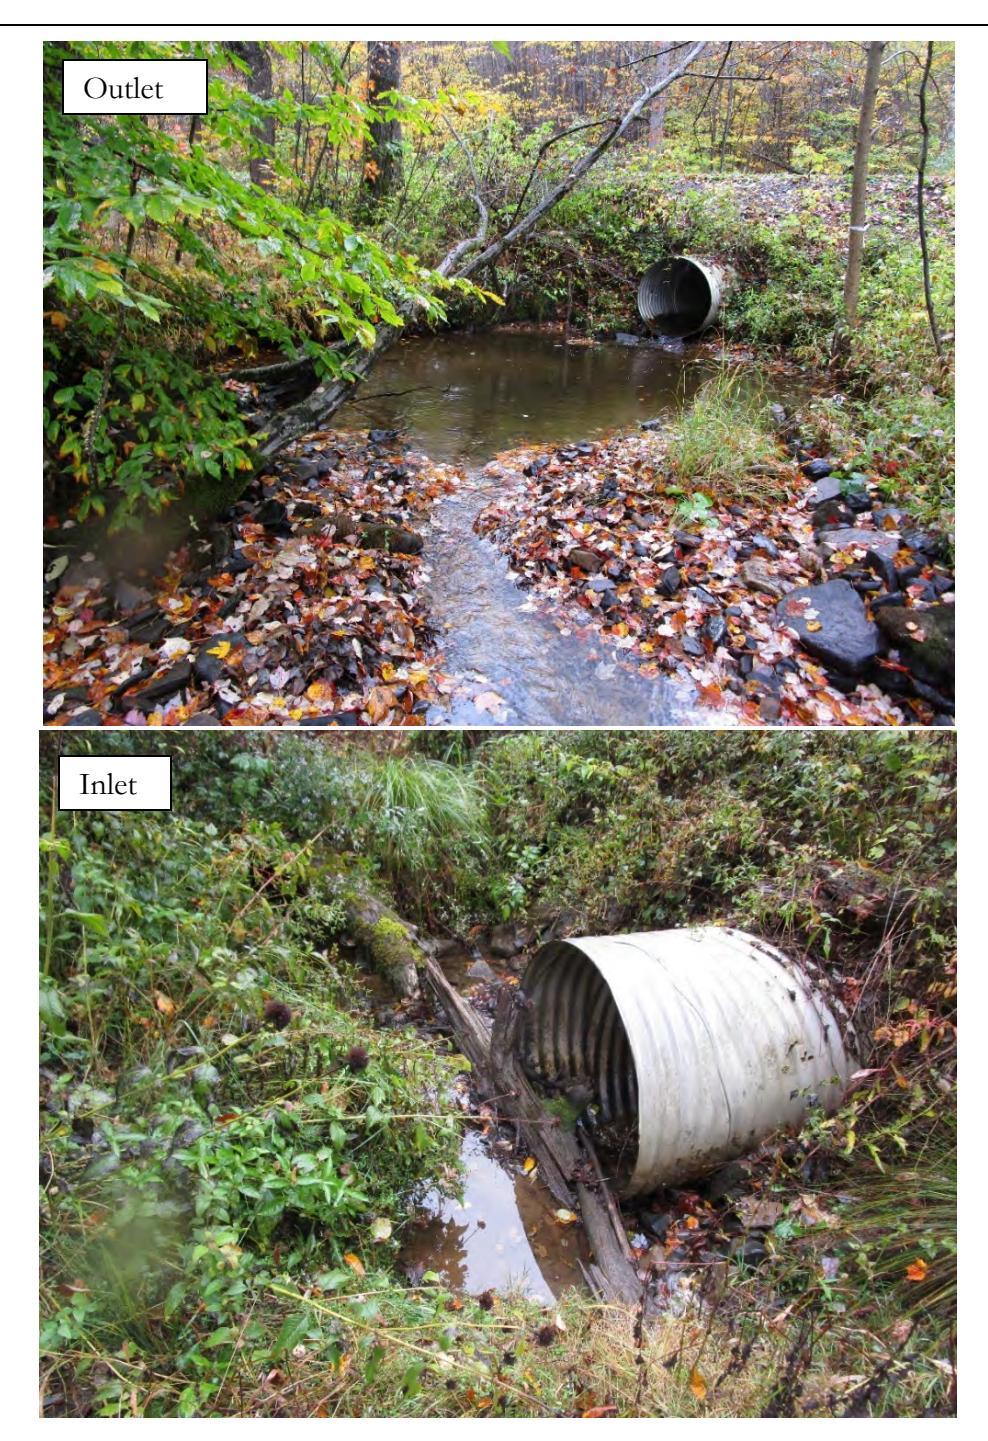
Segment 5550	N 41.74596, W 79.13863

Description: Culvert across FR 154 is creating a large pool downstream and there is a debris jam at the upstream side of the culvert which inhibits flow.

Recommendation: Resizing culvert and replacing with squash pipe.

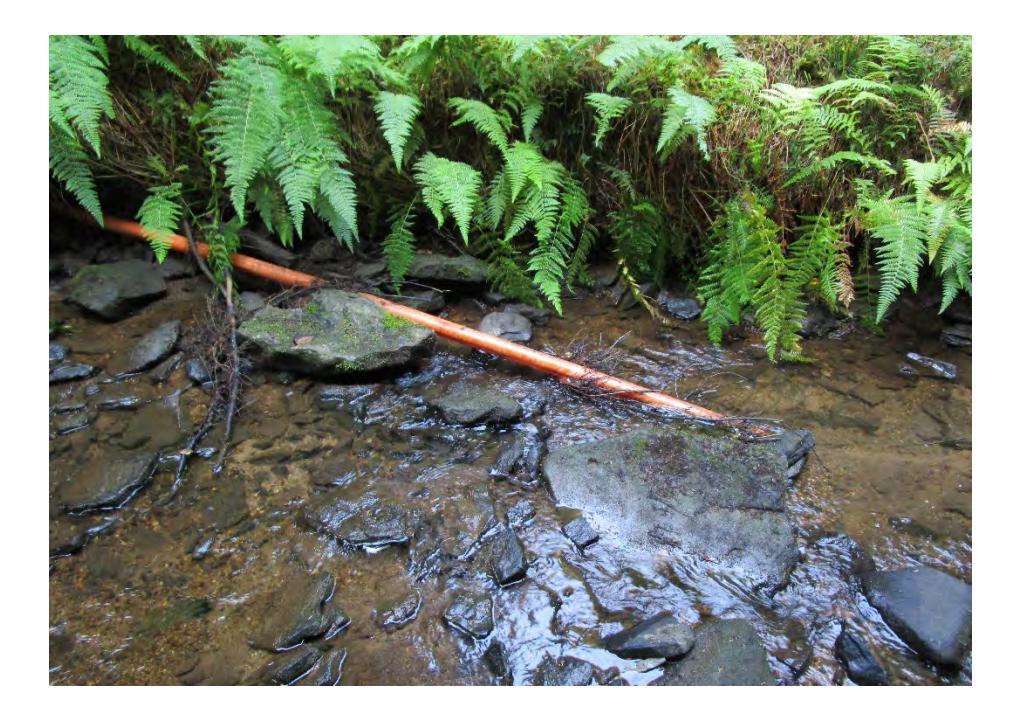
Description: Possible gas line found. State of activity unknown. No oily sheen was found around the pipe or downstream of the pipe.

<u>Recommendation</u>: Determine activity status of pipe.

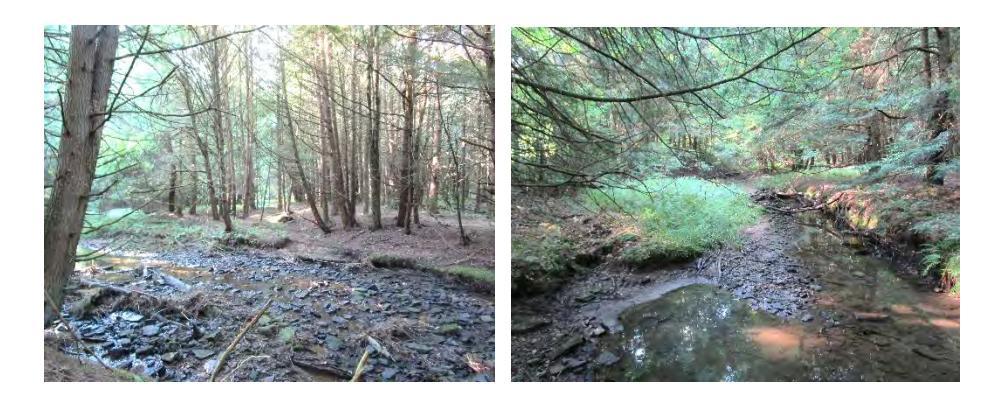
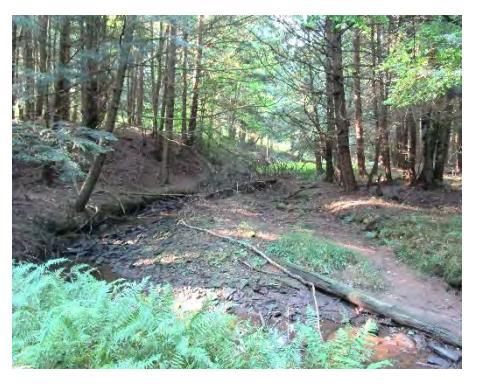
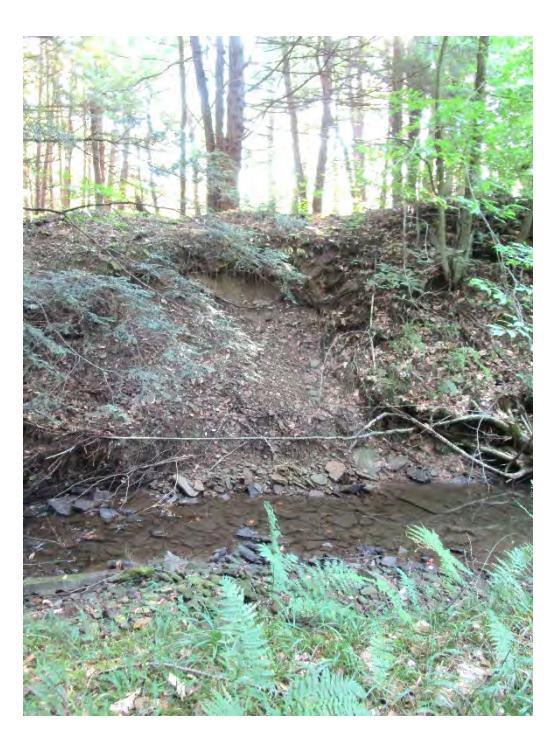
Segment 5551	N 41.745724, W 79.126722 and upstream

Description: Erosion occurs regularly throughout this segment.

<u>Recommendation</u>: There are several opportunities throughout this segment for streambank stabilization / fish habitat structures.

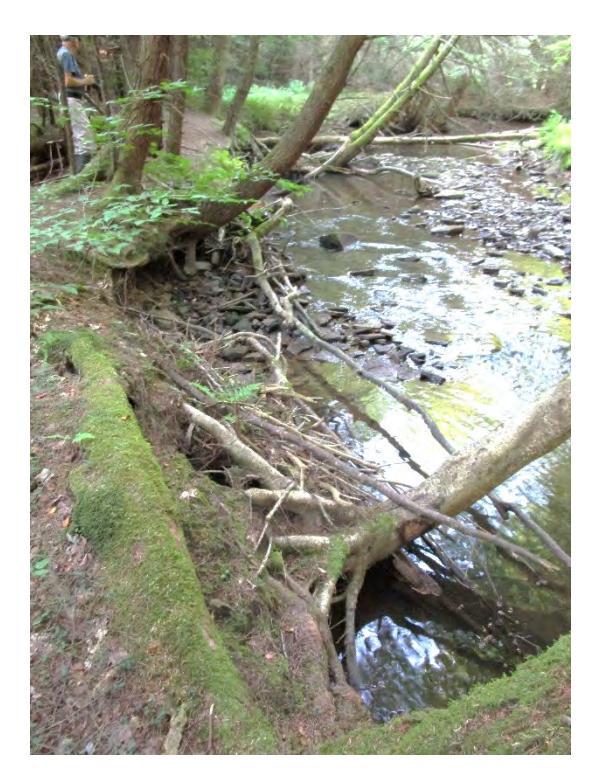
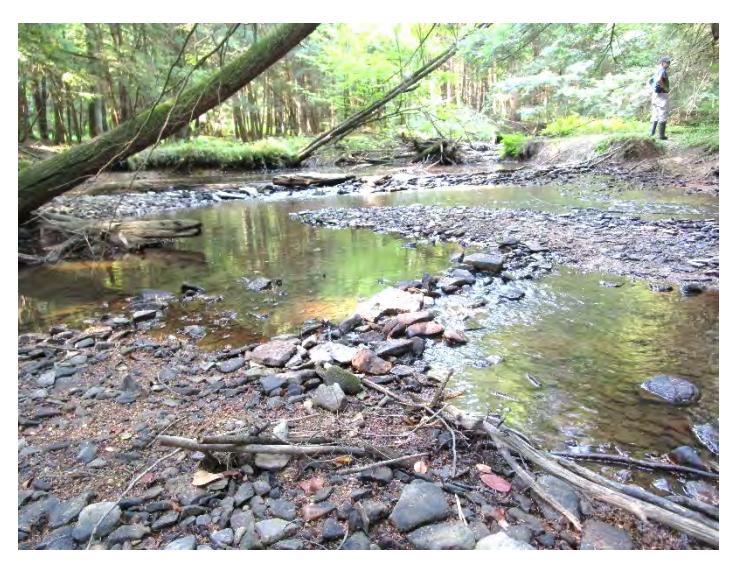
Segment 5551

Description: There is a 15' eroding streambank with 1.5' incised bank that could cause flow problems if it is not addressed.

<u>Recommendations:</u> Stabilize toe of slope and vegetate streambank

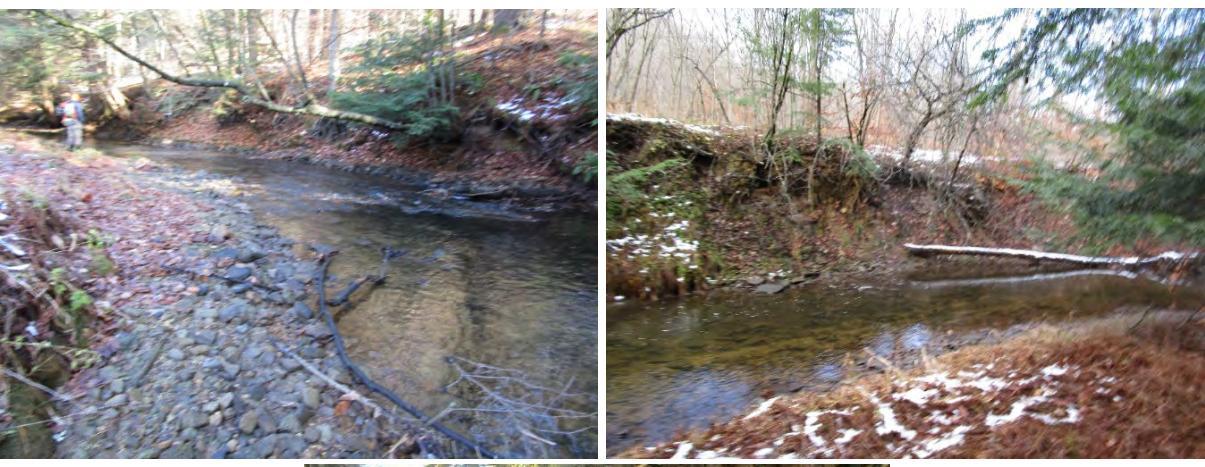
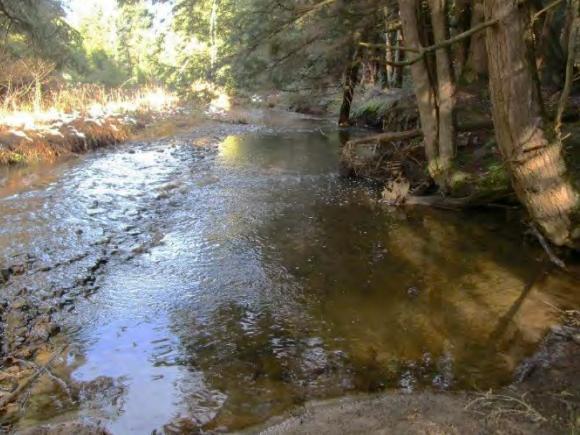
Segment 5603a	N 41.73912, W 79.14917

Description: This segment shows several areas of erosion and incised streambanks.

<u>Recommendation</u>: The gravel bar in the third photo is sending water straight into the right descending bank (RDB). Root wads might work well here to divert water around the bend and protect the streambank. LWM could work to reduce the erosion and incision in other areas.

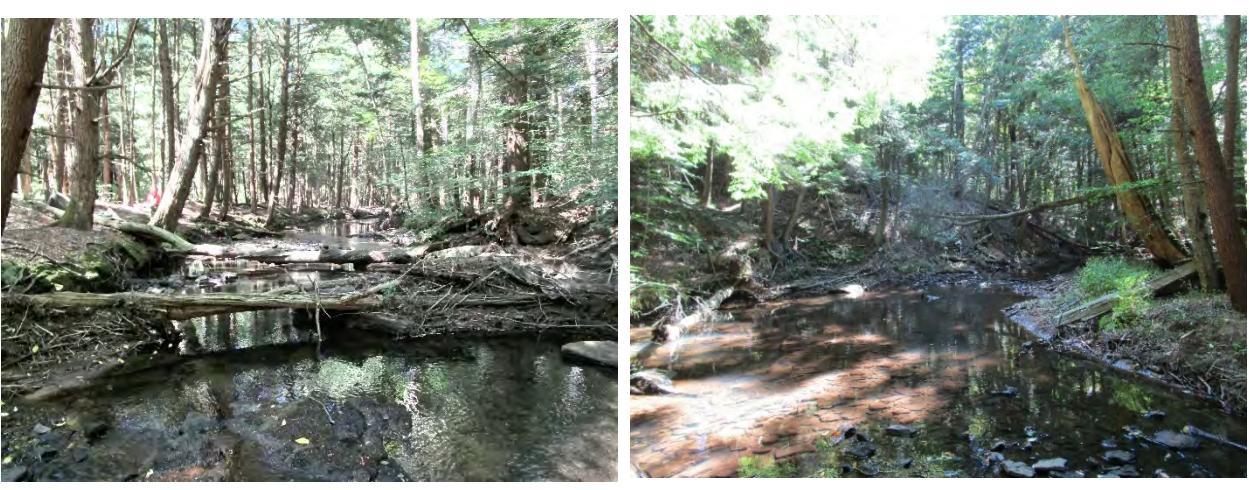
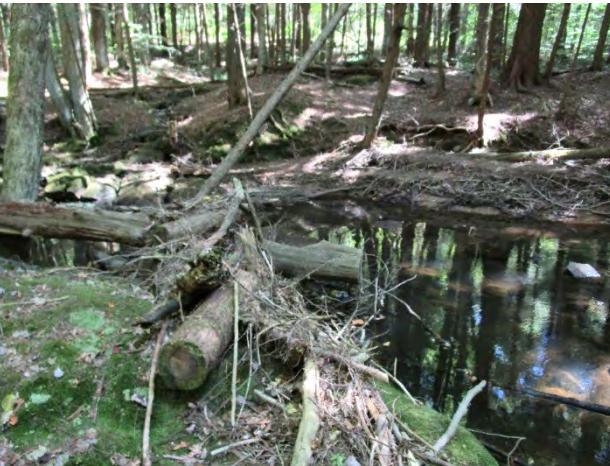
Segment 5658	N 41.7310, W 79.1596 (throughout segment)
	N 41.72652, W 79.15981 (cut logs)

Description: This segment has an abundance of downed wood that can be utilized to create stable structures that will create habitat and protect streambanks. There is also a fair amount of erosion in this segment that could be addressed.

<u>Recommendation</u>: Place LWM in locations of existing wood-fall and install supplemental tree plantings in areas of open space along the stream. We also recommend not cutting logs out of the stream as LWM can add habitat and help protect streambanks from erosion.

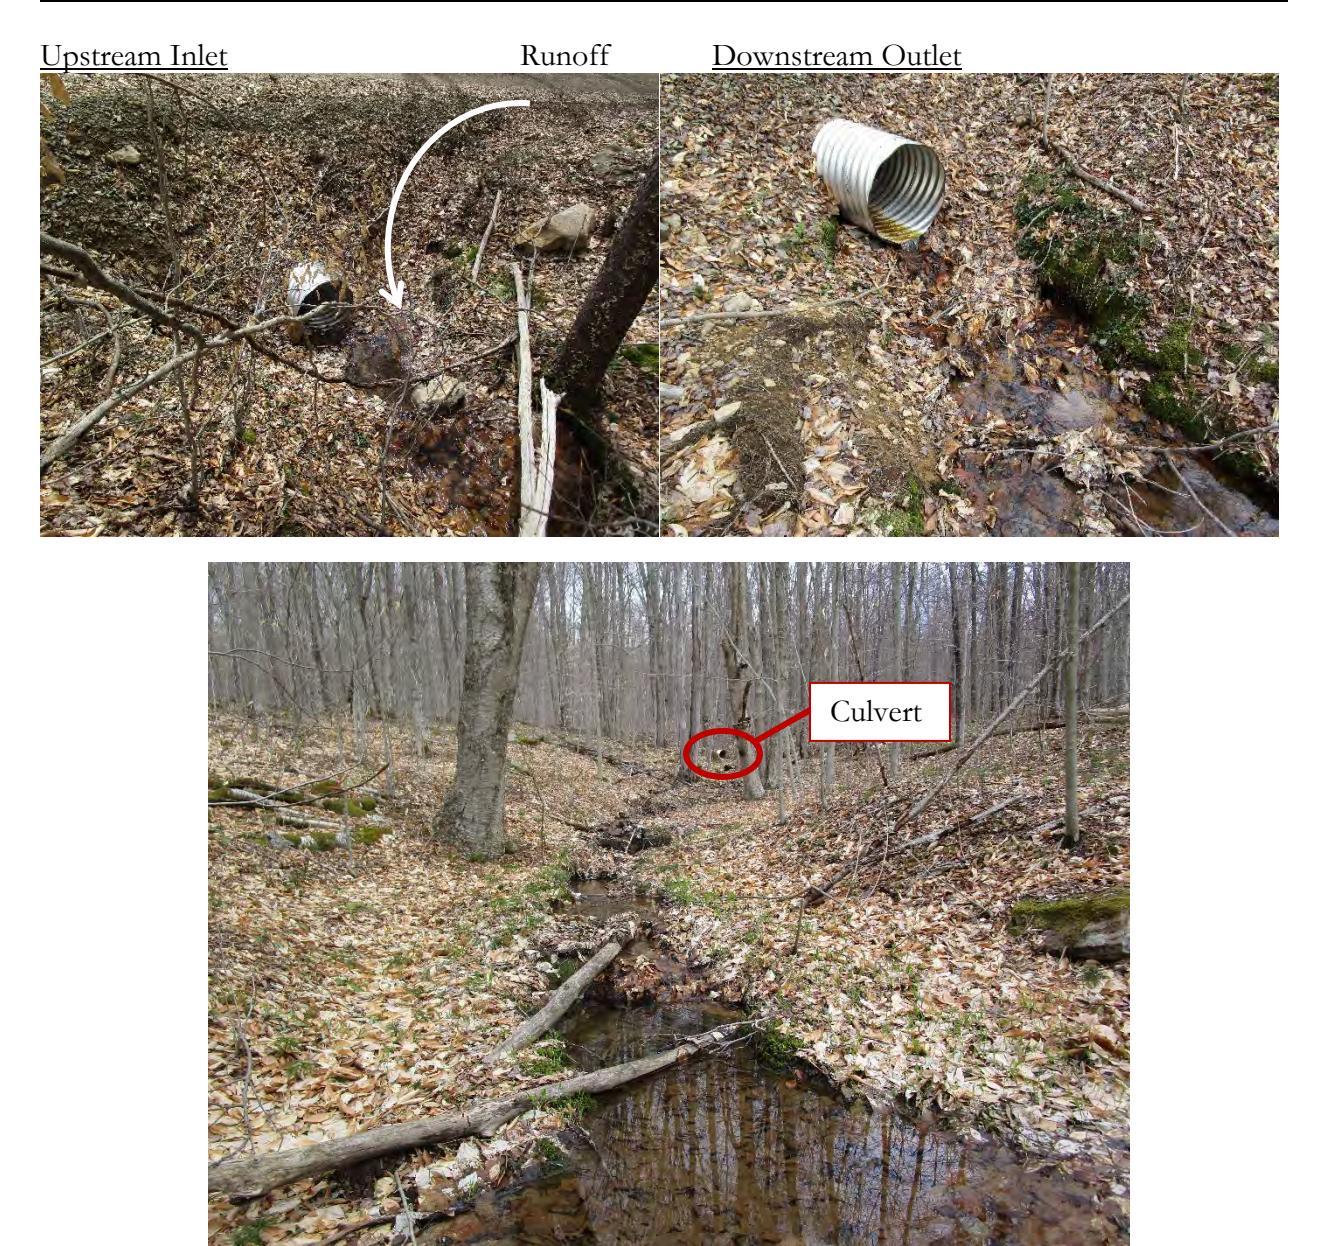
Segment 5662	N 41.72463, W 79.16964

Description: Culvert creating an AOP barrier on the downstream side. There is also possible stormwater runoff entering the stream from FR 252.

<u>Recommendation</u>: Recommend replacing with a resized culvert or a bridge.

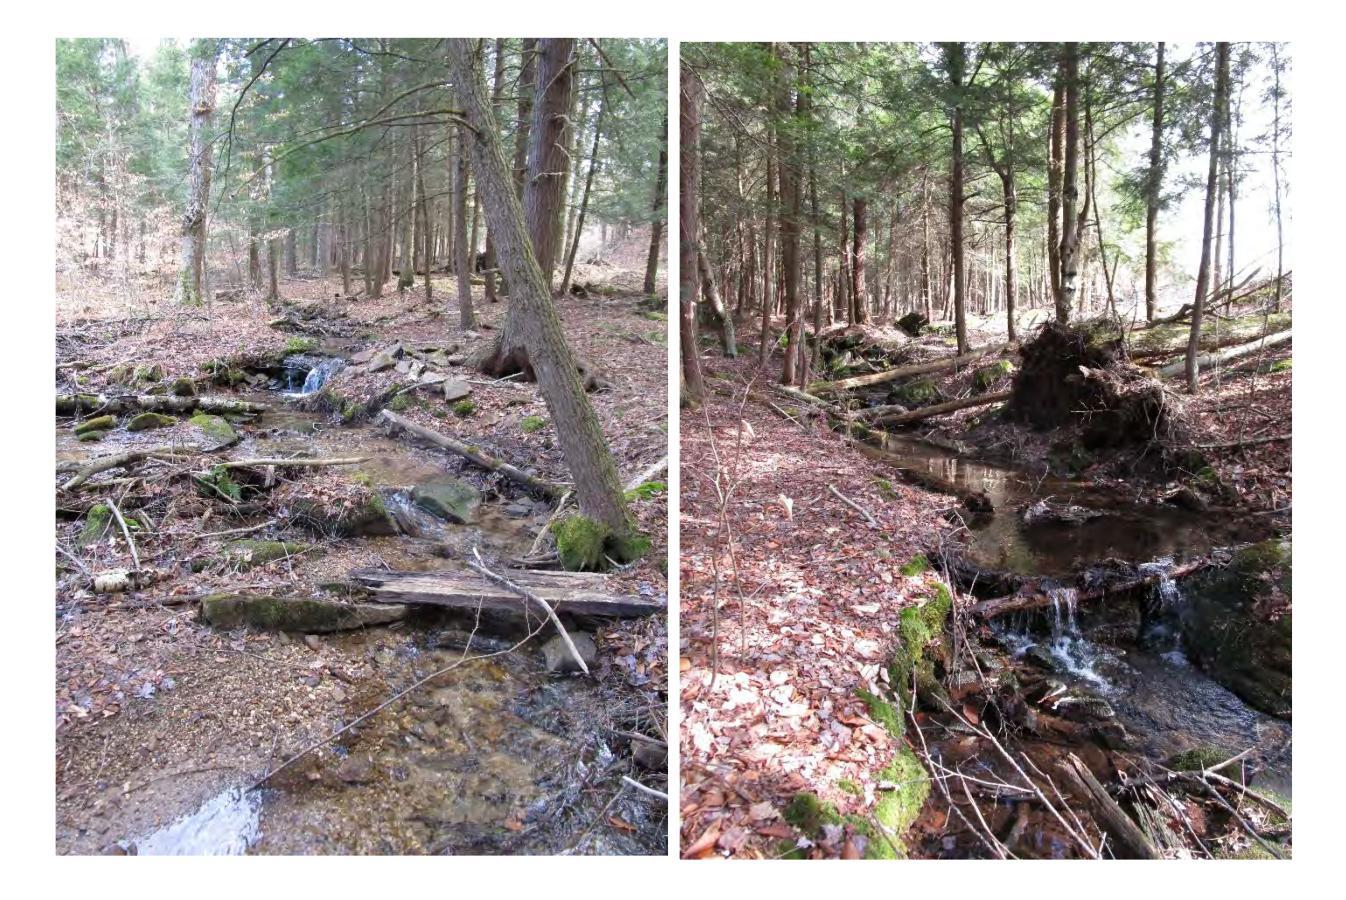
Segment 5698

Description: There are many natural elevation changes that could pose possible aquatic organism passage barriers.

<u>Recommendation</u>: It's possible to add appropriately sized LWM to reduce the height of the elevation changes making it easier for aquatic organisms to travel the channel.

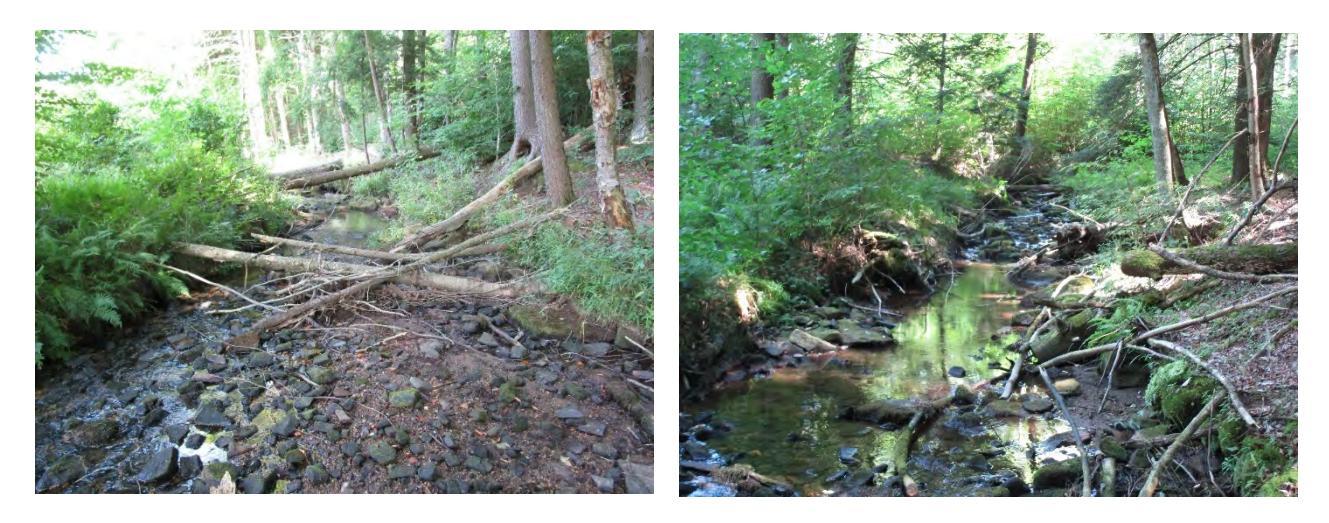
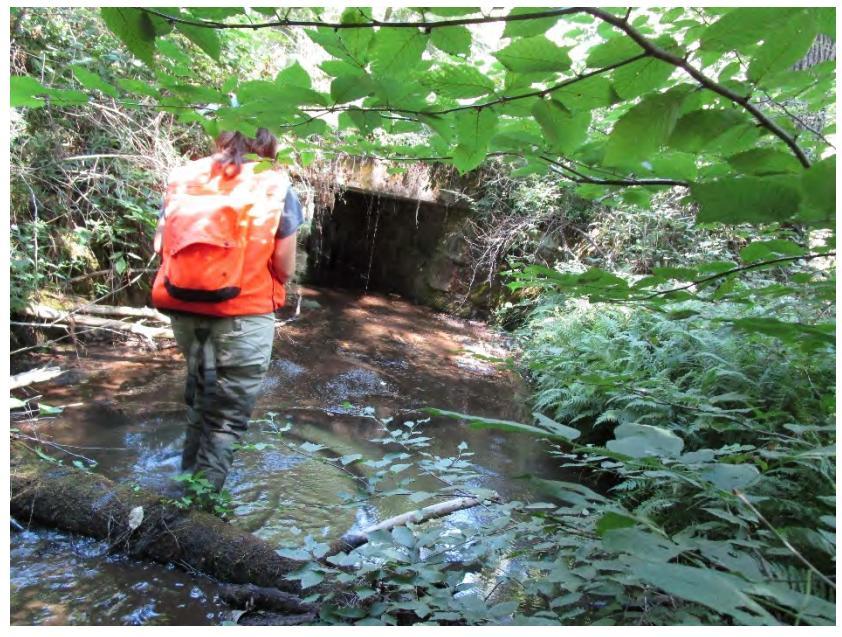
Segment 5701

<u>Description</u>: Box culvert creating aquatic organism passage barrier. <u>Recommendation</u>: Opportunities for LWM projects at N 41.71528, W 79.15850 and N 41.71460, W 79.15604

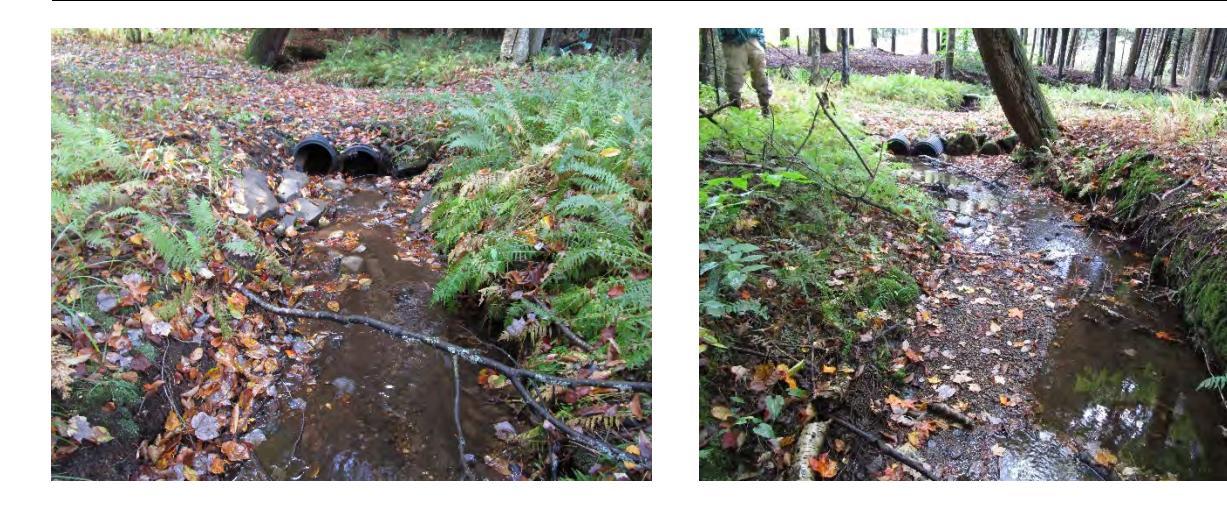
Segment 5715	N 41.71188, W 79.14658
Description: Two culvert pipes provide a private road crossing.

<u>Recommendation</u>: Recommend replacing the culverts with a small bridge.

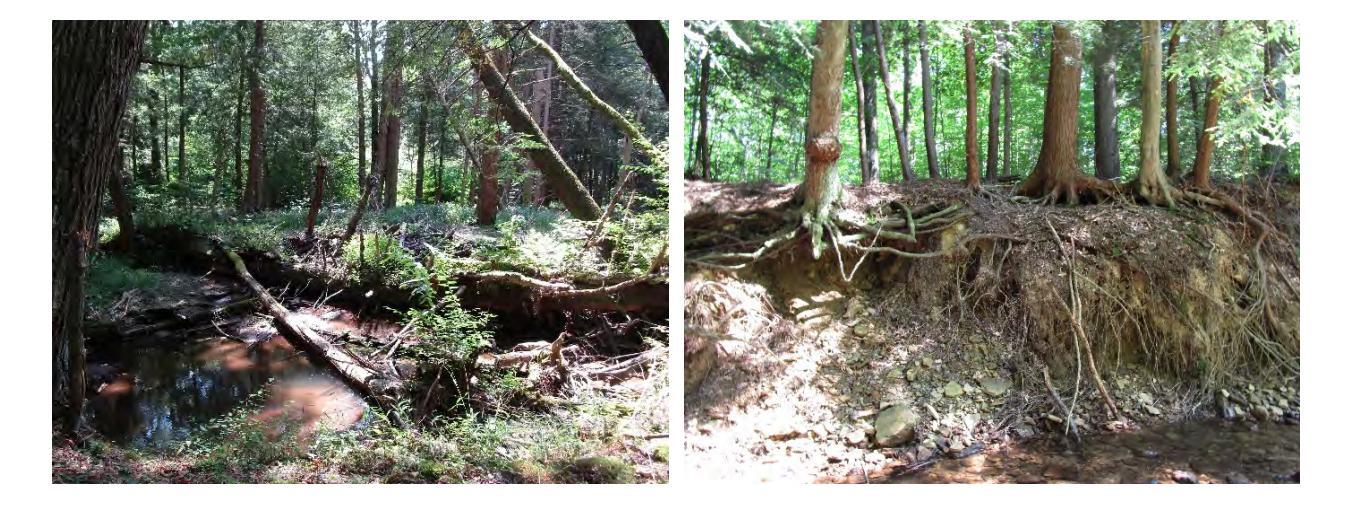
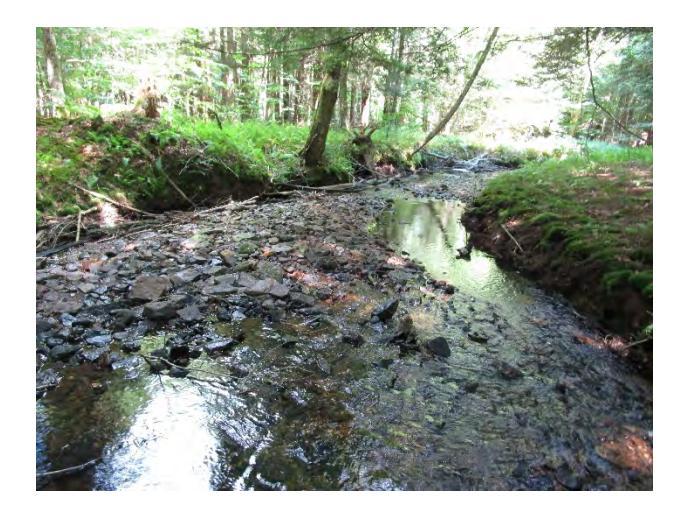
Segment 5742

<u>Description</u>: Large logs already down can use some embellishment as log jams. <u>Recommendation</u>: Areas of erosion could be addressed. Channel downstream could be reconnected to the floodplain. There is also potential near the top of the segment for a large woody material project at N 41.70984, W 79.16807 to reconnect the stream to the floodplain.

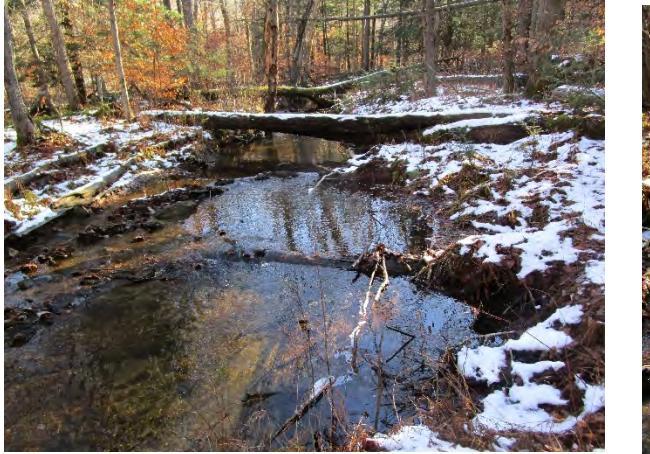
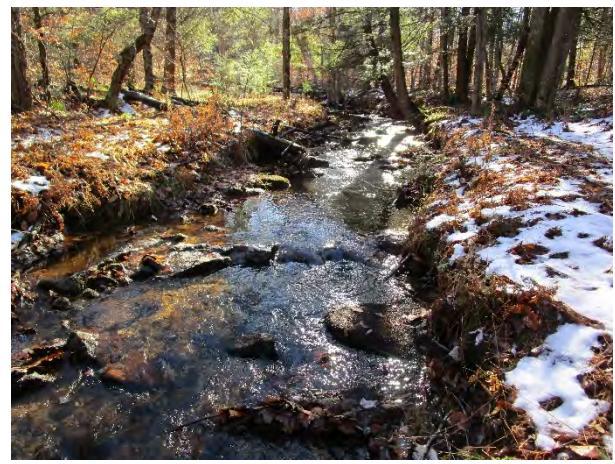
<u>Description:</u> Erosion and incision occur regularly through this segment. <u>Recommendation</u>: LWM would also benefit this segment by addressing areas of erosion and adding fish habitat.

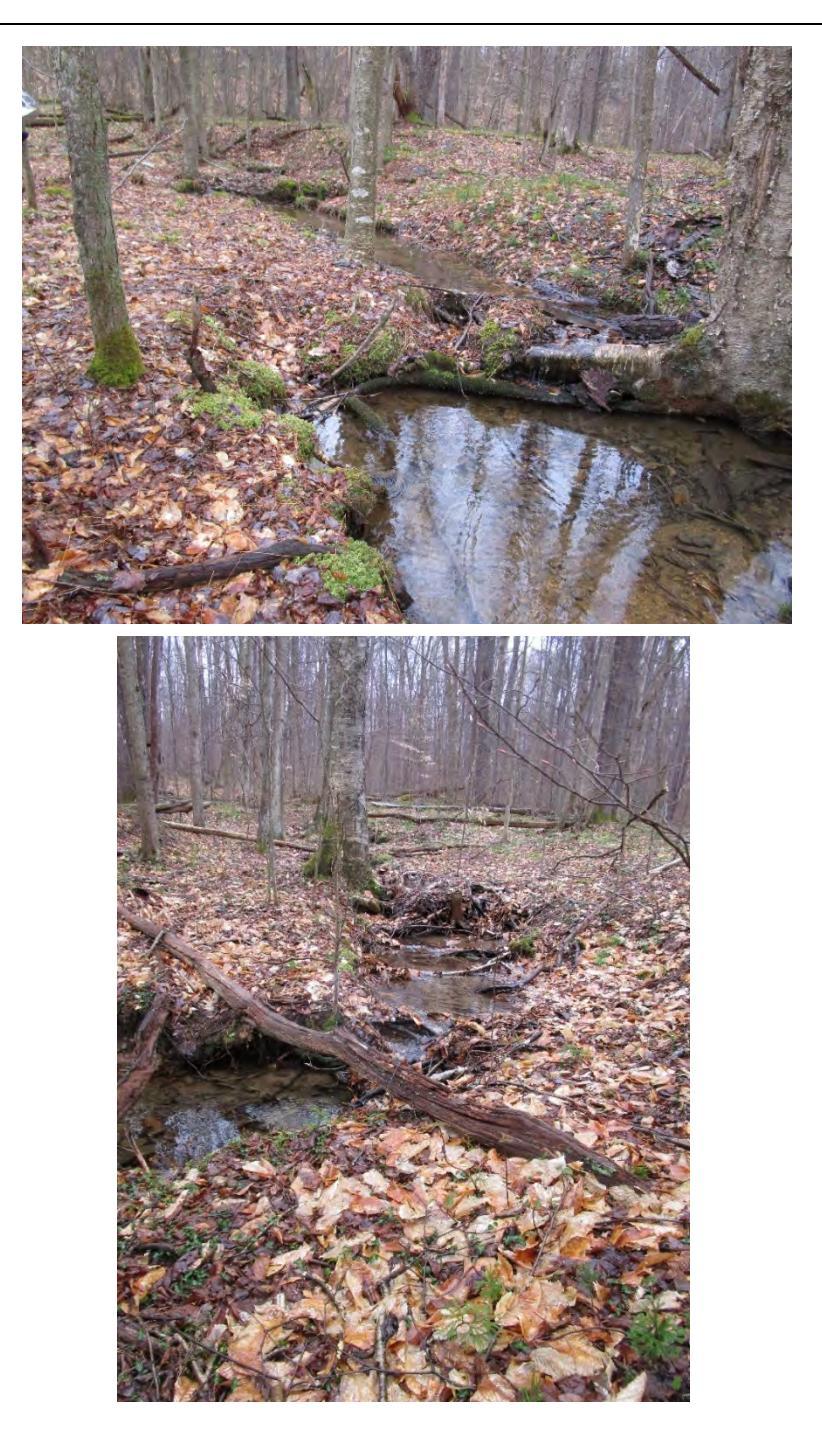
Segment 5879	N 41.7010, W 79.1608
--------------	----------------------

Description: The slope of this segment causes 1ft elevation changes that could pose AOP barriers.

<u>Recommendation</u>: Establish areas of appropriately sized LWM to build up the streambed and reduce the height in current elevation changes to make the channel more passable.

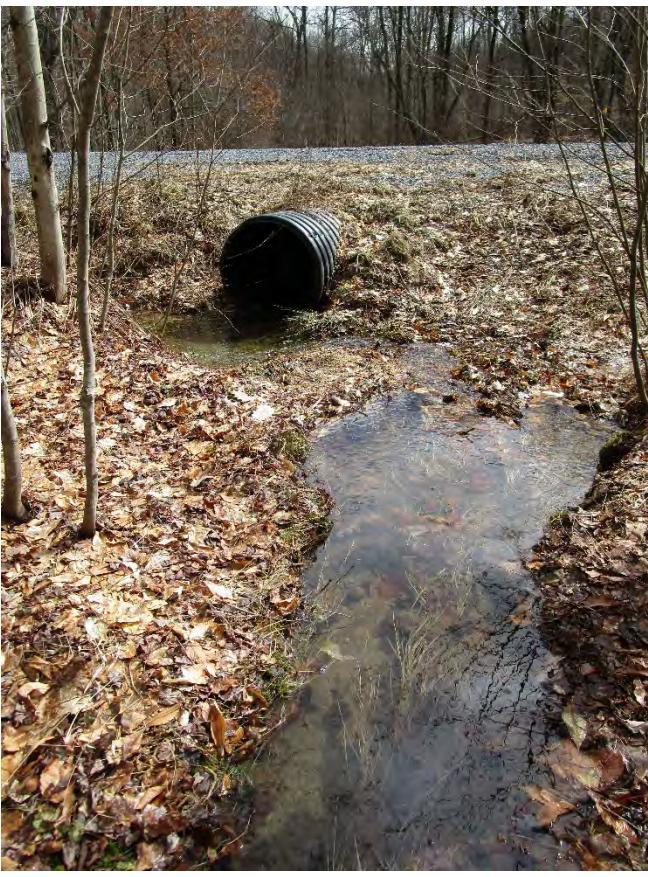
Upstream Inlet

Description: Undersized culvert is causing an AOP barrier and incision of the channel downstream.

<u>Recommendation</u>: Replace with a resized squash pipe. Add LWM or other in-stream devices reconnect the incised channel to its floodplain.
