## Coldwater Conservation Implementation Reporting Guidelines

### **Project summary**

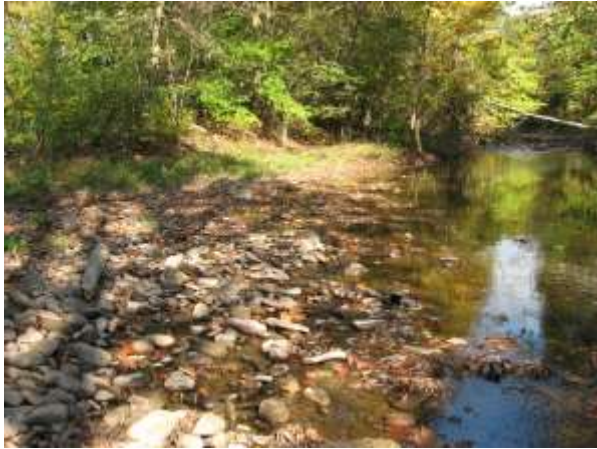
Stiffler site before stream restoration

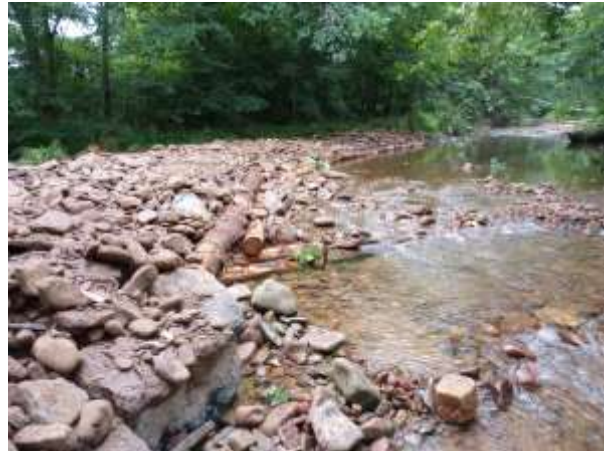
Stiffler site after stream restoration

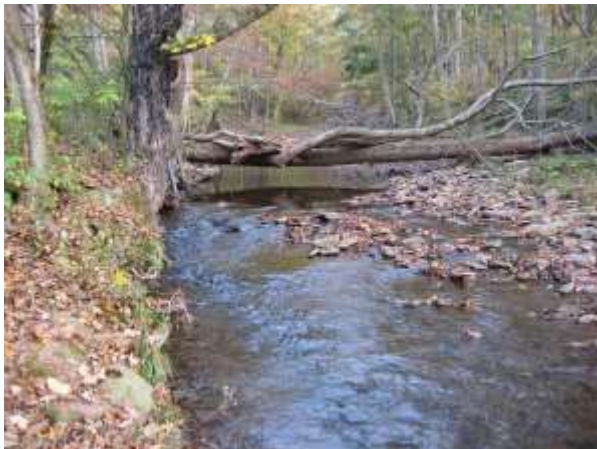
Blue Knob State Park Data Logger Site before

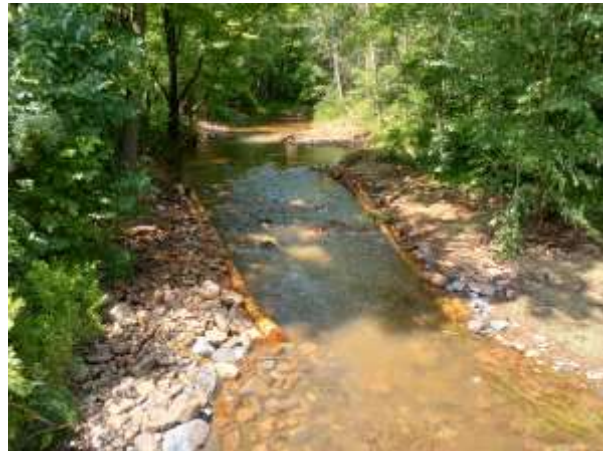
Blue Knob State Park Data Logger Site after

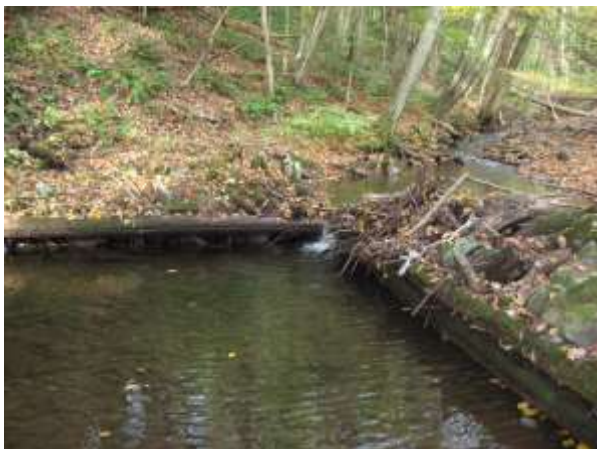
Wallacks Branch Burnt House site before

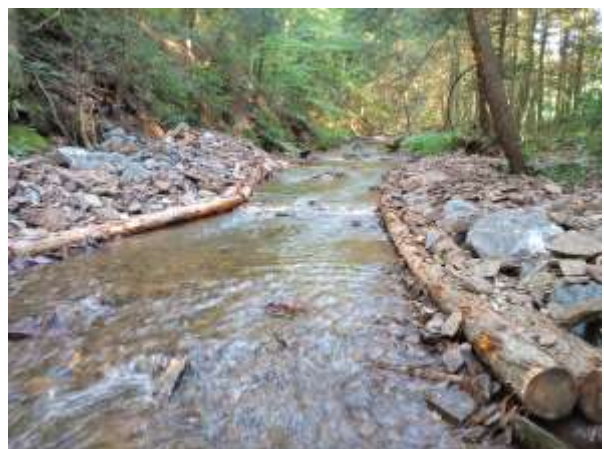
Wallacks Branch Burnt House site after

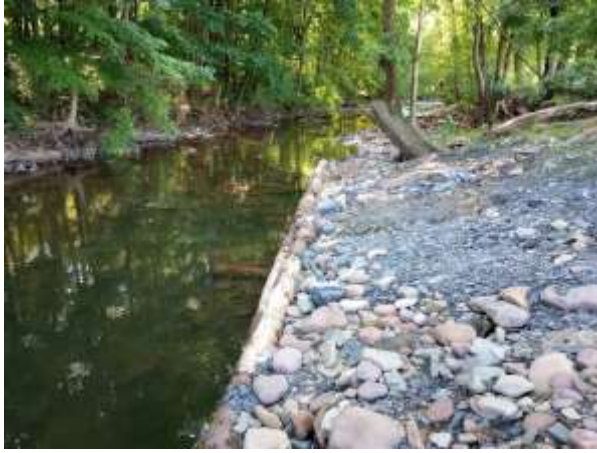
Bobs Creek Kids' Area site after restoration

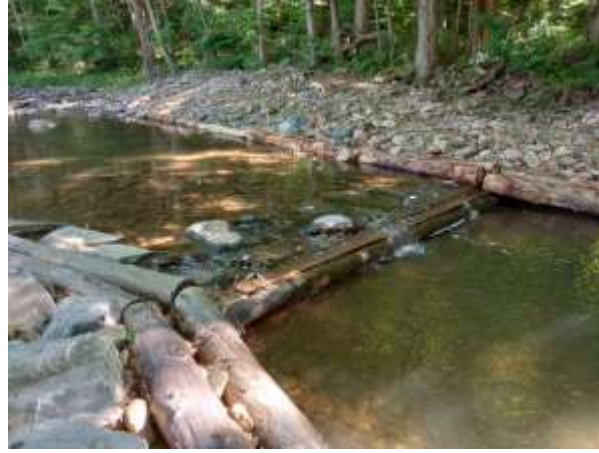
Bobs Creek at Ickes site after restoration
