STONY RUN WATERSHED

Coldwater Conservation Plan

**STONY RUN WATERSHED
CHESTER COUNTY, PENNSYLVANIA**

COLDWATER CONSERVATION PLAN- 2010

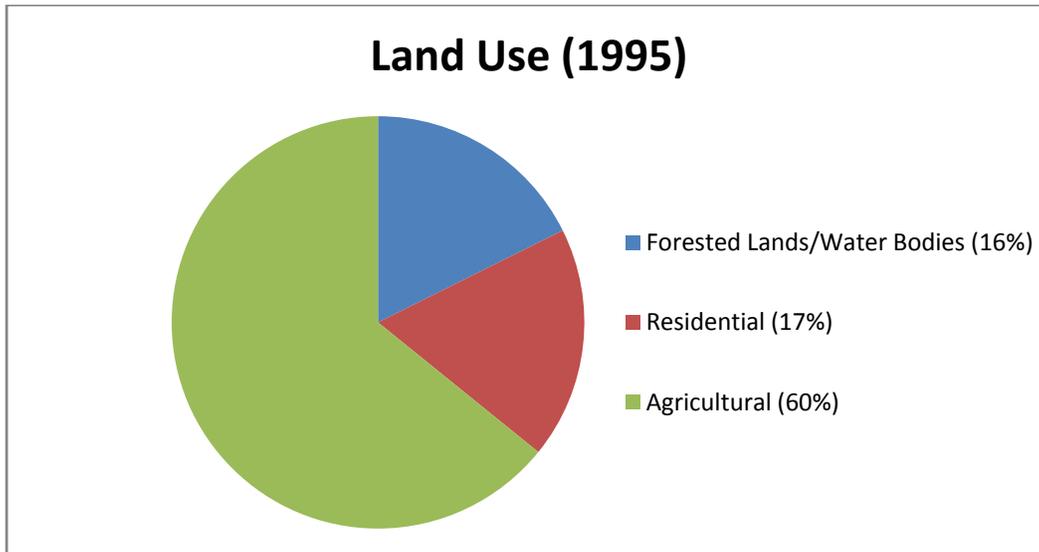
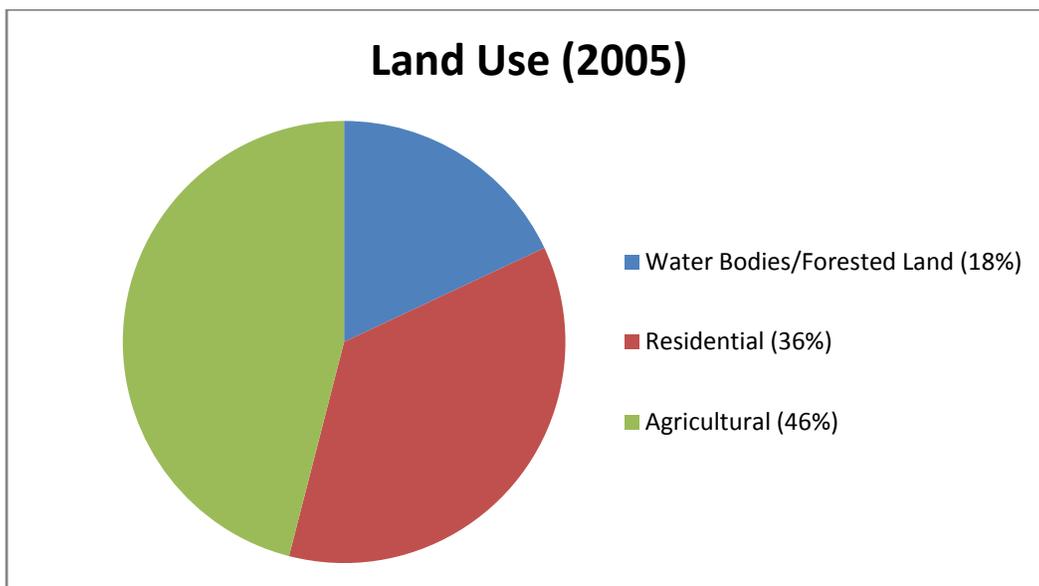
As depicted in the above comparison of land use between 1995 and 2005, the continued urbanization of the watershed is shown in the decrease of agriculture from 60% to 46% and the increase in residential and other developed land uses from 17% to over 36% of the watershed. While some improvements are noted from this change including an increase in forested riparian buffer and better soil conservation and erosion control practices, urbanization brings a new set of problems including increased impervious surfaces, changes in storm water infiltration and flow, on-lot septic systems, lawn maintenance practices, among others. Changes in storm water flow to the watershed now exist due to the presence of at least 11 separate storm water detention/retention basins (mostly related to residential subdivisions) which affect storm water flow within approximately 8% of the watershed. These structures which have only been built during the last 10 to 20 years represent a likely change in the amount of storm water runoff that is now directed away from the aquifer and to the surface stream.

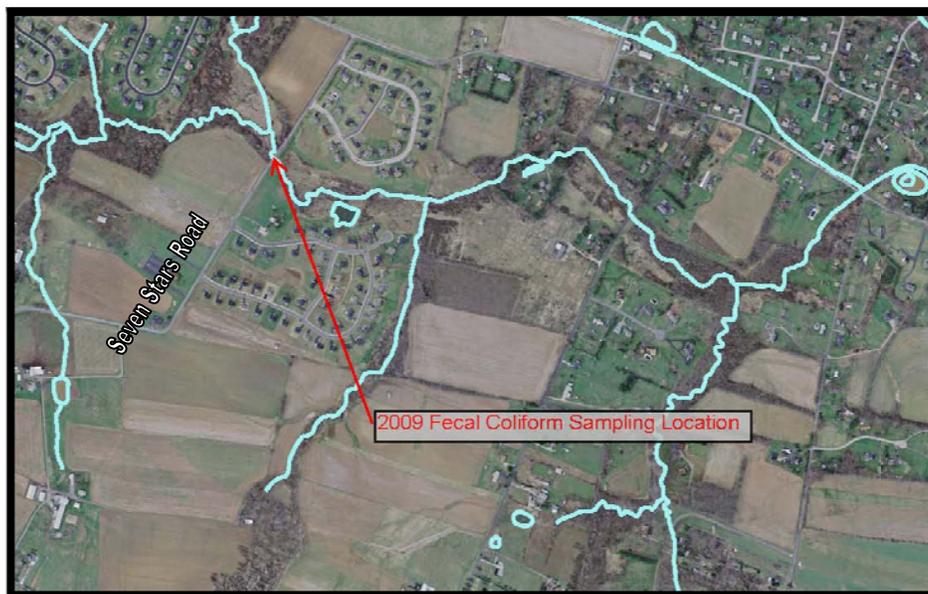
This mean value exceeds the PADEP “swimming season” criteria of 200 col/100 ml although does not exceed the 2,000 col/100 ml criterion established by PADEP for the remainder of the year. Research by the USGS in the Brandywine Creek Basin in central Chester County found elevated levels of fecal coliform in surface water was likely attributable to several sources including agriculture runoff, groundwater contamination from residential septic systems, urban/residential activities and local wildlife (Town, 2001). Interestingly, this study also found an improvement in fecal coliform levels during the 1970s and 1980s that corresponded with a decrease in agricultural land usage. This finding is consistent with the improvement noted in the Stony Run macroinvertebrate data during the same time period.

2009 Fecal Coliform Sampling			
Date	Colonies per 100/mL	Date	Colonies per 100/mL
7/18/2009	715	8/13/2009	1100
7/15/2009	460	8/19/2009	1294
7/22/2009	650	8/25/2009	210
7/29/2009	960	9/1/2009	144
8/5/2009	200	9/8/2009	481
Geometric Mean	578	Geometric Mean	460
PADEP “Swimming” Criteria	200	PADEP “Non-Swimming” Criteria	2,000

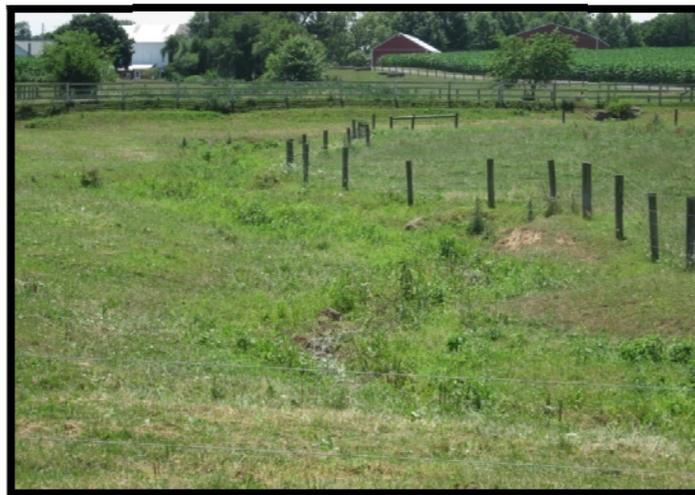
Photo 1 – View of unnamed tributary (UNT-14) with no riparian buffer.

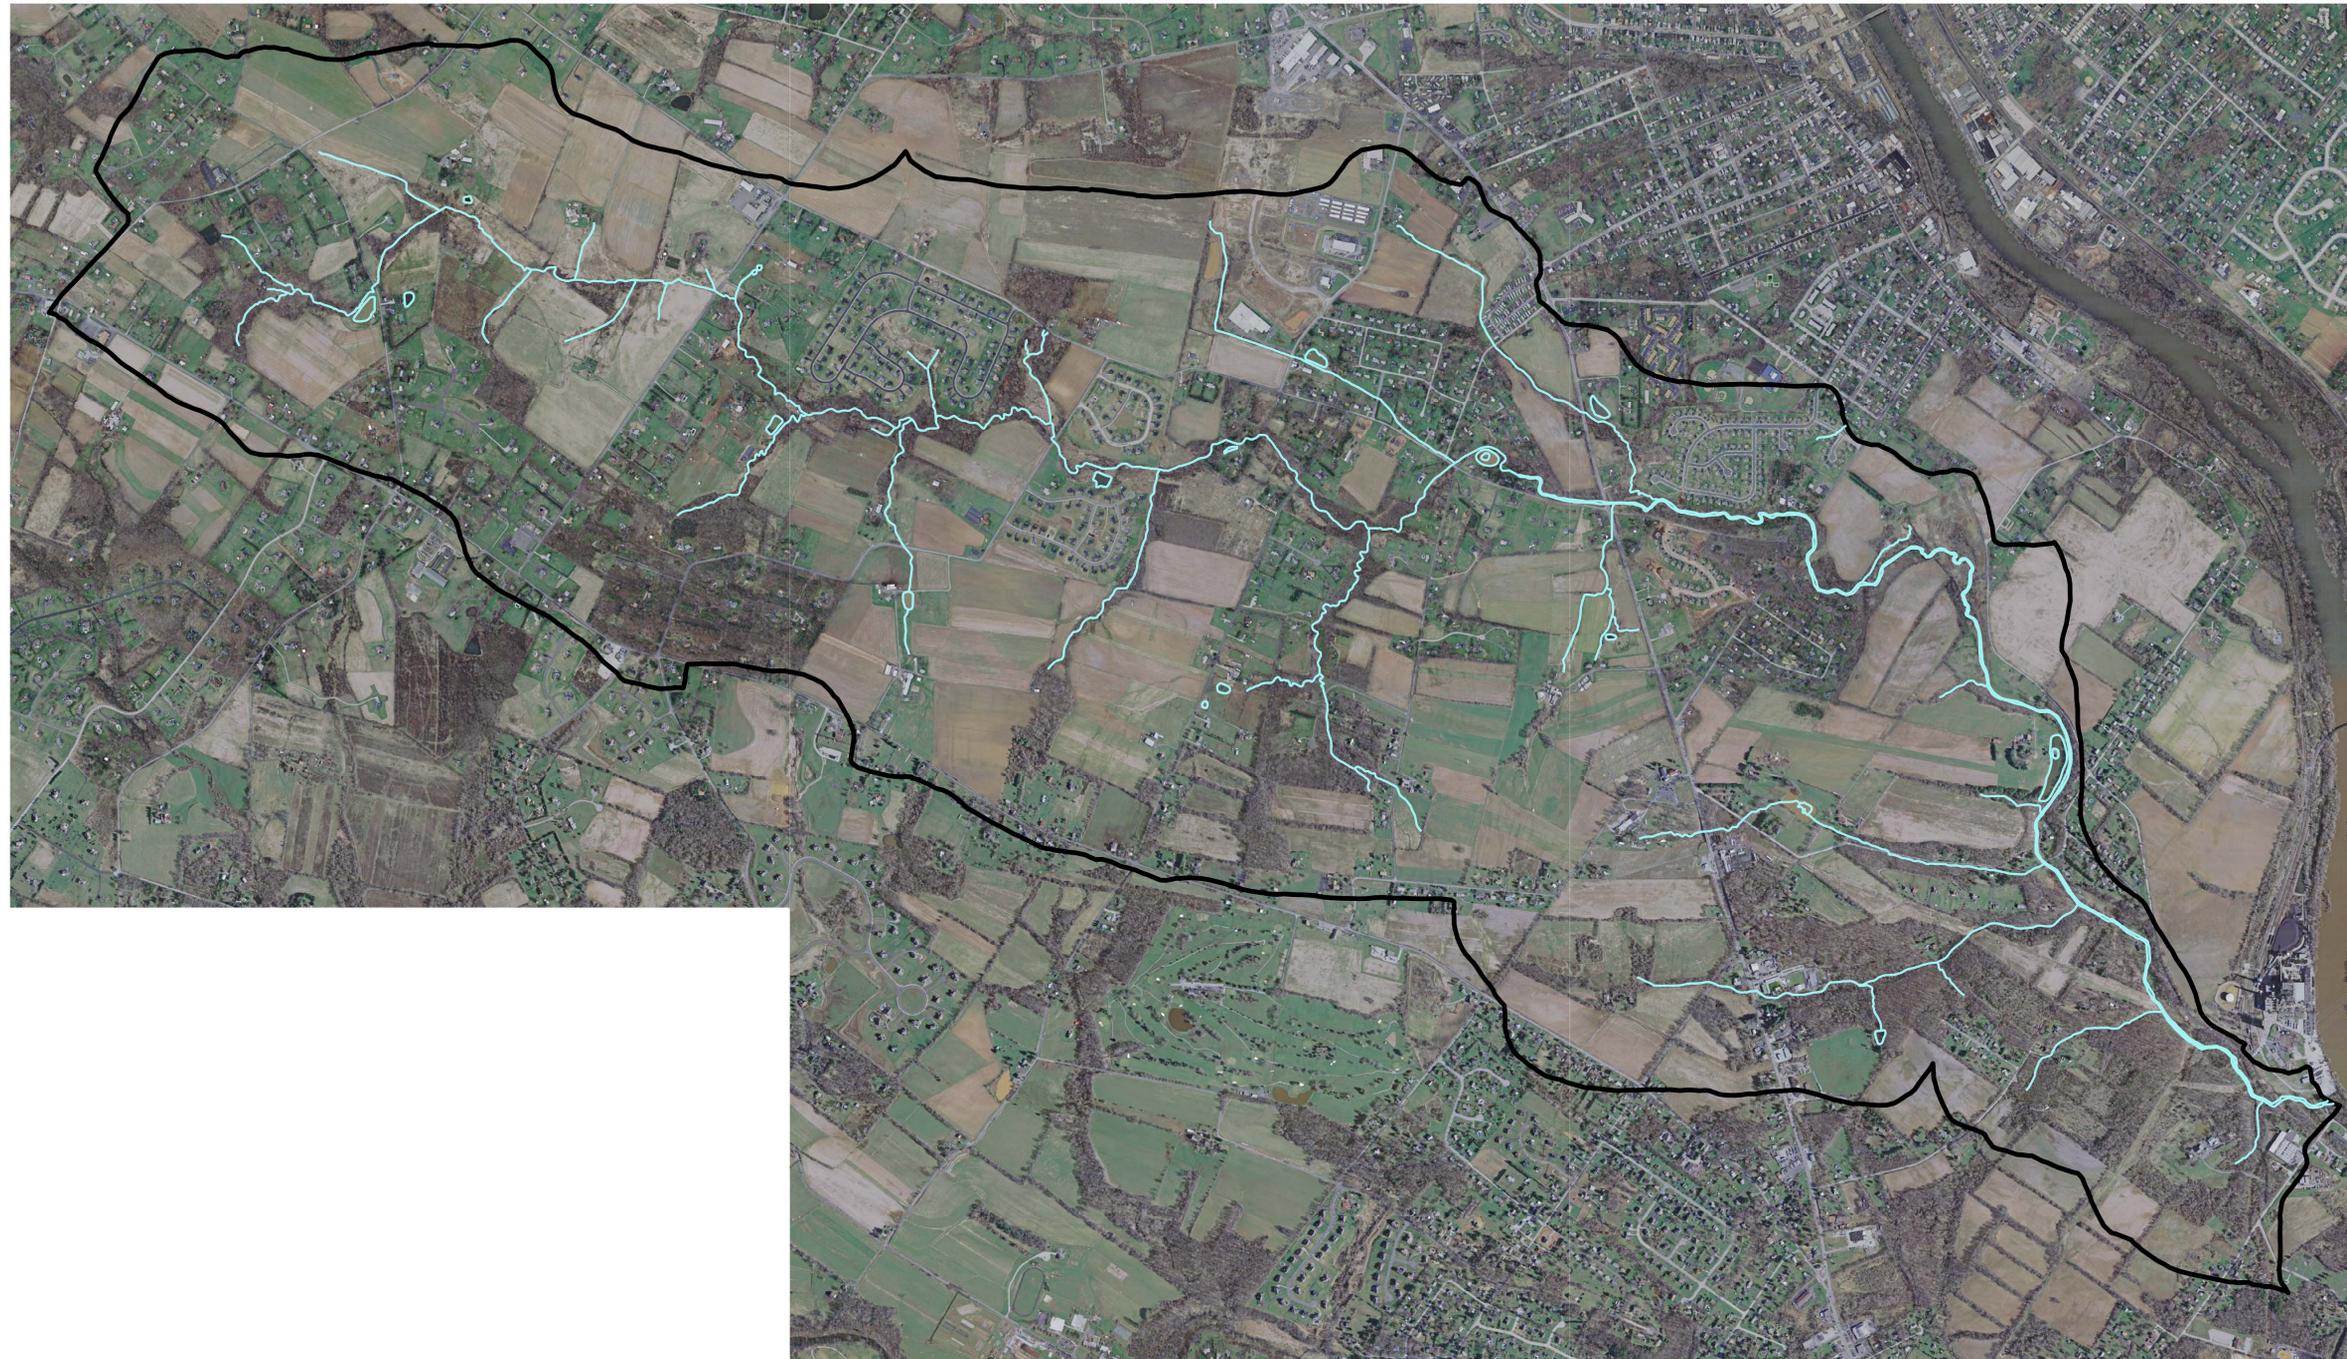
As can be seen on Figure 2, of the 10.2 stream miles of the Stony Run, 53% are first order streams which drain 59% of the watershed (Chester County Water Resources Authority et al., 2002). This is an important consideration as first order headwaters (being the "roots" of the watershed) provide 70% of the mean annual water volume and 65% of the nitrogen flux observed in second order streams (Alexander et al., 2007).

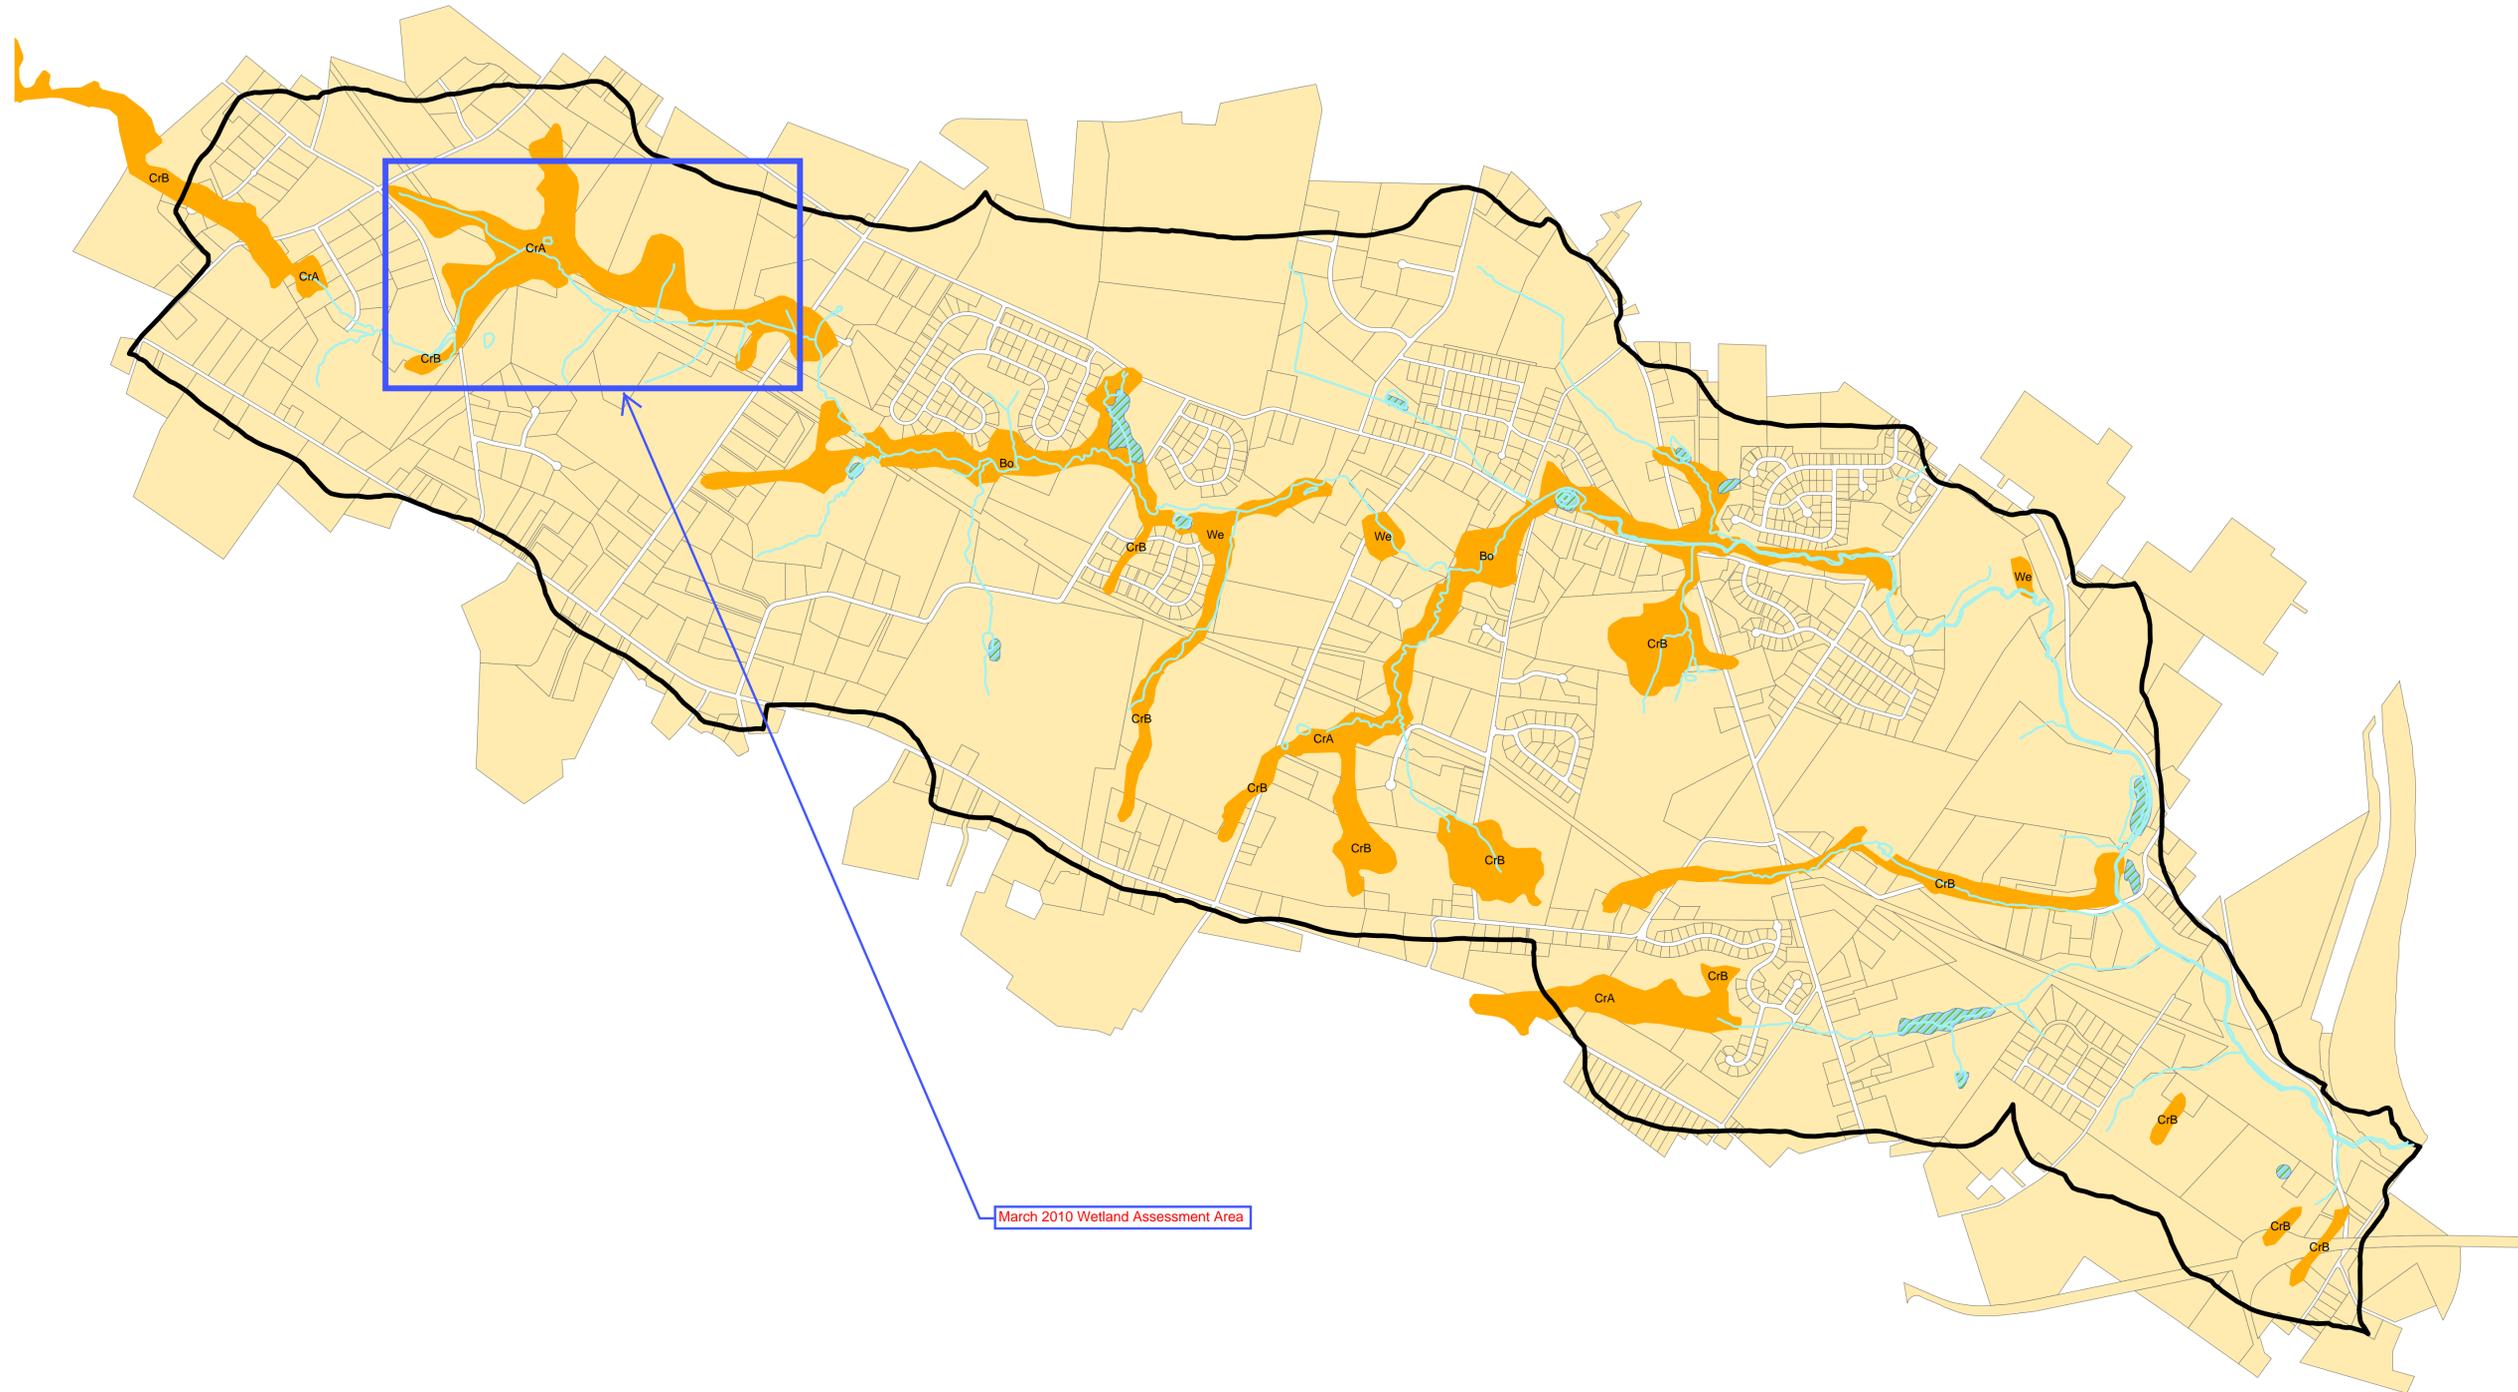
Hydric Soils Mapping

Soils within the Watershed are predominantly of the Penn and Readington Soil Series developed on the Mesozoic sedimentary bedrock. As noted by GVA (2003), much of the soils in the watershed are classified as Group C Hydrologic Group. When wet, these soils have a slow infiltration rate generally due to a restrictive layer within the soil horizon. Consistently, there are significant areas of hydric soils mapped in the watershed including Croton, Bowmansville, Wehadkee soil series (refer to Figure 3).

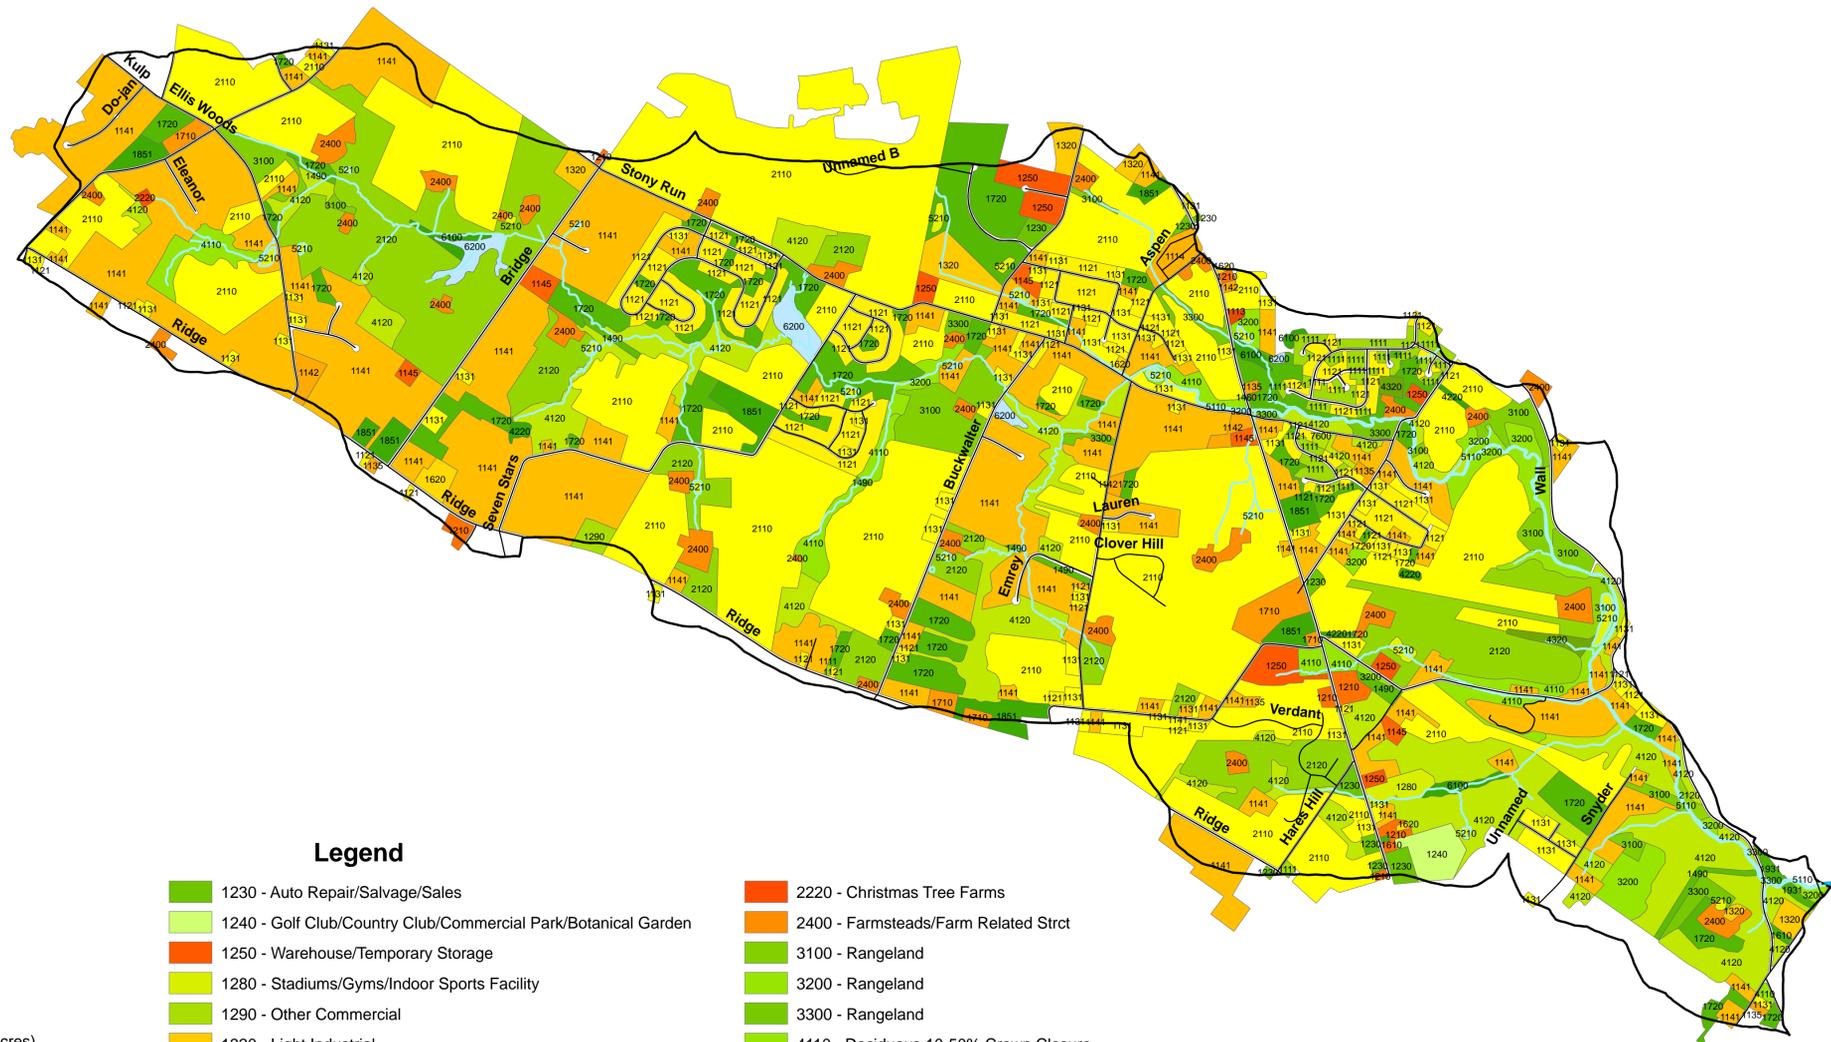
This change in land use pattern is reflected in benthic macro invertebrate data collected from the Stony Run by the United States Geological Survey (USGS) as well as the Stroud Water Research Center. The most recent land use data is shown on Figure 4.

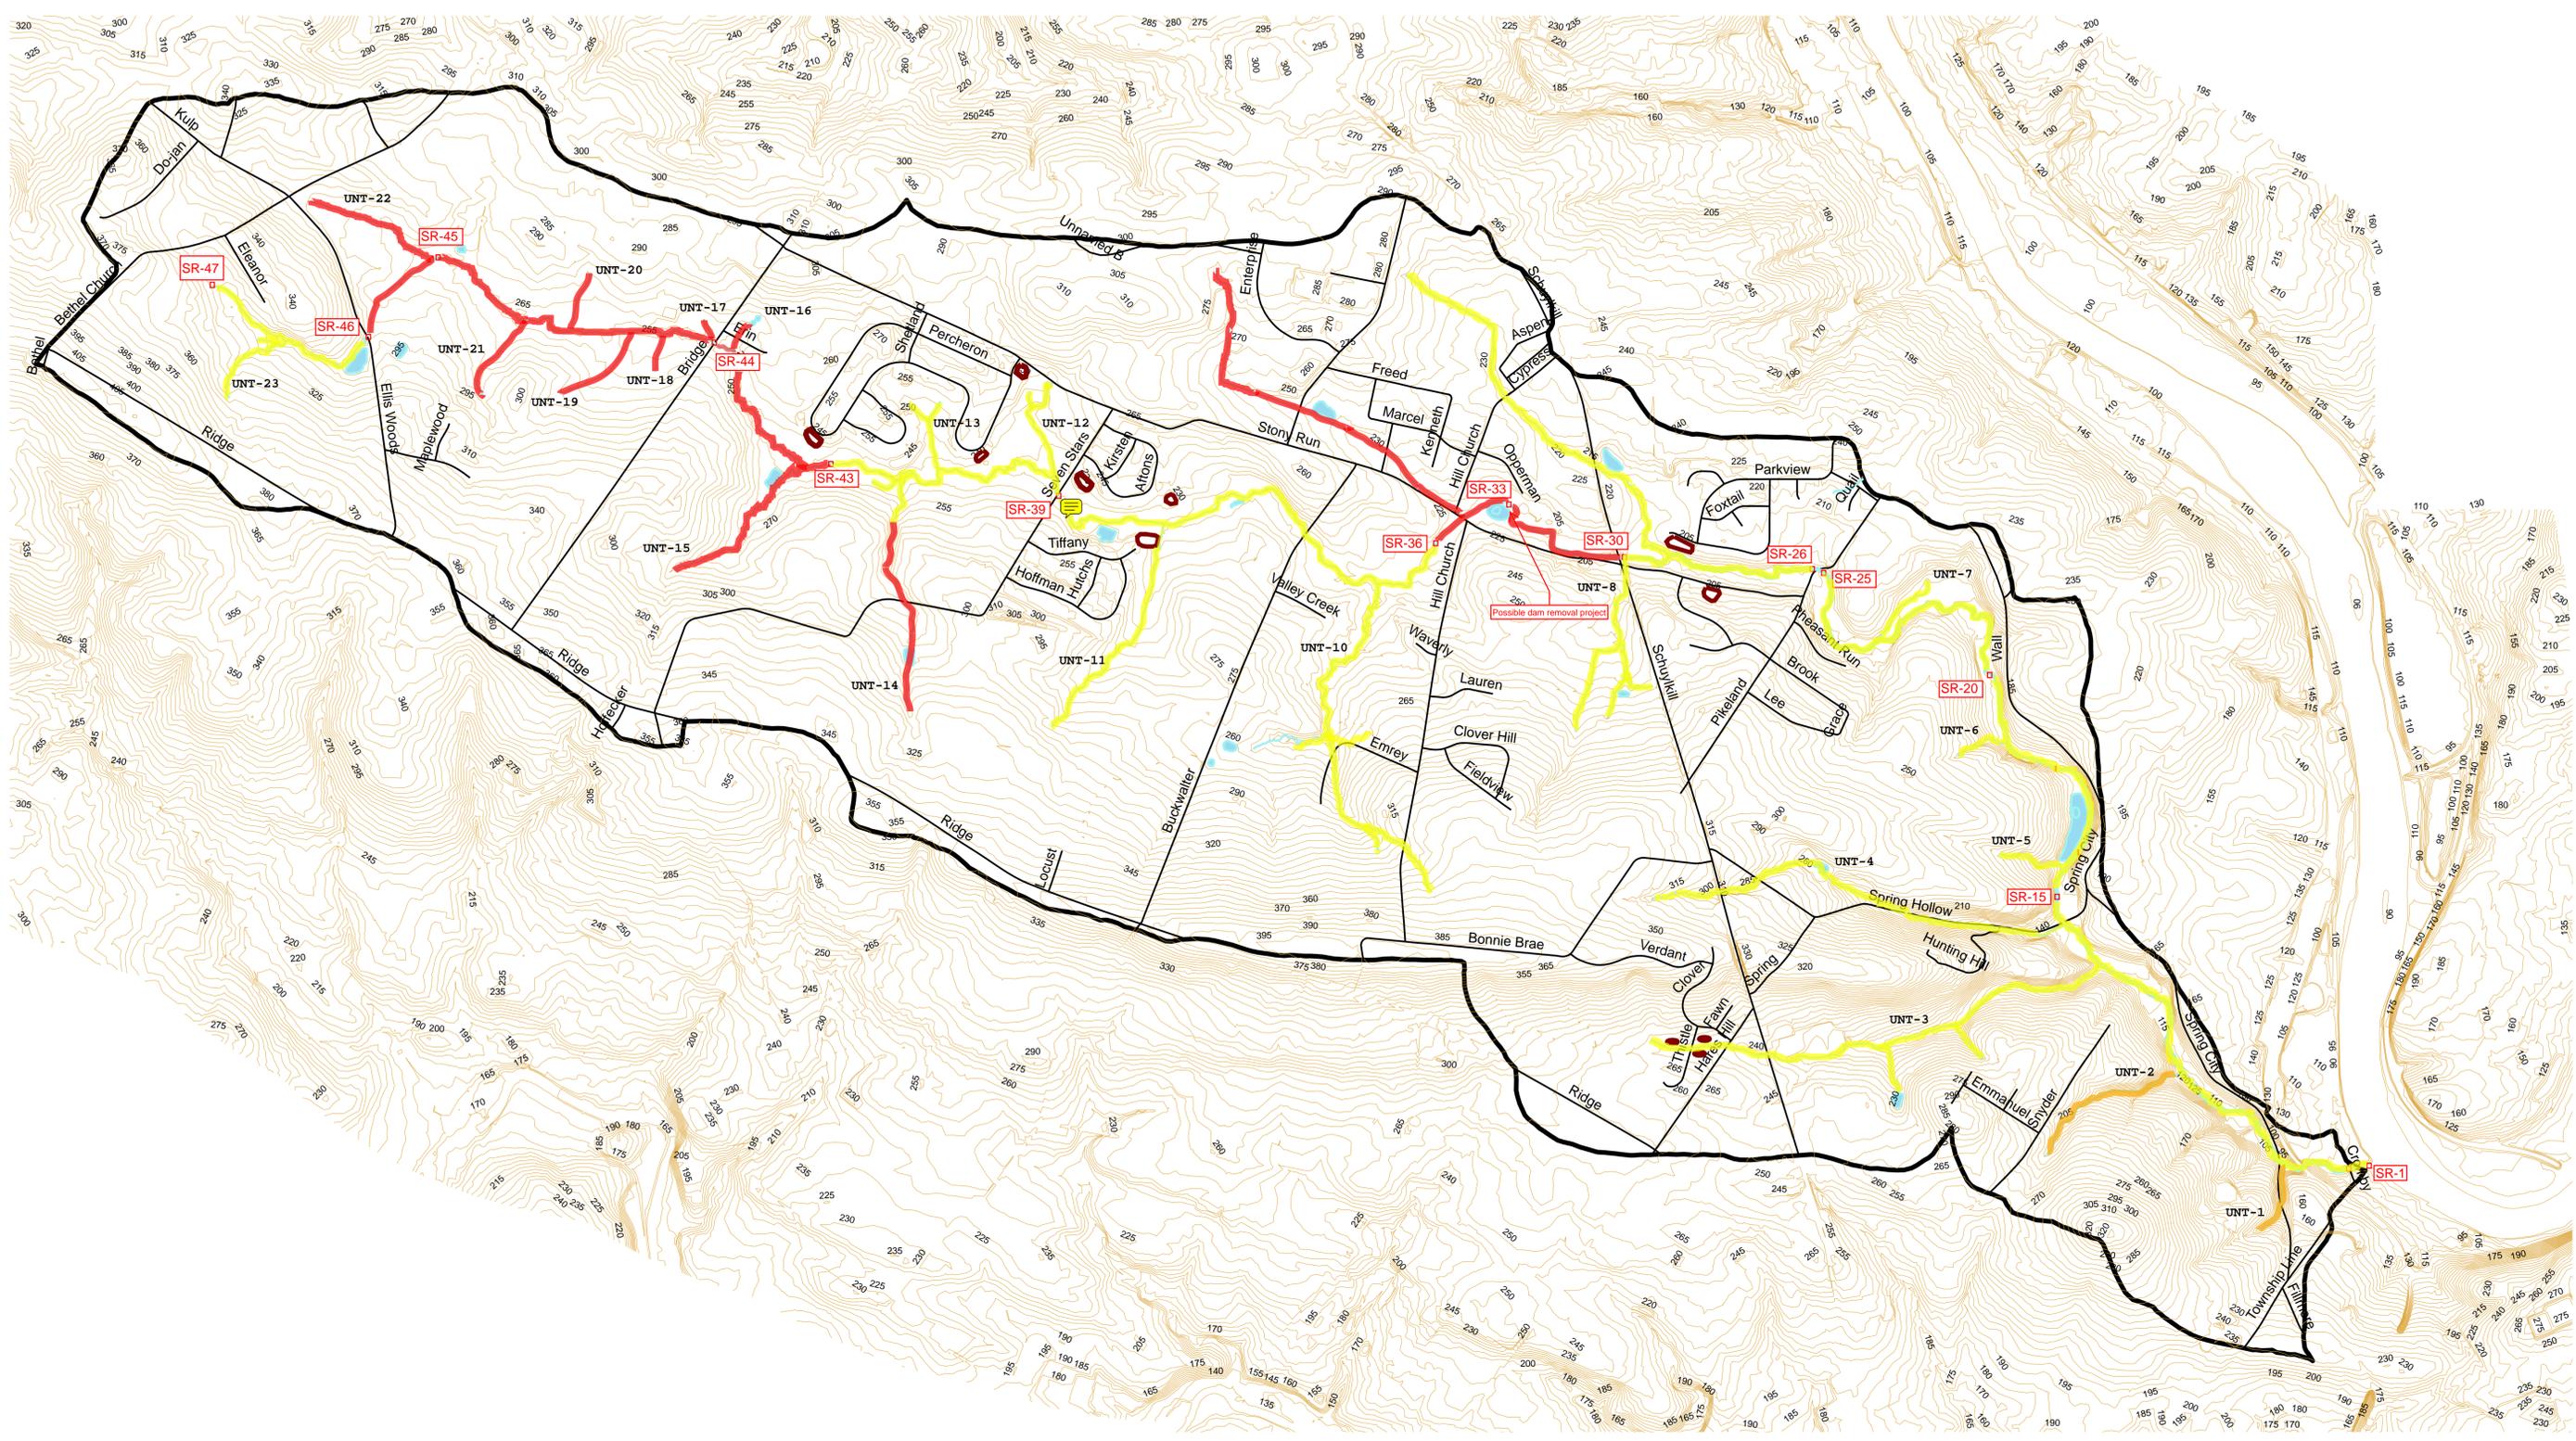
Figure 5 - Watershed Assessment Scoring Summary
 Drawn By: JCR
 Checked by: EJJ
 Date: 08-04-2009

As shown on Figure 5, scores were generally in the “Poor” to “Fair” categories and decreased upstream with the lowest scores in the headwaters. Many sections showed significant man-made alteration, channelization and areas where the channel has become disconnected from its floodplain due to downcutting. However, many of these same areas (mostly in the lower sections) have become largely stabilized with well established forested buffers (it should be noted however, that a stream channel in such a condition is not healthy for aquatic communities.)

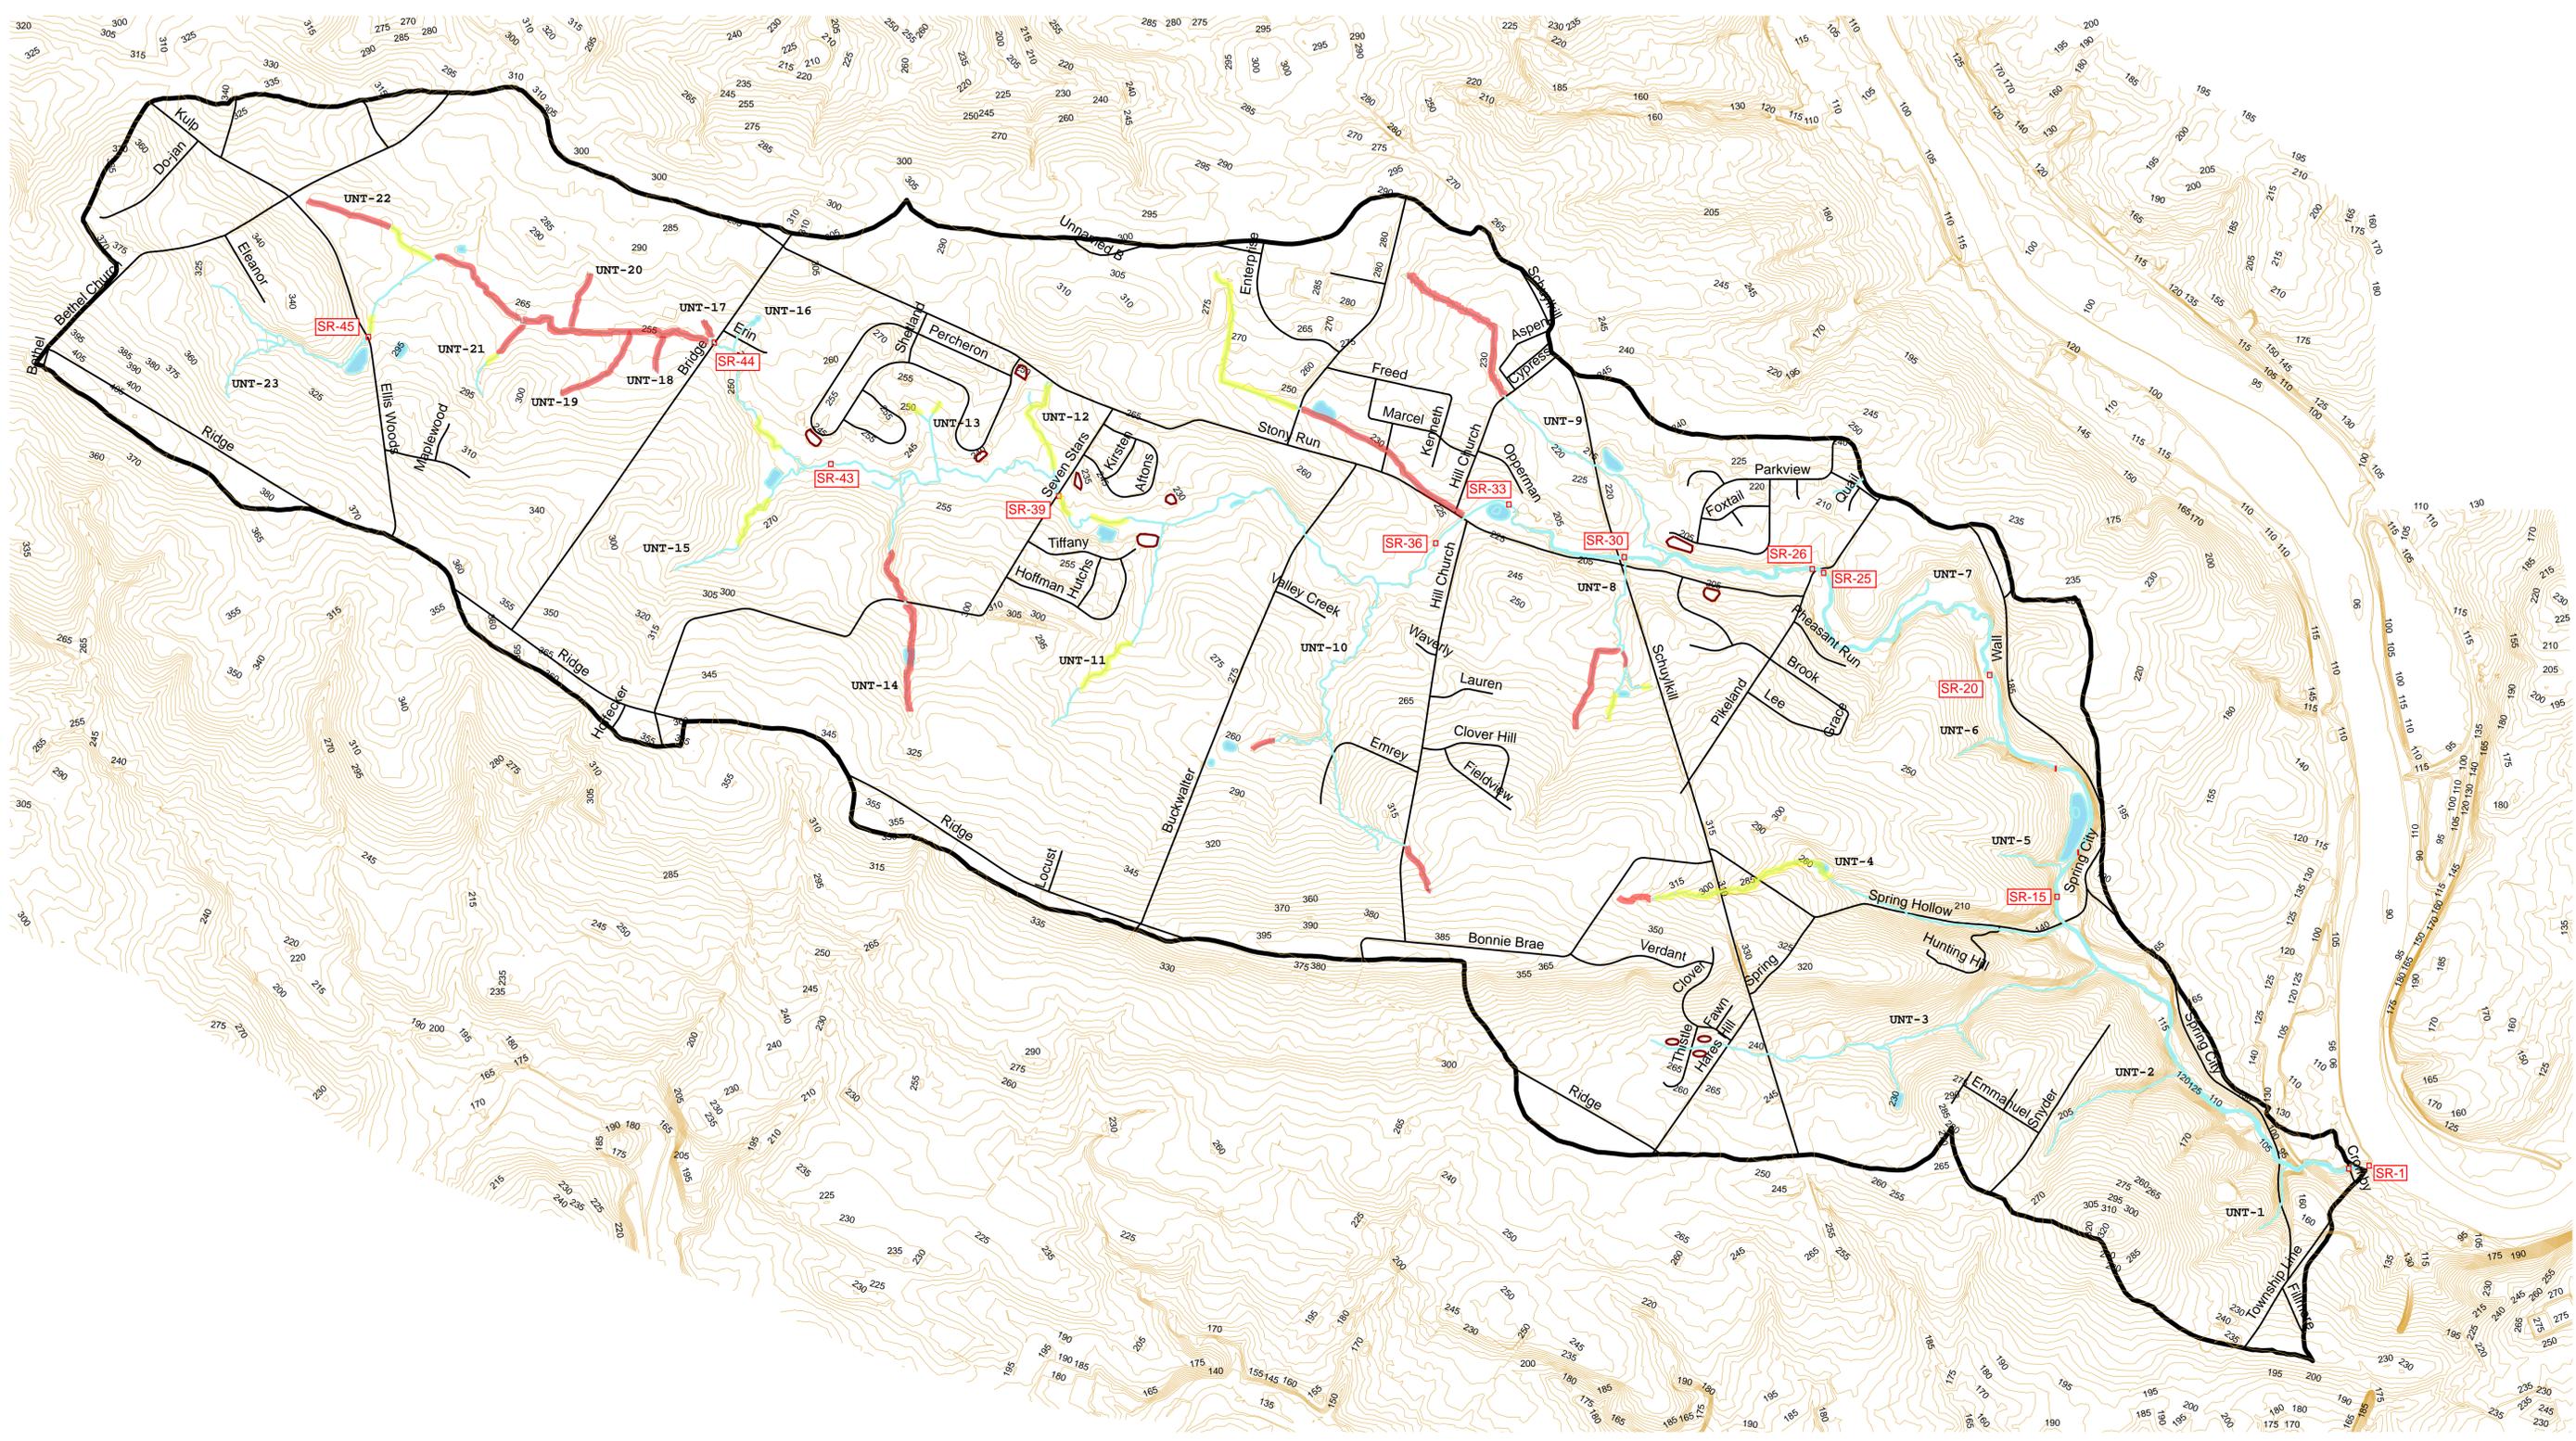
Riparian Buffer Condition

Contrastingly, in upstream areas with absent riparian buffers much of the land use is agricultural and residential. Heavy siltation from eroding banks and algal growth on substrates are evidence that without a wetland or forest buffers, nutrient-laden surface runoff represents a continued threat to the Stony Run. Figure 6 shows areas without significant riparian buffer.
