Implementation Grant Final Reporting

Wildlands Conservancy Coplay Creek Restoration Project 2015 Final Report for Coldwater Heritage Partnership Implementation Grant

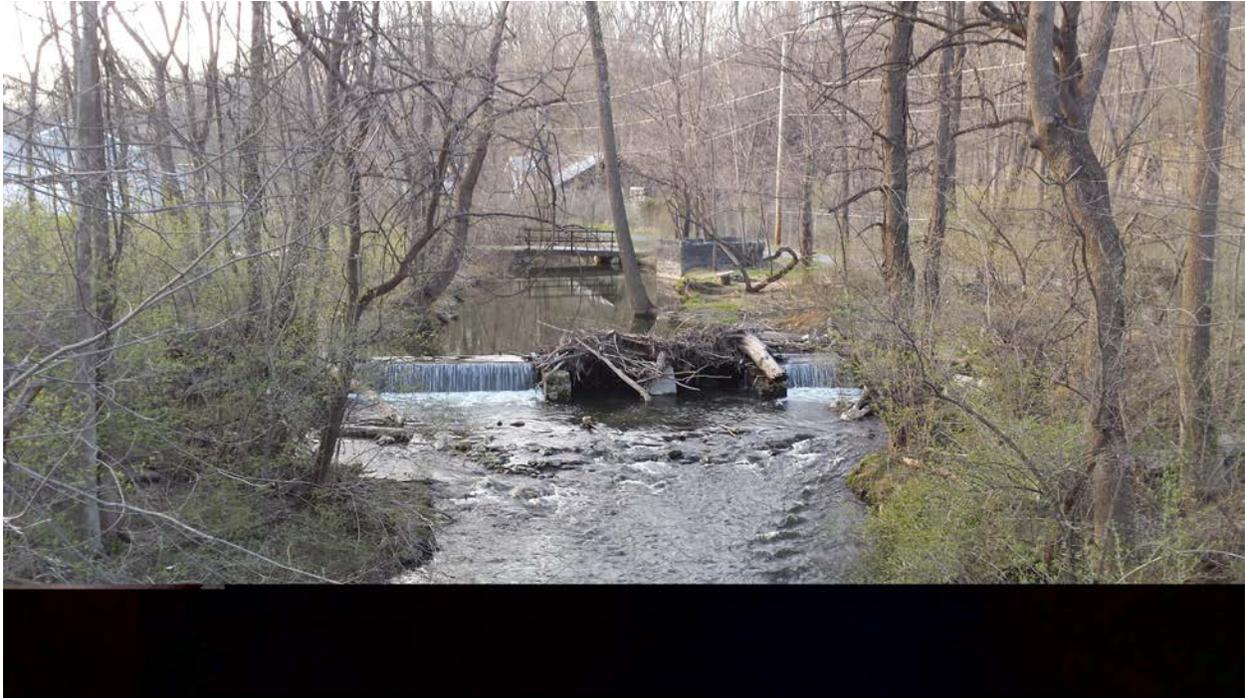
Before:

In 2011, the Coplay Watershed Assessment was developed to rank stream reaches and develop recommendations for stream restoration. Identified in the Assessment were two aging, obsolete dams on Coplay Creek that were causing habitat and water quality degradation. The dams were creating slow-moving, sediment-laden pools of water full of algae and low in suitable habitat for coldwater fish species. With help from Coldwater Heritage Partnership funds, Wildlands Conservancy was able to implement recommendations to remove the dams impacting Coplay Creek.

We completed the design and permitting necessary for dam removal through DEP. Once the approvals came through, Wildlands was able to hire a contractor to begin the construction phase of the project. Both dams were removed, restoring free-flowing conditions from the Lehigh River through the Coplay Creek. We removed tons of concrete, rebar and other large hazardous pieces of metal from the stream. Wildlands also placed material to stabilize the surrounding streambanks to prevent further erosion and degradation of habitat. This was especially important at one of the sites where the dam was causing severe erosion of the Ironton Rail Trail that runs along the creek. The attached photos show the stream before and after dam removal.

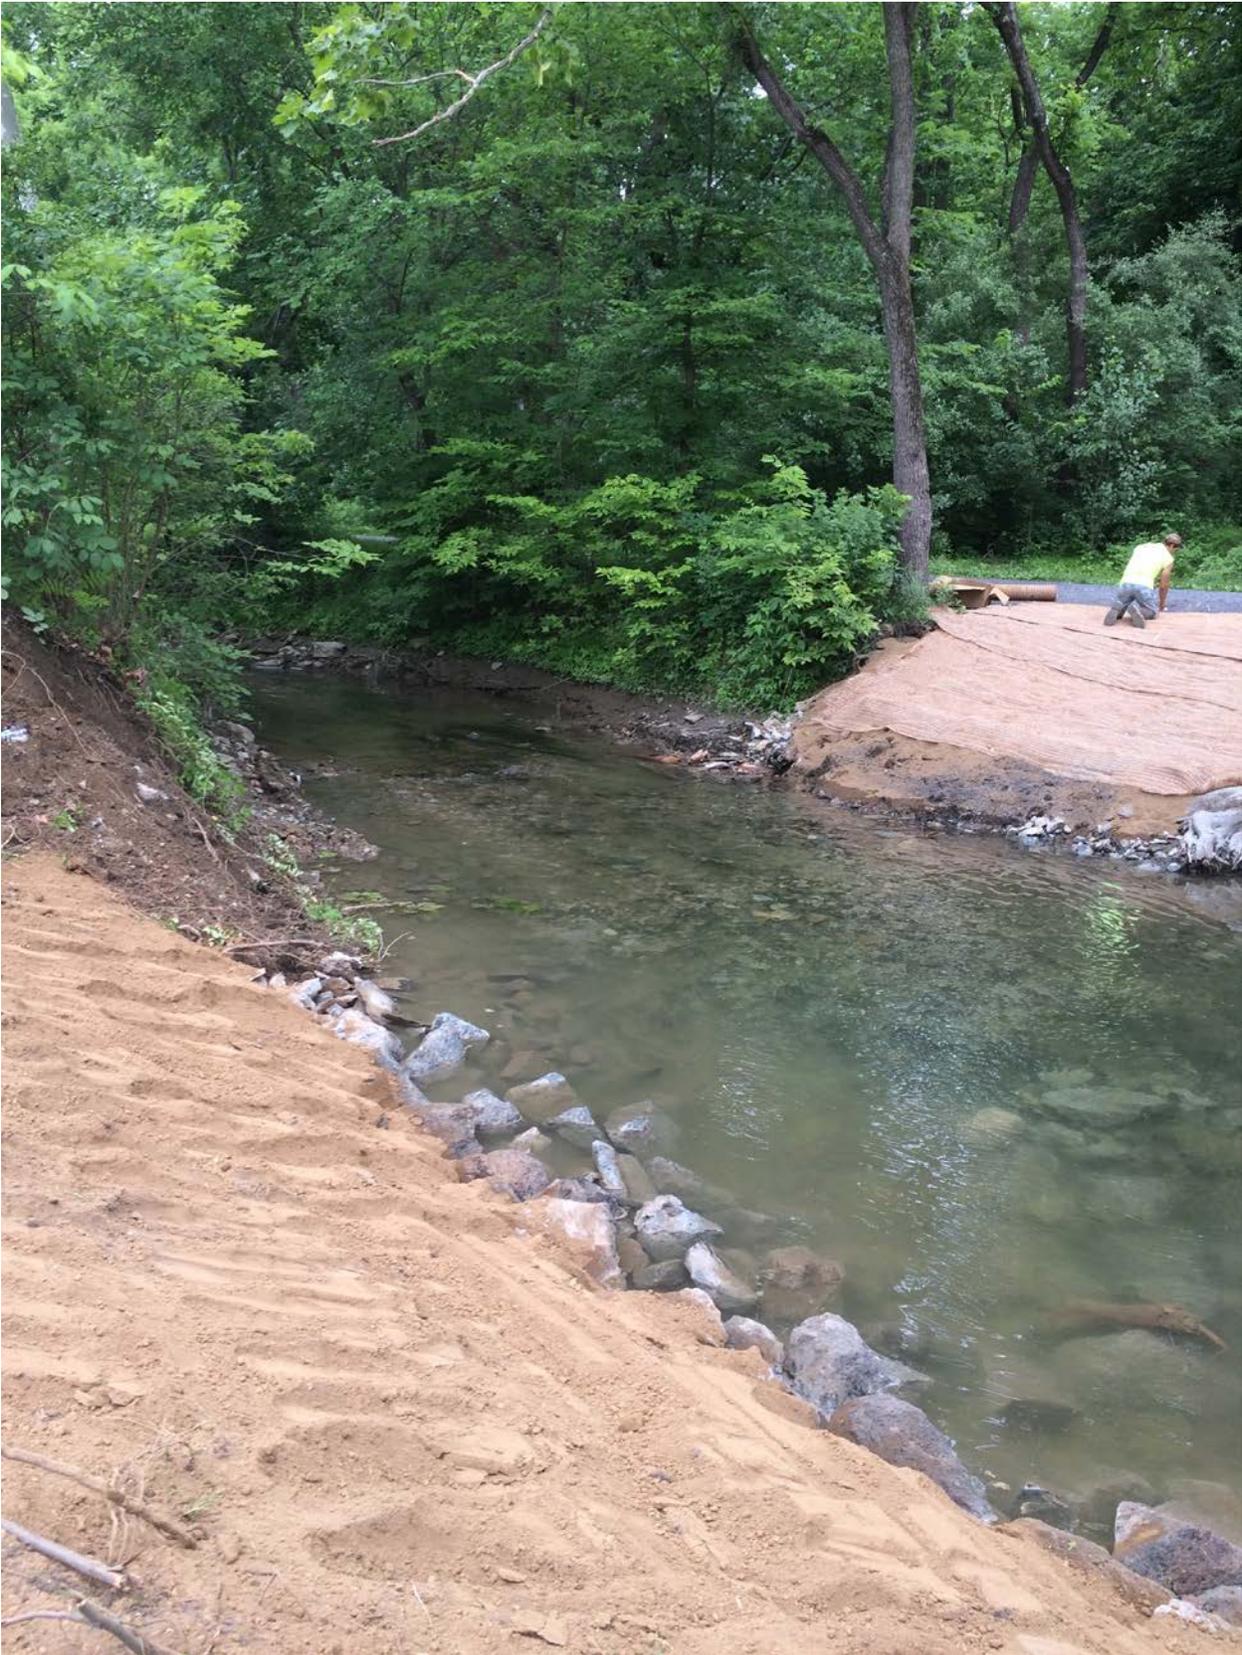
After:

Immediately after the dams were removed, Coplay Creek began to look more like a healthy, free-flowing, natural stream. The stream at the project sites began to narrow and carve a deeper path in the stream channel. Grading along the banks created bank stability and restored flood function to allow for floodplain storage during storm events. The banks of both sites were seeded with native grasses to provide immediate cover and stabilize the newly formed banks. Once the stream and banks settled, Wildlands and community partners planted various native herbaceous species to establish a new riparian buffer.
