Skinner Creek Conservation Planning Project

PREPARED BY
SENECA CHAPTER OF TROUT UNLIMITED

SECTION 1. PURPOSE OF STUDY/WATERSHED BACKGROUND

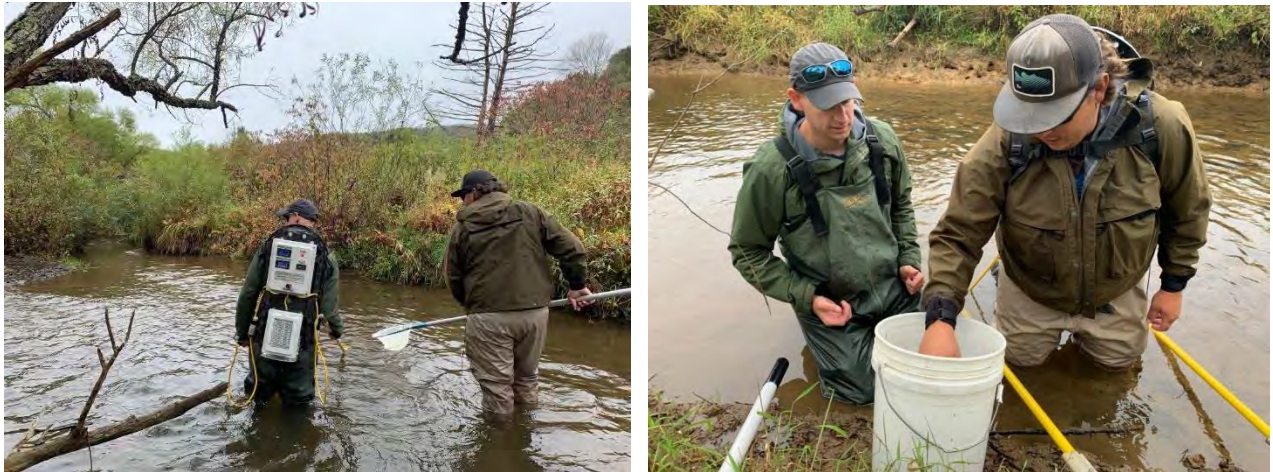
Figures 4 & 5. DEP Aquashock fish surveying

100-meter presence/absence fish surveys were completed at two different sites on Skinner Creek using backpack aquashock (Figures 4 & 5) on October 3, 2019 by NW Regional DEP Biologists. Each site consisted of one pass with two netters and two probes (200 Volts, 8.0 amps).

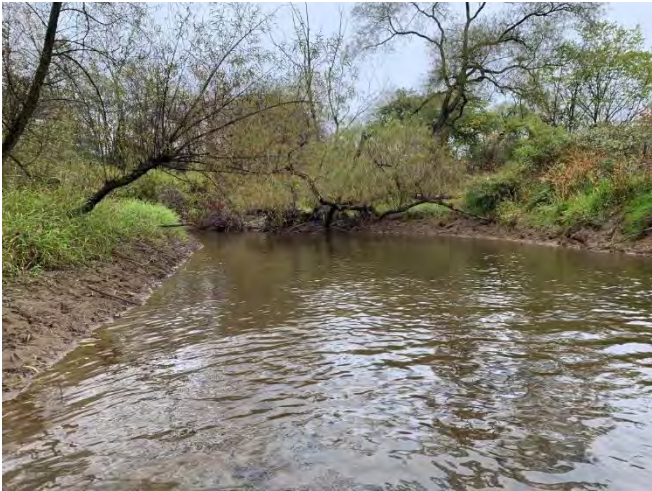
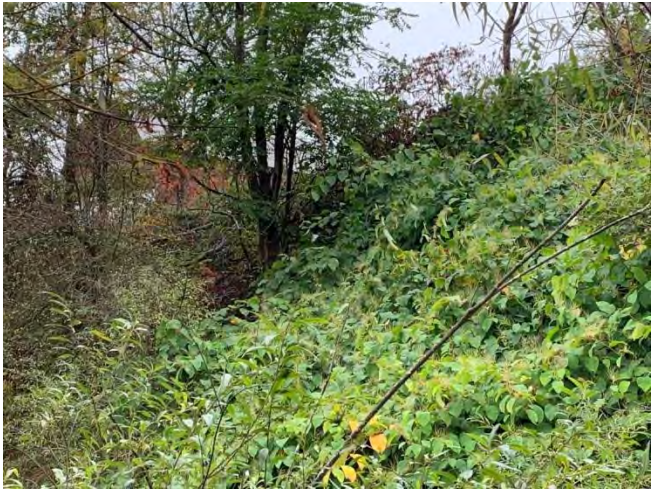
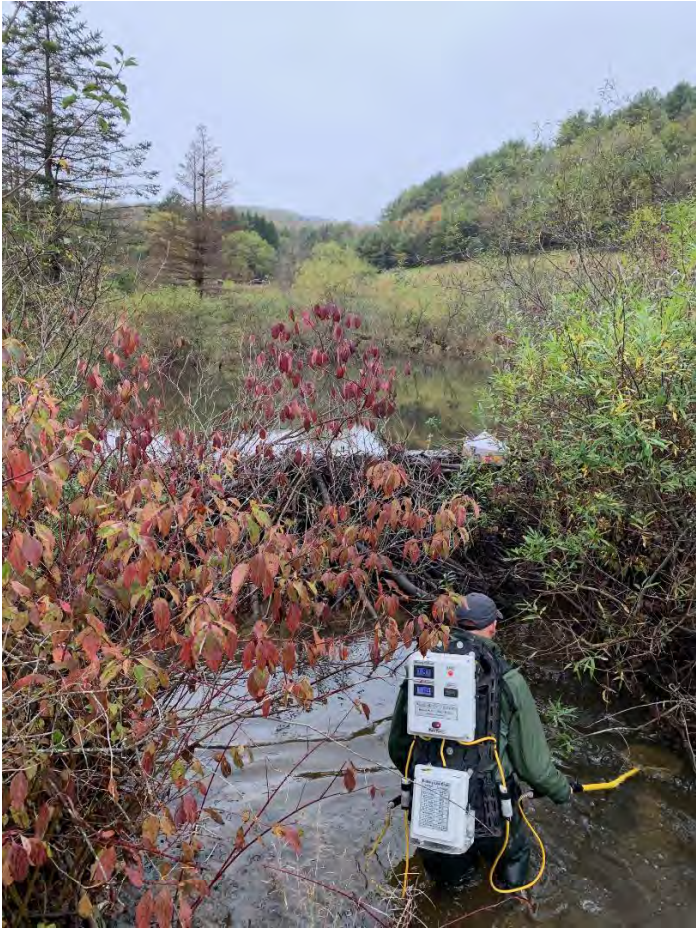
Habitat assessment scores for the four station sites of Skinner Creek are shown in Table 9 for each parameter. It was noted SN2 habitat had some boulders, mostly cobble and gravel, and lots of sand from upstream beaver ponds. SN3 had channelization from the pond which borders the stream and an old hatchery located upstream. IBI scores for all locations were not calculated. Overall habitat scores for Skinner Creek ranged from suboptimal to optimal with water appearance being clear and odorless. Invasive knotweed was also seen along banks of Skinner Creek (Figures 6 & 7).

Figures 7-9. Invasive knotweed was noted in riparian areas near SN1

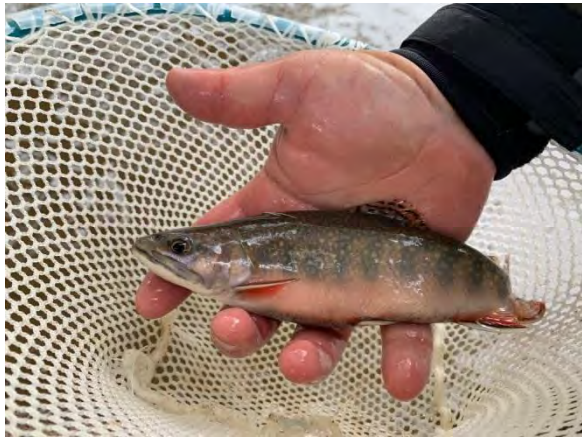
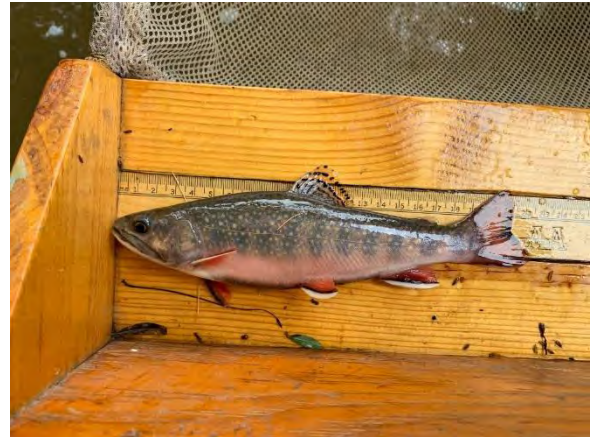
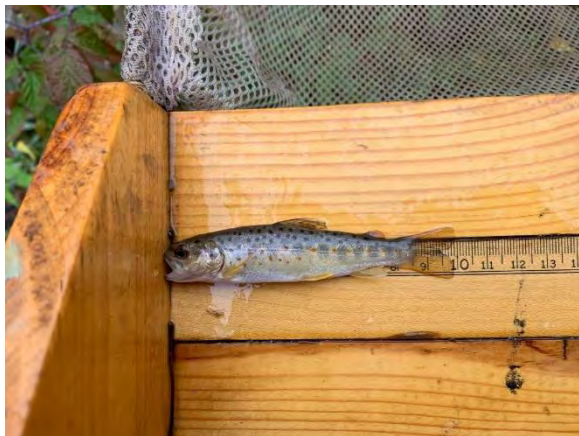
From field data collected, 413 fish were counted in total from the two sites, with twenty-five species in total recorded (Table 11) with help from the NW Regional DEP Office. Relative abundance was recorded together from both sites, most fish collected being a common species for Skinner Creek. The most abundant fish encountered were Blacknose Dace, Common Shiner, and Mottled Sculpin. An American brook lamprey was also collected while surveying

Figures 10-12. Native brook trout and young of year brown trout

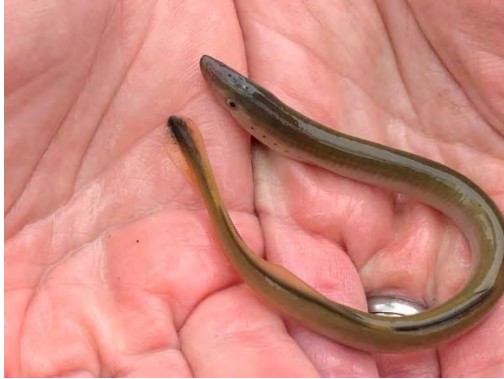
Figure 13. Adult American brook lamprey found while surveying
