# Upper Standing Stone Creek Coldwater Conservation Plan

## Huntingdon County, Pennsylvania

Huntingdon County Conservation District  
March 2020

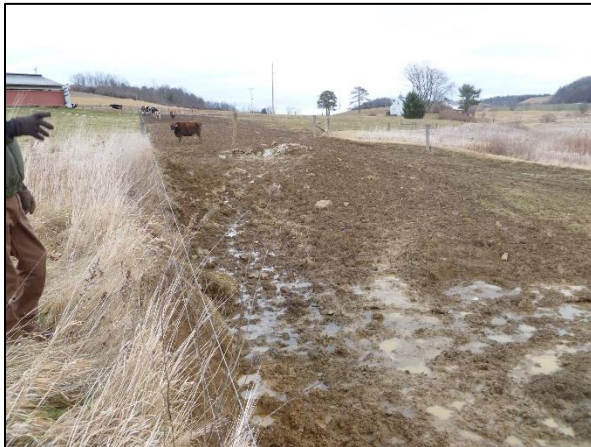
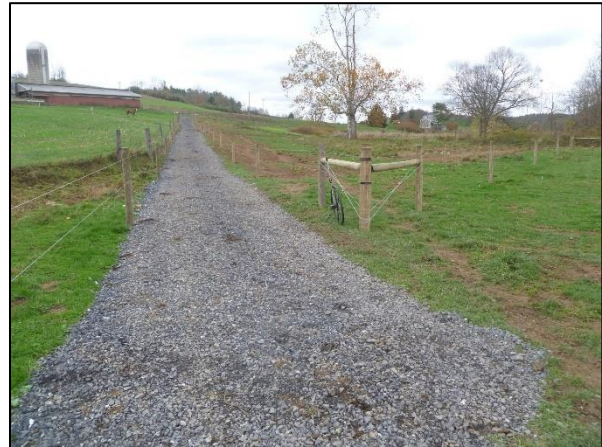
Photos 2-3. Before and after example of an NRCS cattle walkway stabilization project to improve soil health and water quality (*photos provided by James Steward*).

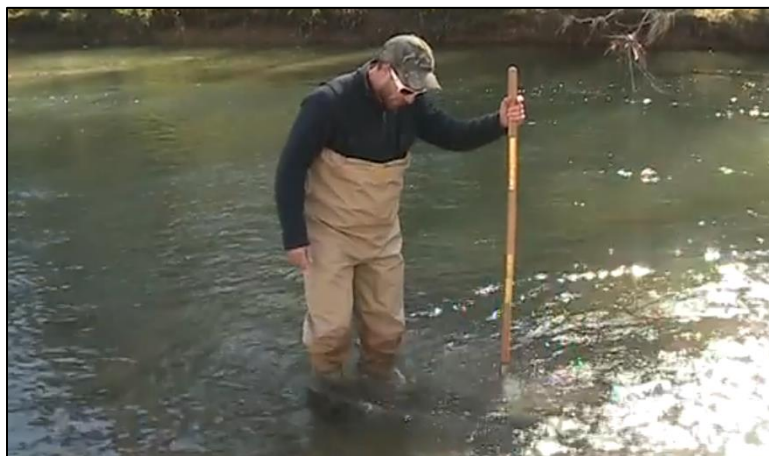
Photo 7. HCCD Watershed Specialist collecting a benthic macroinvertebrate sample in Standing Stone Creek.

Benthic macroinvertebrate samples were collected at each sample site following PADEP methodology for wadeable, freestone, riffle-run streams (Shull and Lookenbill 2018). Collection begins by delineating a 100-meter reach along the stream of interest. A six-kick composite sample is collected from the reach using a 12-inch wide x 10-inch high D-frame net with 500-micron mesh. For each kick, the collector places the net against the stream bottom and disturbs a one square meter area immediately upstream of the net for approximately one minute. The collector attempts to distribute the kicks among a variety of riffle habitats (e.g.,

slow-flowing, shallow riffles and fast-flowing, deeper riffles). Kicks were also conducted throughout the width of the stream to include the left, middle, and right areas. This is done to ensure the composited sample provides an accurate representation of the macroinvertebrate community throughout the stream reach.

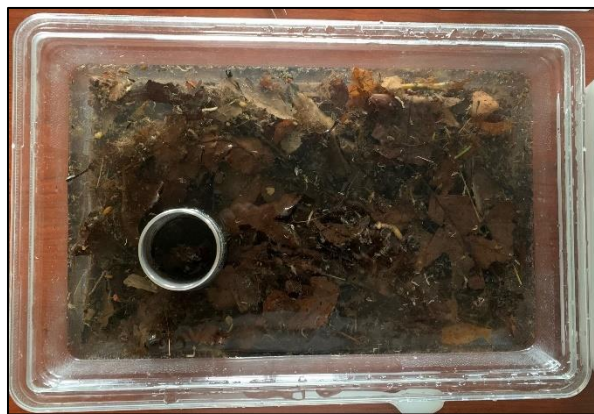
Photo 9. Subsampling pan with sample contents and one “cookie cutter” grid selected.

In the laboratory, benthic macroinvertebrate samples were sorted and processed following PADEP methodology for macroinvertebrate samples collected from freestone streams (Shull and Lookenbill 2018). Prior to subsampling, the composited sample is removed from the collection container and placed in a 500-micron sieve. The sample is gently rinsed under running water to remove ethanol and minimize damage to the macroinvertebrates. The sample is then placed in an 18-inch x 12-inch x 3½-inch pan, marked off into (28) 2-inch x 2-inch grids. Water is added to the pan before sample placement to ensure the macroinvertebrates are evenly distributed throughout the pan, and to prevent the contents of the sample from drying out during the subsampling process. Once the contents of the sample are placed in the pan, four 2-inch x 2-inch grids are randomly selected.

The materials and organisms from the selected grids are removed from within four-square inch circular “cookie cutters” placed in the randomly selected grids and removed using spoons, turkey basters, tweezers, and other implements as needed. The extracted contents are then placed into a second pan with water. Identifiable organisms are then picked and counted from the second pan.

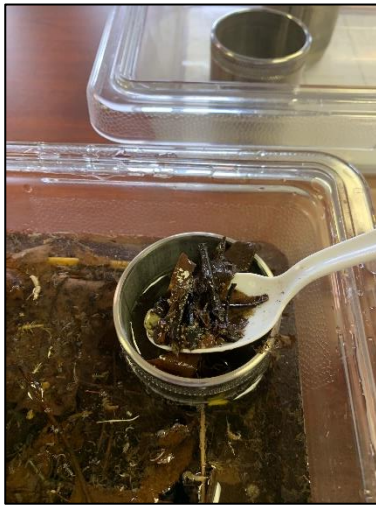
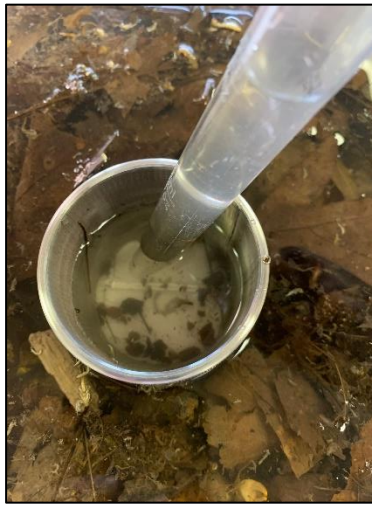
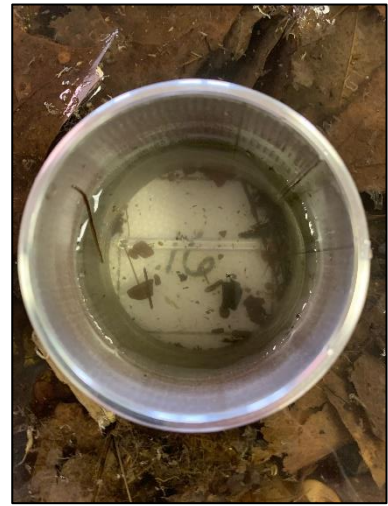
Photos 10-12. Contents of the subsampling grid are removed using spoons, turkey basters, etc.

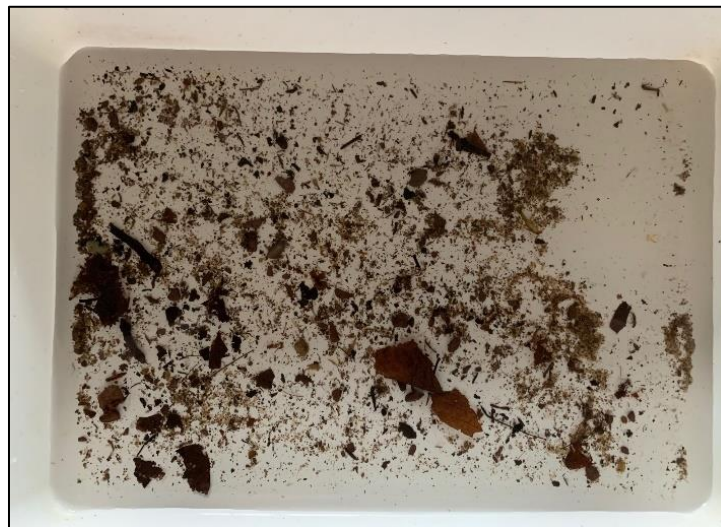
Photo 13. Contents from the subsampling grid are placed into a second pan and picked for identifiable organisms.

If less than 180 identifiable organisms are picked from the second pan, an additional grid is randomly selected and extracted from the first pan. The materials and organisms from this additional grid is moved to the second pan, and the organisms are picked. This process goes on until a subsample target number of  $200 \pm 20$  organisms is reached.

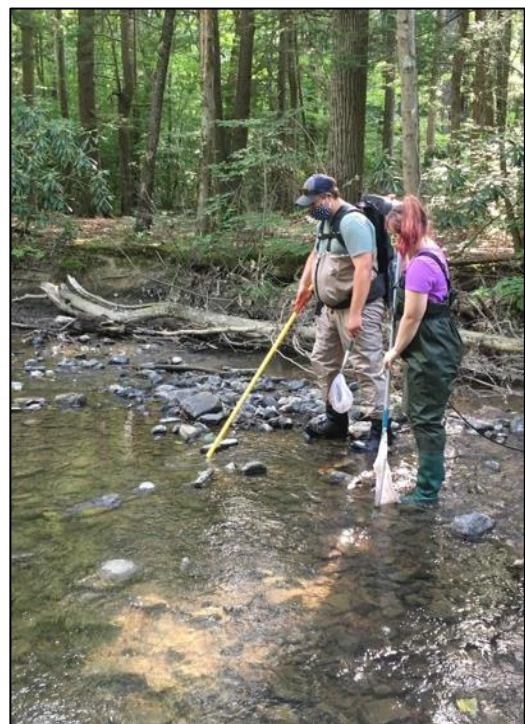
Photo 14. Electrofishing crew ready to begin a survey reach on Laurel

Fish biodiversity surveys were accomplished using two Smith-Root LR-24 backpack electrofishing units with pulsed direct currents ranging from 200 to 550 volts. Electrofishing began at the downstream origin of the sample reach and commenced in an upstream direction. This is done to account for the natural tendency that fish are “pushed” upstream to avoid the electrical current. Electrofishing concluded at a predetermined stopping point near the end of the sample reach that provided a natural barrier to upstream escape (i.e. shallow riffle or log jam). It is understood that some fish will not be captured, but a concerted effort is made by the electrofishing crew to capture every fish sighted during the survey. Stunned fish were captured using 5mm mesh nets and placed into 5-gallon buckets prior to processing. To reduce mortality, buckets were regularly exchanged with cool, fresh water to ensure adequate dissolved oxygen and remove waste by-products. At the conclusion of electrofishing, the crew leader records the shock time (in seconds) for each backpack electrofishing unit, as well as the GPS location for the sample reach.

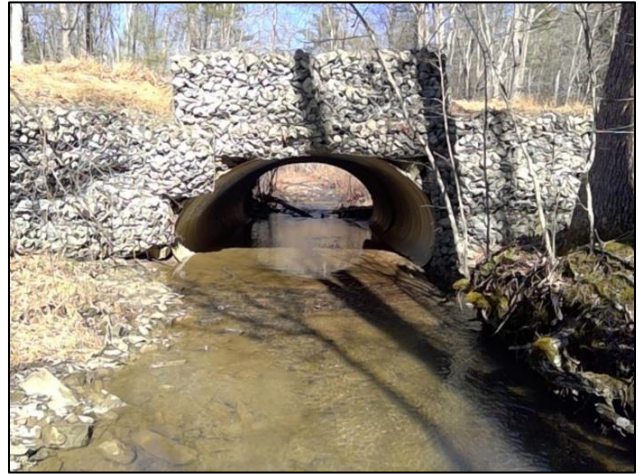
Photo 15. Example of stream crossing culvert allowing AOP.

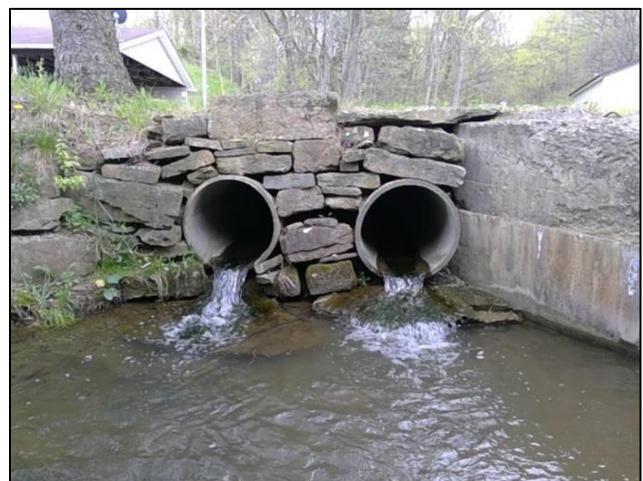
Photo 16. Example of stream crossing culvert allowing No AOP.

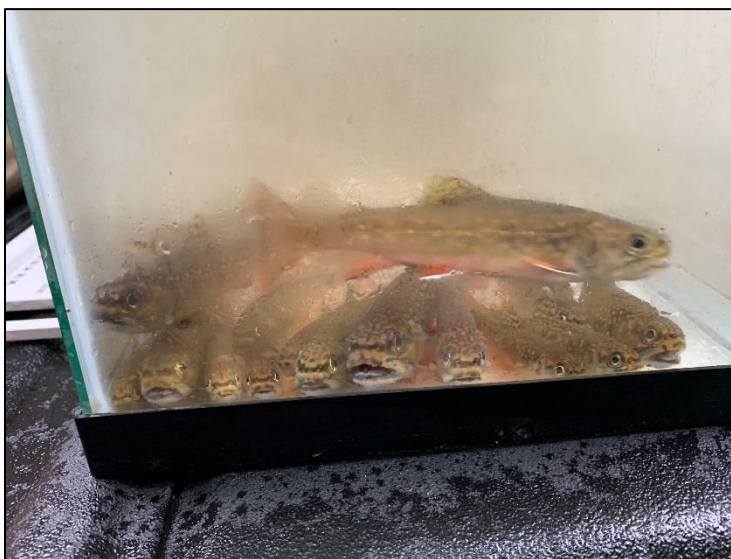
Photo 18. Wild brook trout (*S. fontinalis*) from East Branch Standing Stone Creek.

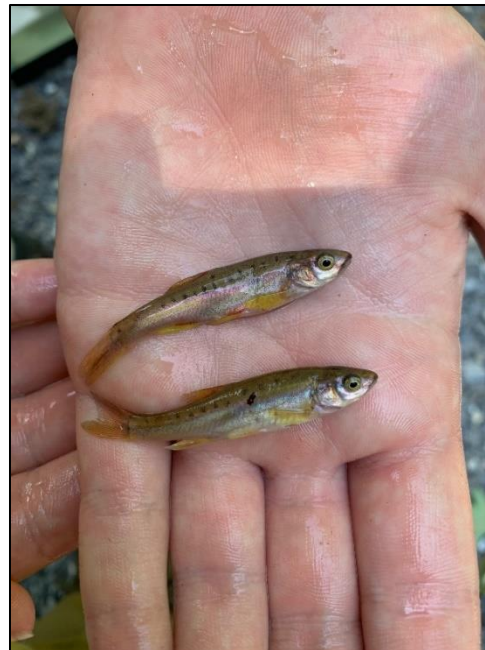
Photo 19. Mountain redbelly dace (*C. oreas*) from Herod Run.

Another interesting find during this study was the presence of mountain redbelly dace (*C. oreas*) at 3 sites along Herod Run, a tributary to Standing Stone Creek. According to Stauffer et al. (2016), the mountain redbelly dace is a nonnative minnow species found in only two streams in Pennsylvania, both of which are located within Huntingdon County. Their presence in Herod Run was first described in 2011 by Grant et al. (2015) and it is unknown how their presence may impact native fish communities.

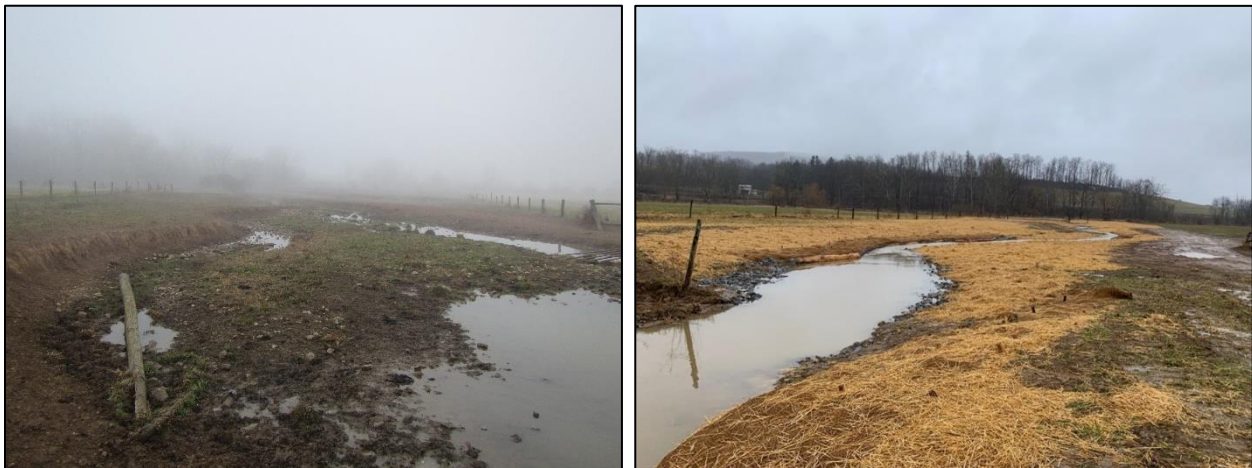
Photos 21-22. Before and after pictures from a stream restoration project along Shavers Creek, a comparable HQ-CWF stream to Standing Stone Creek, in Huntingdon Co. 2021.

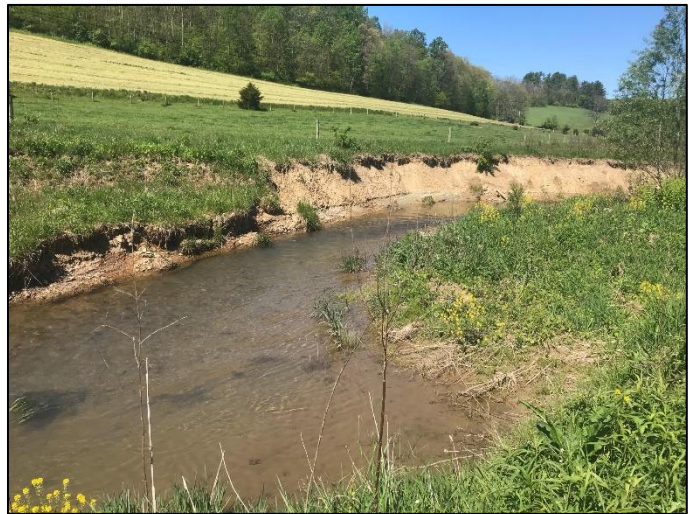
During the HCCD's assessments, staff observed Herod Run flowing through many open areas of agricultural land. While some of these areas did include BMPs, such as stream fencing to exclude livestock, many stream sections lack such practices. As a result, these areas likely contribute to increased levels of sediment and nutrient pollution in Herod Run, and ultimately Standing Stone Creek.

Photo 23. Example of eroding stream banks along Herod Run at site HR-01.

Therefore, to reduce sediment and nutrient pollution in Herod Run, the District recommends collaborating with local landowners residing in the Herod Run watershed to implement the following:

1. Agricultural BMPs, such as livestock exclusion fence and stabilized stream crossings, to reduce erosion and manure runoff while balancing the economic needs of the farm.
2. Construct in-stream structures, such as mud sill and toe log, to stabilize eroding stream banks and increase the amount of available fish habitat.
3. Plant riparian forest buffers to improve runoff filtration, mitigate flood severity, shade the stream (reducing water temperatures), and increase terrestrial wildlife habitat.
4. Replace undersized culverts and other stream-road crossings to increase aquatic passage and allow organisms to access all areas of the watershed, such as the forested headwaters.

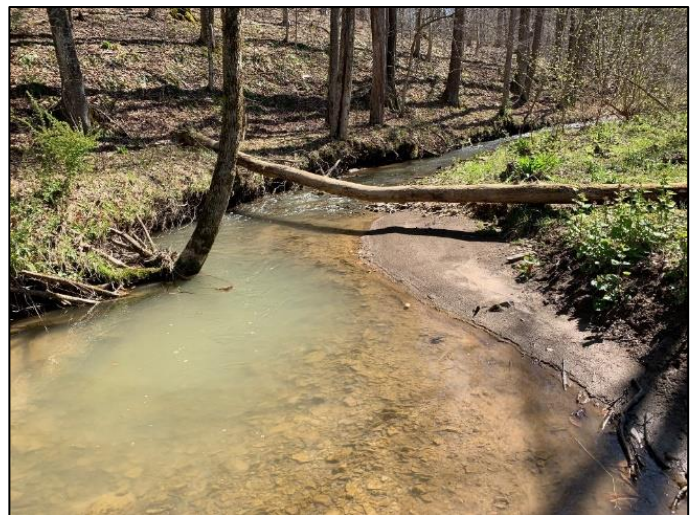
Photo 24. Example of sediment deposition along Herod Run at site HR-02.

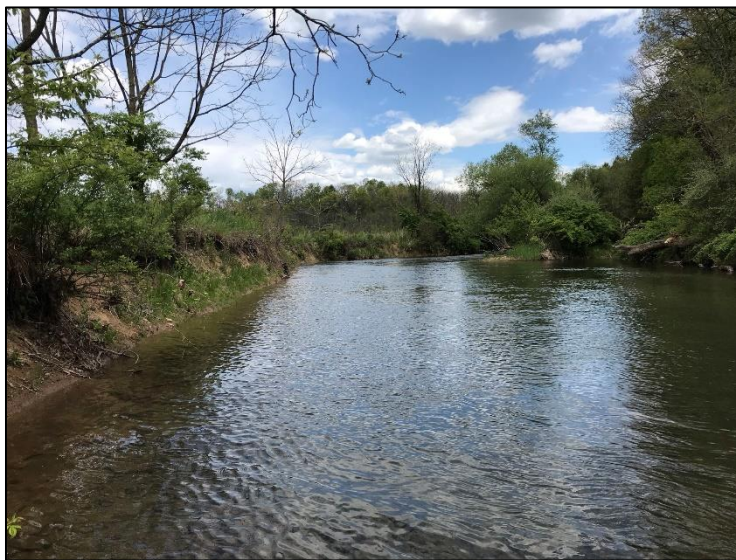
sites that showed signs of degradation through bank erosion and lack of in-stream fish habitat. While these degraded areas were not as severe as the degraded areas along Herod Run, these sections of stream (Figure 7) would still benefit from restoration activities and contribute to improved water quality. Therefore, to continue improving water quality conditions in the watershed, the District recommends the following for this area:

Photo 25. Eroding stream banks at sample site SSC-02.

1. Construct in-stream structures, such as mud sill and toe log, to stabilize eroding stream banks and increase the amount of available fish habitat.
2. Plant riparian forest buffers to improve runoff filtration, mitigate flood severity, shade the stream (reducing water temperatures), and increase terrestrial wildlife habitat.

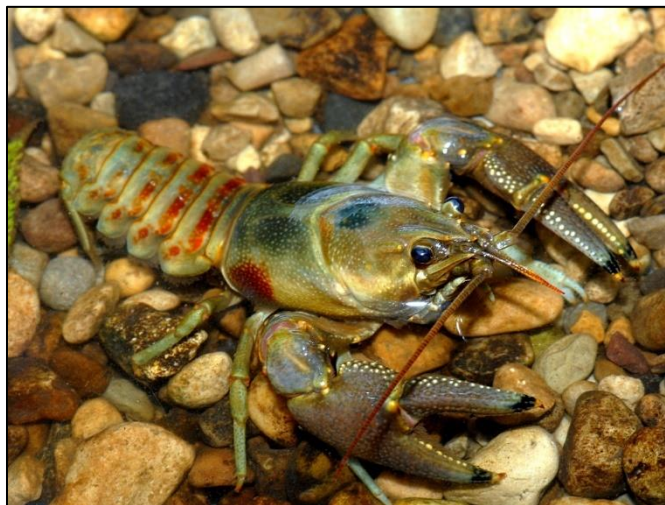
Photo 26. Rusty crayfish. \*Note the characteristic rusty-colored spot on the side of the carapace.

Adult rusty crayfish are typically 3-5 inches long with large, black-tipped claws and a characteristic set of dark rusty-orange spots on each side of the carapace. Rusty crayfish are very aggressive and voracious feeders. They can easily outcompete native crayfish, such as the Appalachian brook crayfish (*C. bartonii*), and can negatively impact fish populations, including bass and trout, by feeding on their eggs and destroying vegetative cover and spawning habitat (Sea Grant Pennsylvania 2018). To prevent the spread of rusty crayfish to new water bodies from Standing Stone Creek, anglers should never transport crayfish from Standing Stone Creek to another water body.

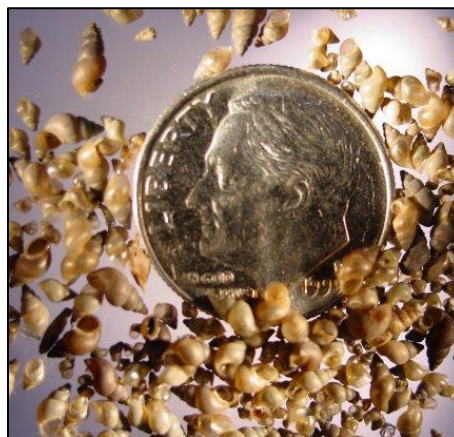
Photo 28. New Zealand mudsnail size compared to a dime.

NZM are extremely small, often only measuring a few millimeters (3-6mm) in length. Due to their small size, mudsnails can become lodged in wading boots, fishing gear, and boating gear, making it easy for them to travel to new environments undetected. In addition, NZM can survive out of water for long periods of time and reproduce extremely fast as the species is asexual, meaning only one individual is needed to produce an entirely new population. Once populations reach higher densities (populations of up to 300,000 per square meter have been reported), mudsnails begin to outcompete native snails, mussels, and aquatic insects for resources. While NZM do not directly impact fish, they can negatively affect fish populations

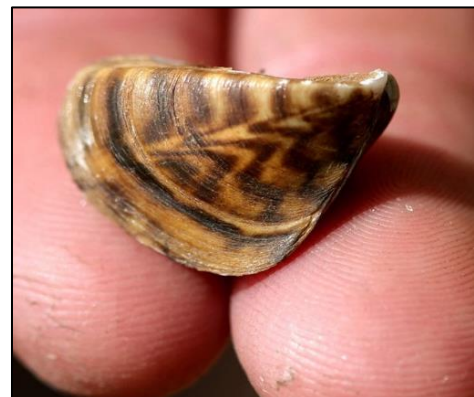
Photo 30. Zebra mussel. \*Note the distinctive zig-zag stripe pattern.

Zebra mussels are generally small and measure approximately a ½ inch to 1 inch in length (roughly the size of a fingernail). The shell forms a signature “D-shape” and is colored brown or tan with a characteristic zig-zag stripe pattern. Zebra mussels are often found clustered together in large quantities and attach themselves to substrate, as well as manmade structures such as buoys, docks, and boat hauls. Each year, zebra

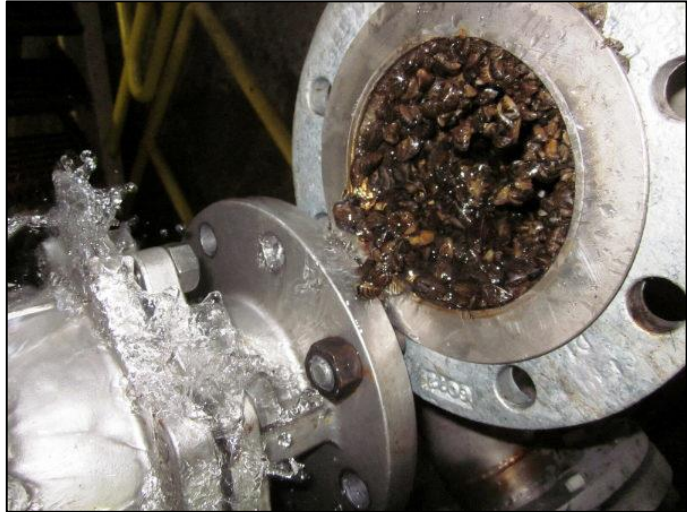
mussels cost the U.S. approximately \$140 million in damage and control costs due to them clogging utility pipes and water intakes at power and water facilities. In addition to economic damage, zebra mussels can negatively alter aquatic ecosystems. Zebra mussels are prolific filter feeders, with a single zebra mussel capable of filtering one liter of water per day. In doing so, zebra mussels consume large amounts of microscopic organisms called plankton. Plankton serve as the foundation for aquatic food chains by serving as food for smaller invertebrates and fish, which are then consumed by larger fish and terrestrial animals such as birds and mammals. By removing large quantities of plankton, zebra mussels can severely alter the natural food chain, indirectly impacting many aquatic organisms (Sea Grant Pennsylvania 2015).

Photo 31. An example of zebra mussel cluster clogging a water intake pipe.
