Bushkill Creek Restoration and Habitat Enhancement Project October 2021 Final Report Grantee: Wildlands Conservancy

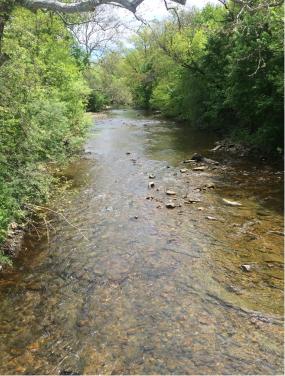
Before photo of stream lacking instream habitat diversity. The depth is uniform throughout the long reach of stream, lacking instream habitat.

- Accomplishments and outputs
 - a. Observed or measured improvement to overall condition of the stream or watershed. The original conditions lacked any instream diversity due to the stream channelization from the construction of the adjacent road. The instream structures immediately enhanced the instream conditions by creating pools and riffles and varying depths and flow patterns. Instream habitat diversity continued to improve after several rain events as the structures and features created by the project became more established.

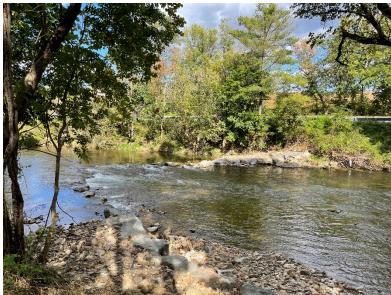
After photo of one of the 19 instream structures. Each structure creates a diversity of flow and instream habitat. A deep pool is forming downstream from the structure while creating more shallow, slower flow conditions along the stream banks for added habitat and stream bank stabilization.

Wildlands hired Flyway Excavating to complete the construction. Flyway has completed numerous stream restoration projects in the Valley and is highly experienced in instream habitat installation. Work began in July and finished in September 2021. The 19 instream habitat structures were built with appropriately sized rock to handle high flows. They were well tested by the many high flows from hurricanes and heavy rain events this summer. The structures provide riffles and pools within the stream channel to benefit aquatic habitat and diversity. The structures are also built to provide stream bank protection to prevent erosion and sedimentation. The construction access to the stream are now serving as fishing and stream access with a well established riparian buffer growing on either sides of the paths. The over one mile stream restoration project is adjacent two municipal parks (Tatamy Borough and Palmer Township) with a biking path connecting the parks to the City of Easton. This highly visible and easily accessible site will serve as a model to the many visitors about the benefits and opportunity for diversity within public parks, and the value of healthy stream systems throughout their community.
