# Big Run Coldwater Conservation Plan

Western Pennsylvania Conservancy

The Coldwater Conservation Plan, developed by the Western Pennsylvania Conservancy for the Big Run Watershed in Jefferson County, contains stream health analysis based upon water quality data collected through sampling and visual inspection, as well as recommendations for potential restoration and protection strategies supported by these analyses. The objective of this document is to generate support and participation from local landowners and municipal entities and to encourage community awareness, so that recommendations can be advanced into the implementation phase, yielding watershed improvements.

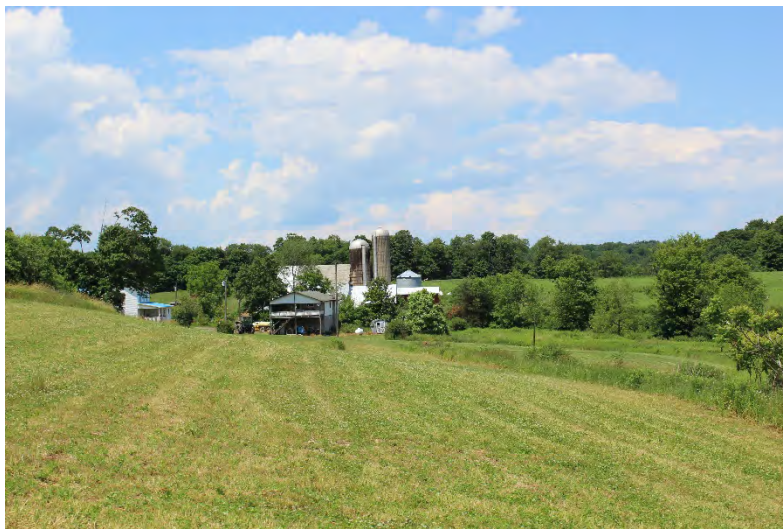
**Photo 1: Land use within the Big Run watershed includes active crop land including hay production.**

Most of the residences within the watershed are scattered along the perimeter of Big Run and their water drains into the named and un-named tributaries of the system. The majority of these residences are a type of agriculture operation, including hayland, livestock and row crops. Runoff from annual cropping activities as well as over-grazed pastures is known to lead to excess sedimentation in the watershed, which can be detrimental to stream ecology without the implementation of BMPs to mitigate the sedimentation. An additional source of sediment are dirt and gravel roads, as there are 13.1 miles of these roads within the watershed. There is also a small amount of abandoned mine drainage (AMD) within the watershed, and sediment from seeps and discharges add to the sediment load. Fine sediment appears throughout the watershed and can be contributed to these land uses.

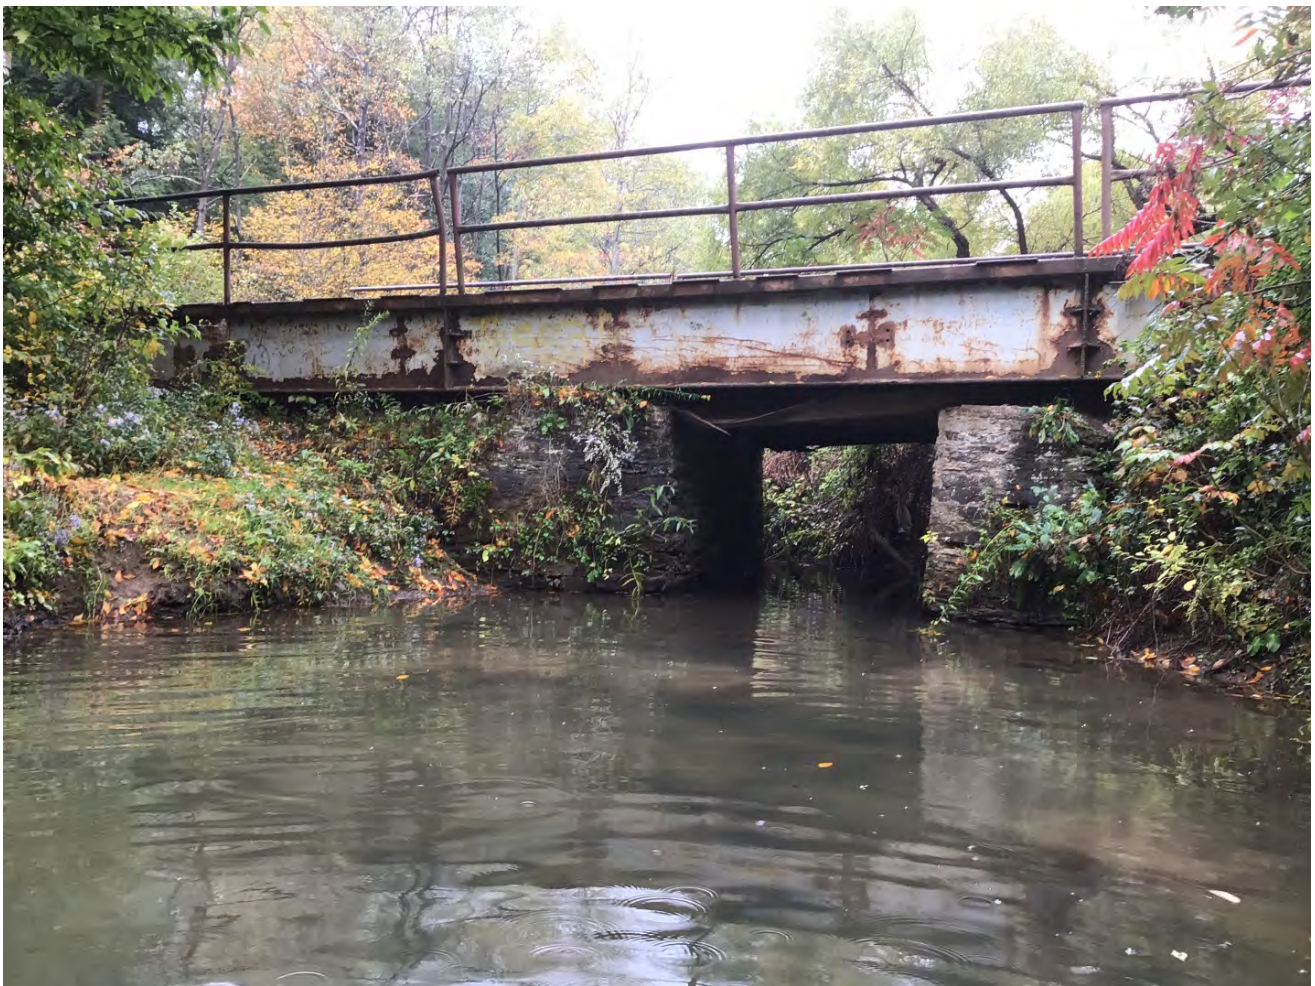
**Photo 2: The bridge on TR 506 crossing Big Run just above the start of the Class A section of the stream.**

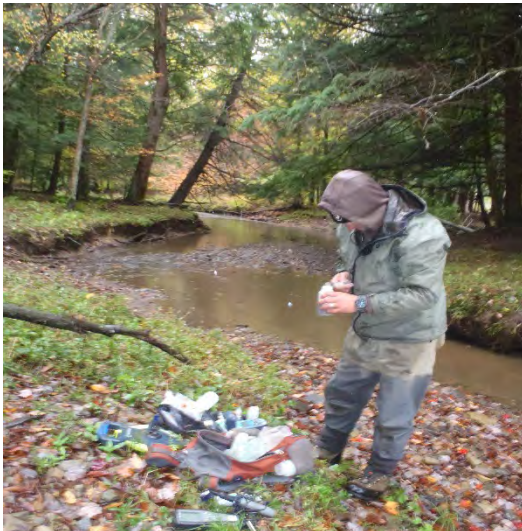
**Photo 4: WPC staff run in-field water quality tests on Big Run.**

In-field water quality sampling and macroinvertebrate monitoring were done twice over the course of this project; once in the fall 2019 and once in the spring 2020. Five sites were chosen based on location within the watershed in an effort to provide the best overall view of the macroinvertebrate populations within the watershed. Three sites were on mainstem Big Run, a lower (BR-1), middle (BR-2), and upper site (BR-3), as well as sites on two named tributaries; McKee Run and Turnip Run. The map titled: Big Run Watershed Monitoring Points (Figure 6) shows that the sites were spread across the watershed to document current conditions on the mainstem of Big Run as well as two major tributaries.

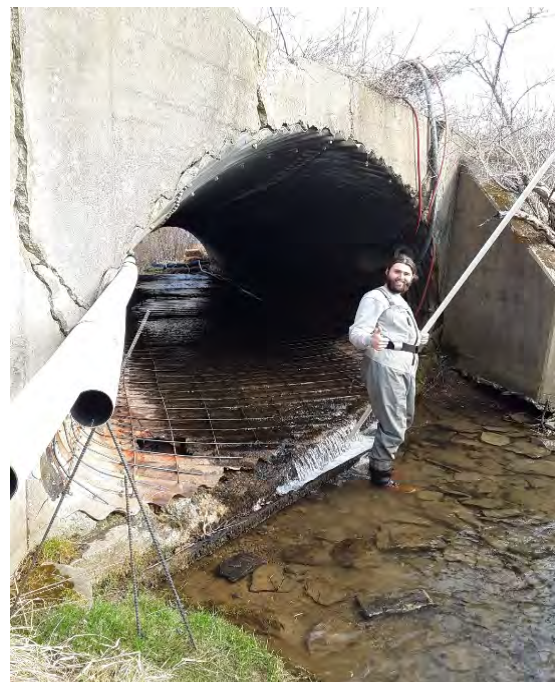
Photo 6: WPC Staff pause for a photo during an AOP evaluation of a culvert in the Big Run watershed.

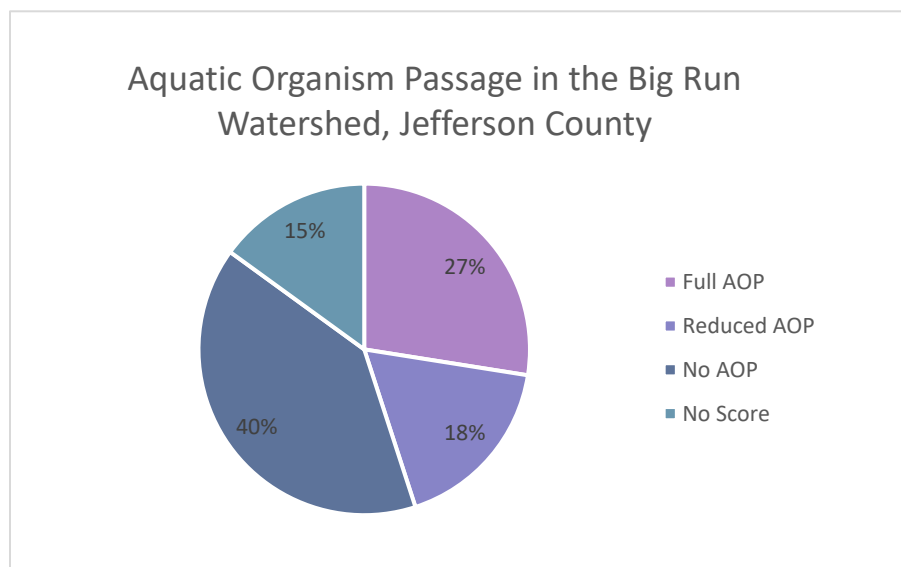
Figure 7: Ranking of the ability of passage for aquatic organisms.

A total of 40 road-stream intersections were examined as part of the Big Run CHP. Structures were scored using the NAACC protocol as referenced in the AOP Overview section. Only crossings that were located on public roadways were scored during the 2019 and 2020 surveys. Structure types assessed included single culverts, box culverts, multiple pipe culverts, and bridges. Examples of these structure types can be found in the NAACC Stream Crossing Survey Data Form Instruction Guide available on-line (NAACC 2016). Numerous crossings that were assessed failed to provide adequate fish passage, which resulted in reduced or no-AOP rankings for 58% of all crossings surveyed (Figure 7 and Figure 8). Many of the crossings that had a ranking of full AOP were large bridge structures often associated with main roads. We examined 24 culverts, only two of which didn't pose as

barriers to aquatic organisms. Of all crossings that were surveyed, a structure found on Turnip Run at the intersection where T506 crosses the stream appears to have the most conservation benefit if this structure were to be replaced. An additional four miles of reconnected habitat will be available to this important population of wild brown trout. Replacing undersized road-stream crossings is of high conservation value not only to trout populations but other aquatic organisms as well.

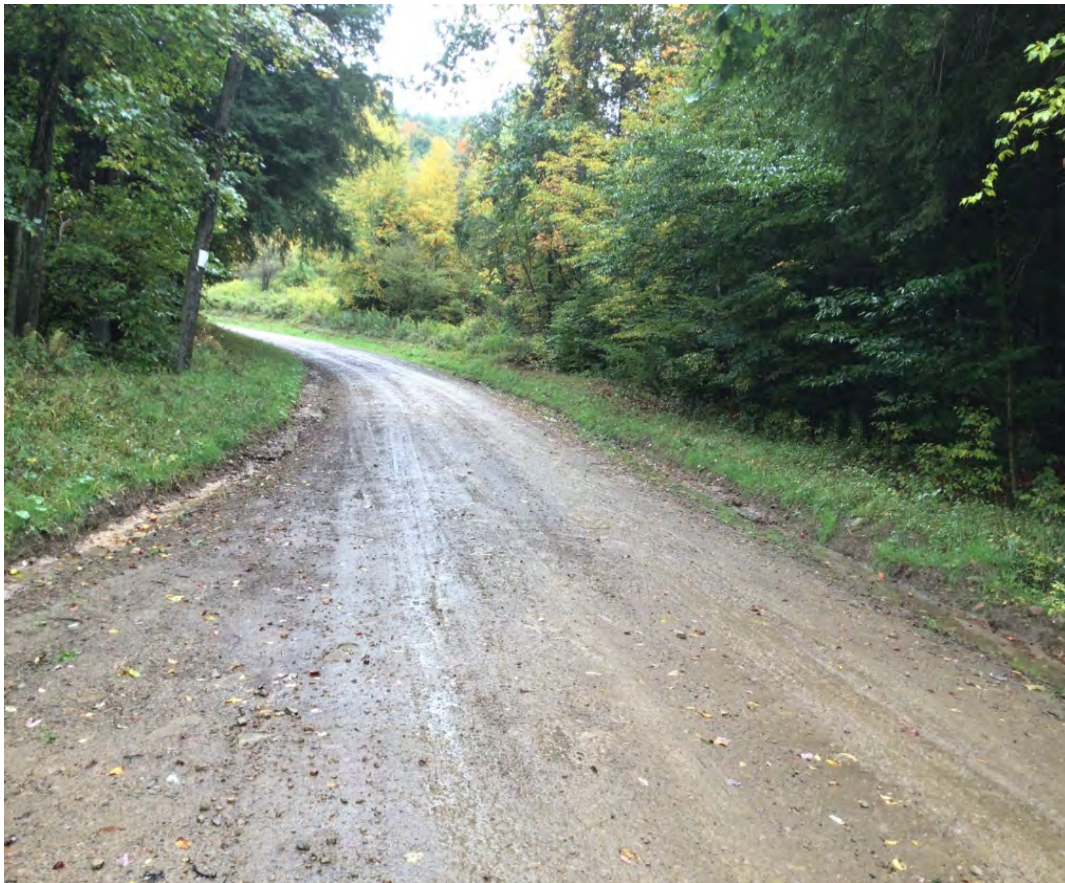
During in-field assessments, dirt and gravel roads were noted when observed within each segment, as well as any obvious issues that may have been associated with them. These issues may have included stream fords, drainage ditches discharging high amounts of sediment to the stream, heavily eroded tire tracks leading to the stream, and changes in streambed substrate composition near the road-stream interaction zone. It can be seen on Figure 10 Dirt and Gravel Roads of Big Run that the majority of the DGRs are in the center of the watershed and often parallel the main stem of Big Run. Having a naturally well buffered stream will do nothing to protect against un-natural sedimentation issues, such as those caused by poor DGR practices, and without the cooperation of the local municipalities to improve issues, sedimentation may continue to plague the watershed.

**Photo 7: Runoff from dirt and gravel roads carry sediment and pollutants and when not maintained properly can negatively impact water quality and aquatic habitats.**

Dirt and gravel roads are recommended to be managed to have a minimum impact on aquatic resources and be removed, decommissioned, or at the very least vegetated when they are no longer needed. Proper Best Management Practices (BMPs) should be installed whenever possible, including but not limited to: re-surfacing with Driving Surface Aggregate, grade breaks, and cross drains. While sediment contributions from dirt and gravel roads were noted as minimal throughout the majority of these watersheds, staff noted high amounts of sand and fine material on many of the segments assessed. They were not noted as DGR sediment contributions as this connection could not positively be established. Some of the material noted was natural to the area, yet it was also hypothesized that tributaries and road ditches in ephemeral headwaters were acting as conduits for fine, sandy sediment to the streams. Additionally, not all Dirt and Gravel Roads were available through GIS mapping, and segments on that map may have improvements recommended for “unmapped” private access roads. Stakeholders seeking to reduce road maintenance and sediment contributions to those stream segments should work with the appropriate township or borough, Jefferson County Conservation District, and the landowner(s) for solutions that benefit all. If possible, while working on DGR improvements, AOP barriers should also be removed/replaced/decommissioned within the same project.

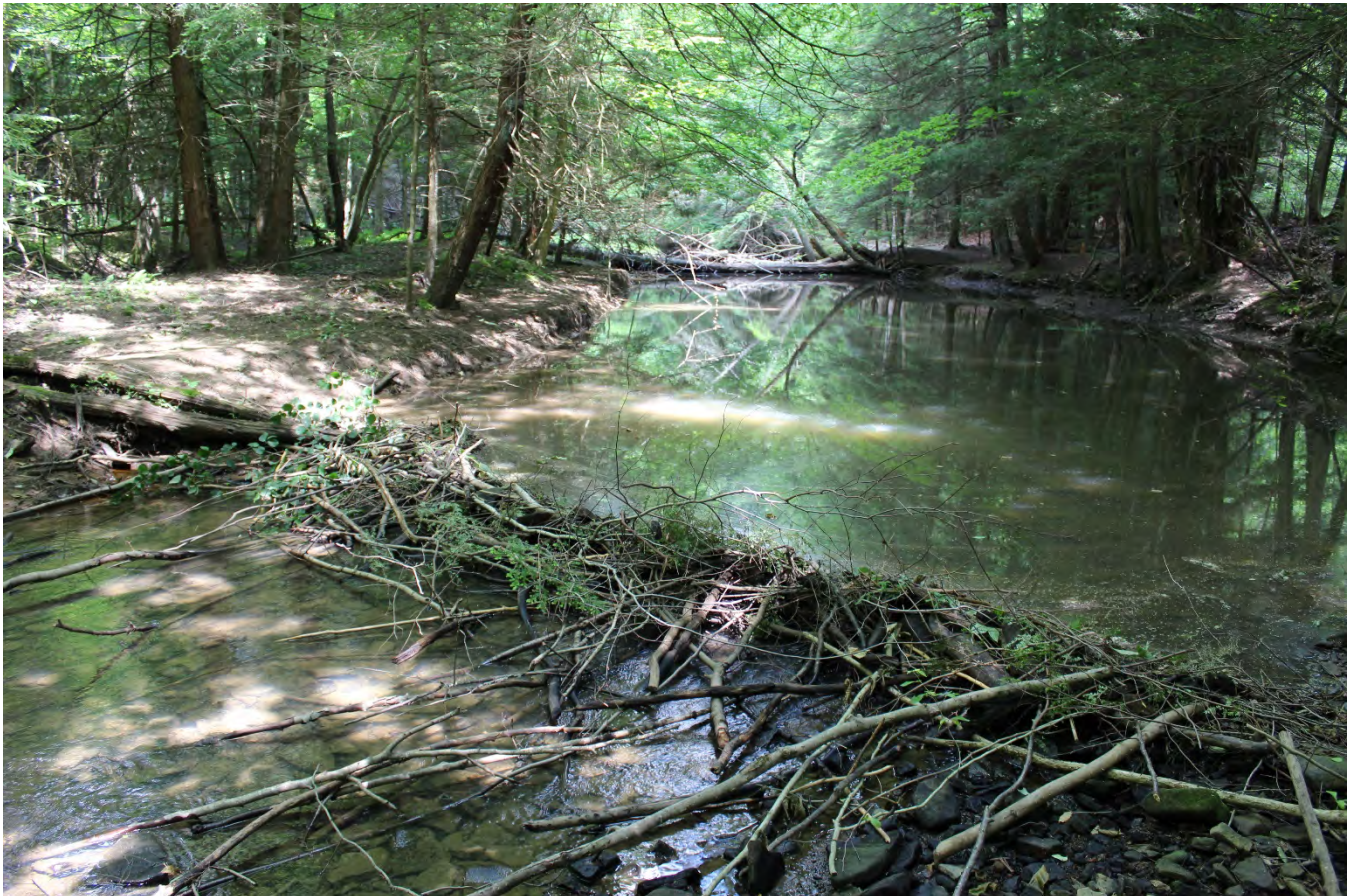
**Photo 8: Beaver activity on Big Run is a common and natural occurrence.**

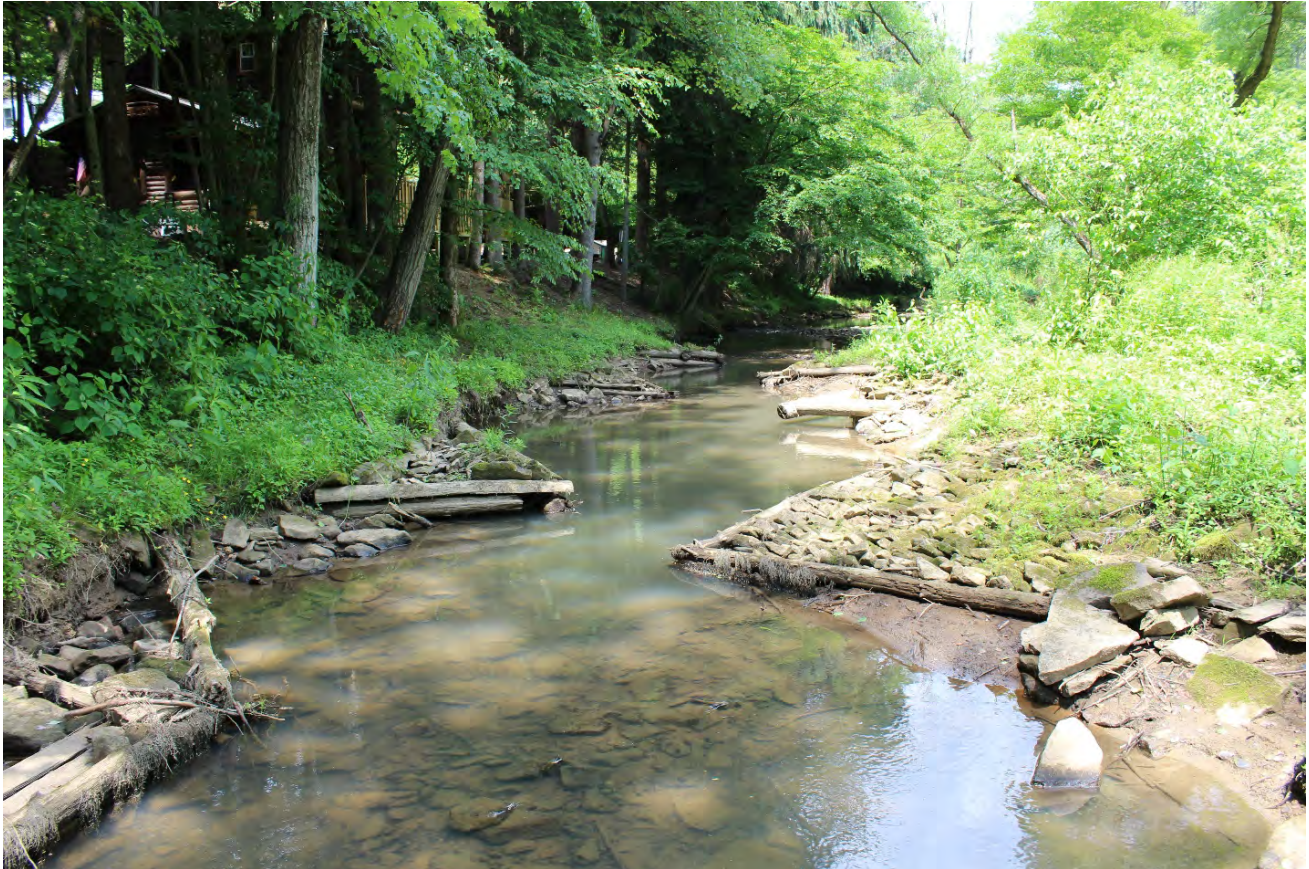
**Photo 9: Antiquated aquatic habitat/stream stabilization structures on Big Run.**

An area of concern within the watershed is a well-intentioned but antiquated aquatic habitat/stream stabilization structures on the mainstem of Big Run. Records indicate these structures were installed in the late 1970's to early 1980's, making them well over 40 years in age and beyond the functional life expectancy of the structures. In addition to the documented age of the structures, visual inspection shows that the integrity of the structures is failing and causing negative effects on the stream bank and stream channel itself.

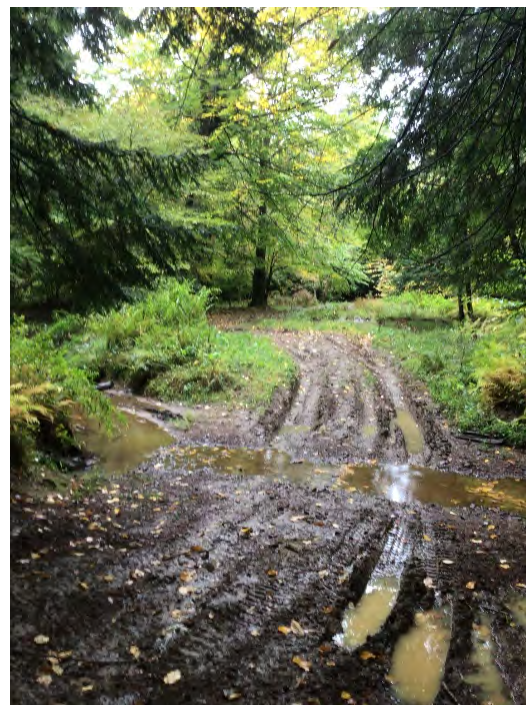
**Photo 10: Private dirt roads and stream crossing can contribute sediment to the streams, as seen in this photo taken on a tributary to Big Run.**
