Final Report for the Simeling Run Streambank Stabilization Project BRC-SR-27-8

**Kelly Williams, Watershed Specialist
Clearfield County Conservation District
6395 Clearfield Woodland Highway, Suite 2
Clearfield, PA 16830
kwilliamsccd@atlanticbbs.net
814-765-2629**

July 22, 2022

Simeling Run Habitat Structure Repair Pictures BRC-SR-27-8

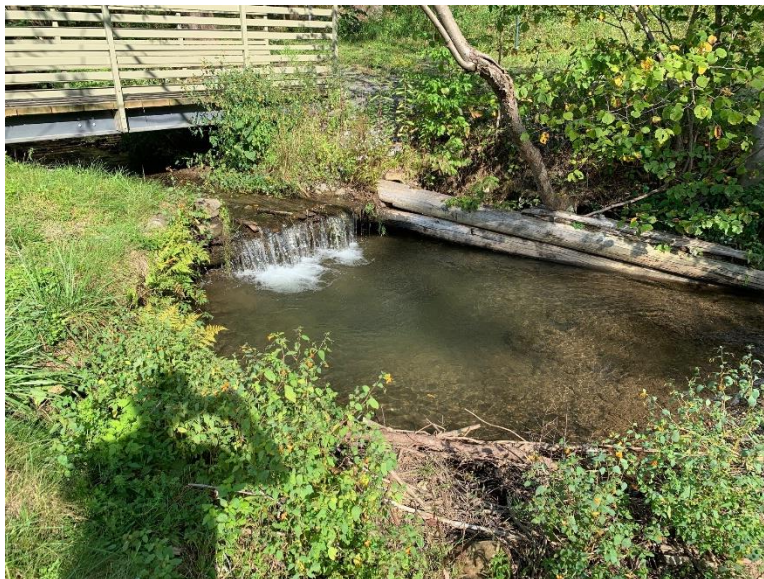
Most downstream structure in need of repair 4/20/2022

The Clearfield County Conservation District, Boggs Township Supervisors, and PA Fish and Boat Commission utilized Coldwater Heritage Partnership funding to repair 3 failing brookie jacks in 150 linear feet of Simeling Run. The brookie jacks were replaced with 3 log framed cross vanes the week of May 31- June 3, 2022. The project is situated in the Boggs Township Park at the intersection of Old Erie Pike and Church Hill Road. The structures that were replaced were installed at an unknown time decades prior, it's believed they were intended to create pool habitat for fishing. Though constructed out of thick timbers, lots of nails, and rebar, the structures began to cause erosion and became aquatic organism barriers. The repaired structures now stabilize the bank and have created pool habitat without being barriers to fish passage.

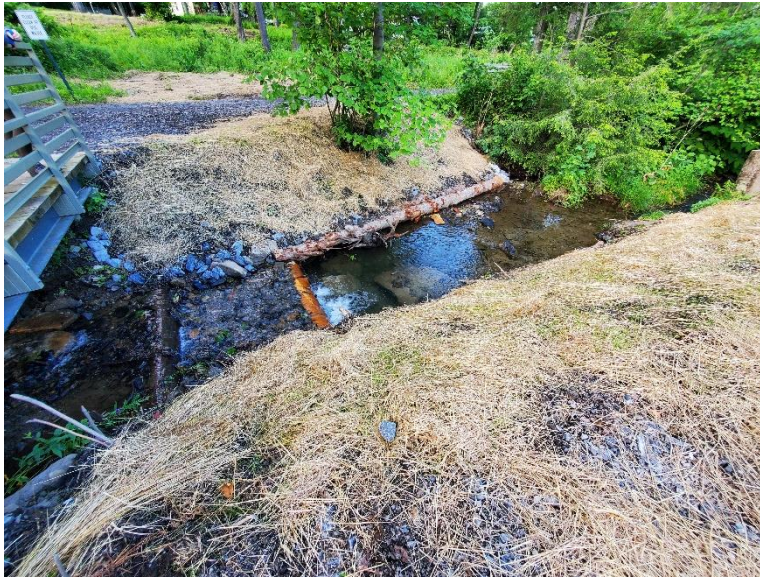
Most downstream structure post repair 6/9/2022

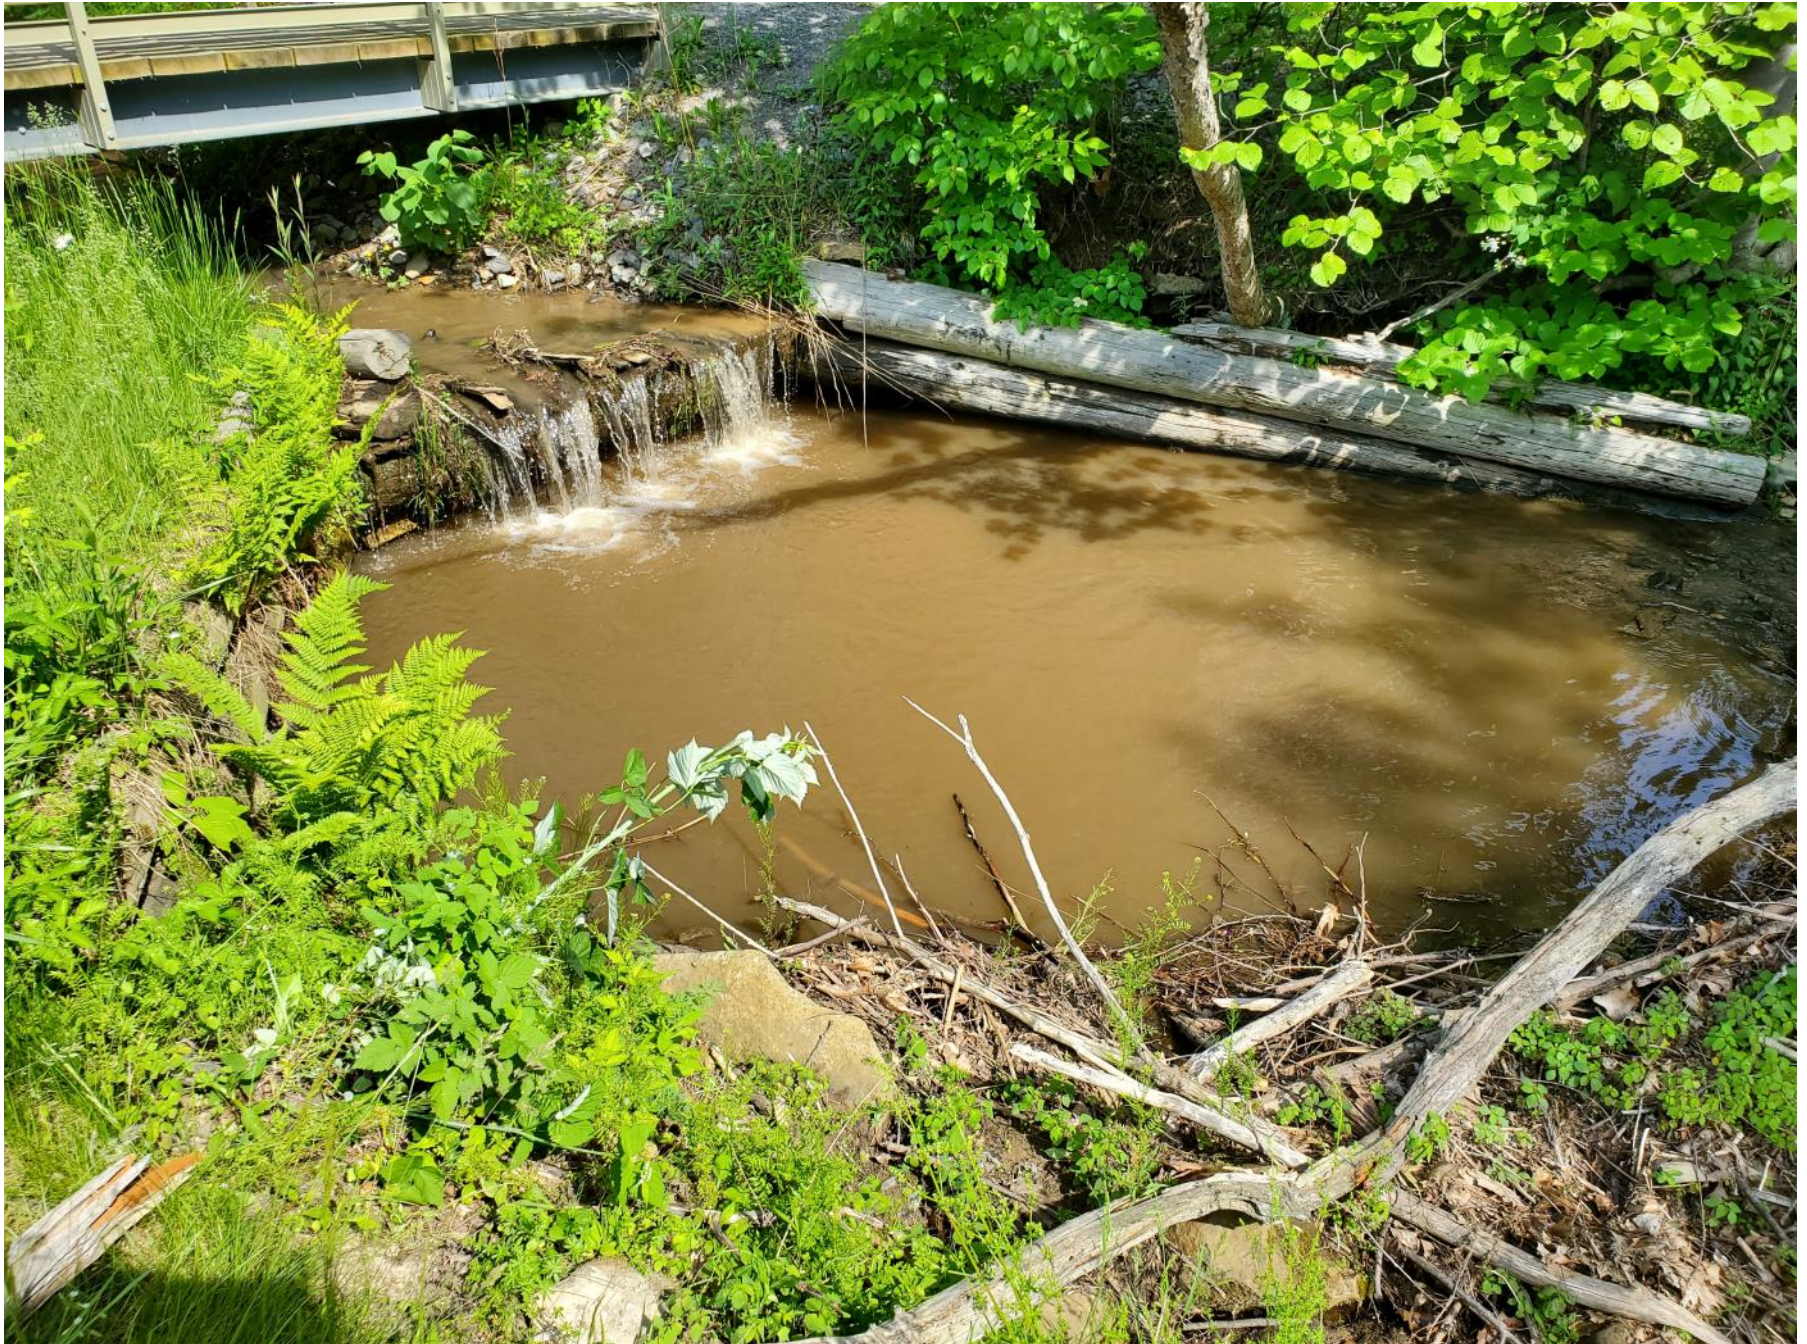
Original structure #3 before repair—6/1/22

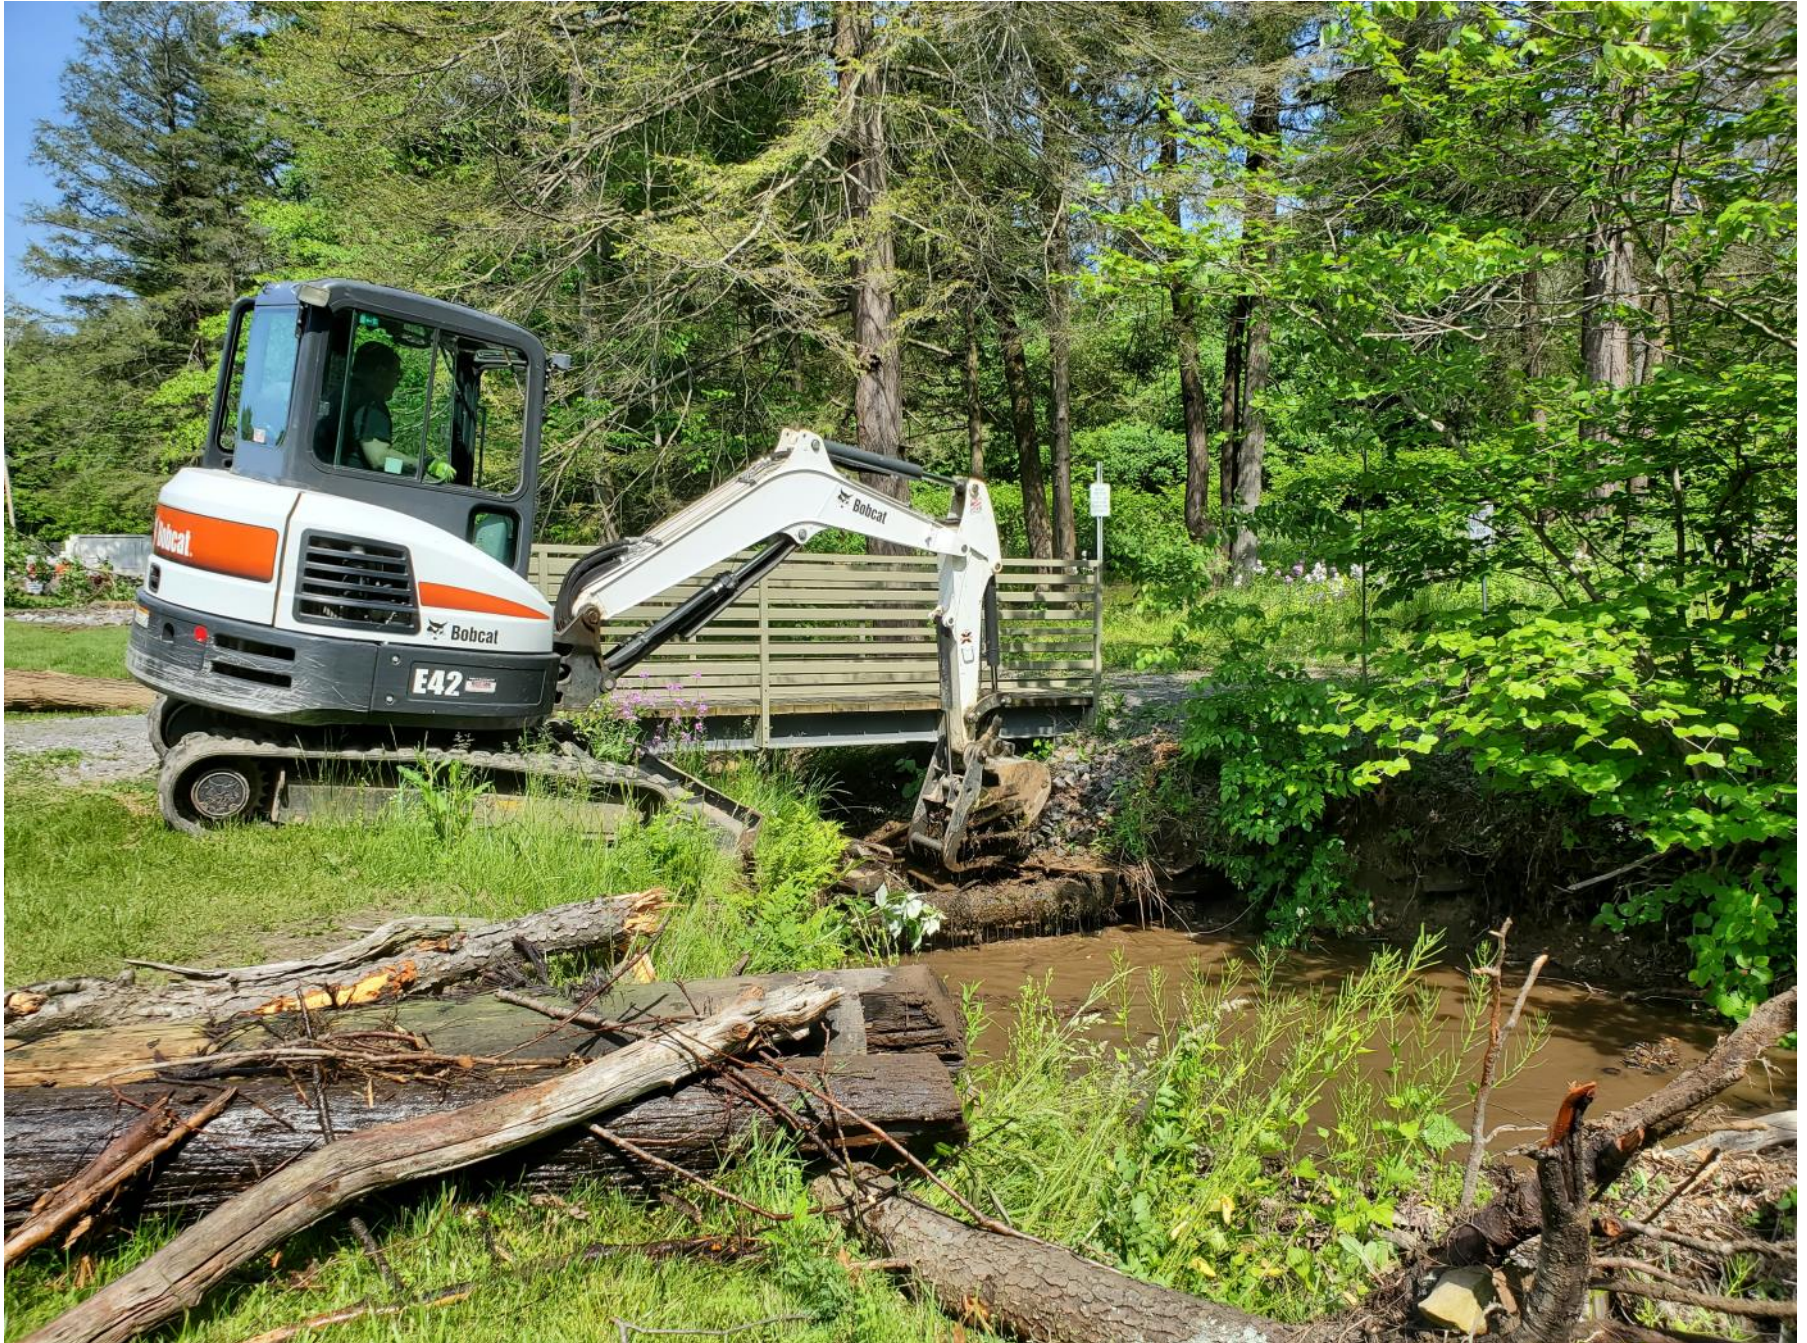
Removing structure 3—6/1/22

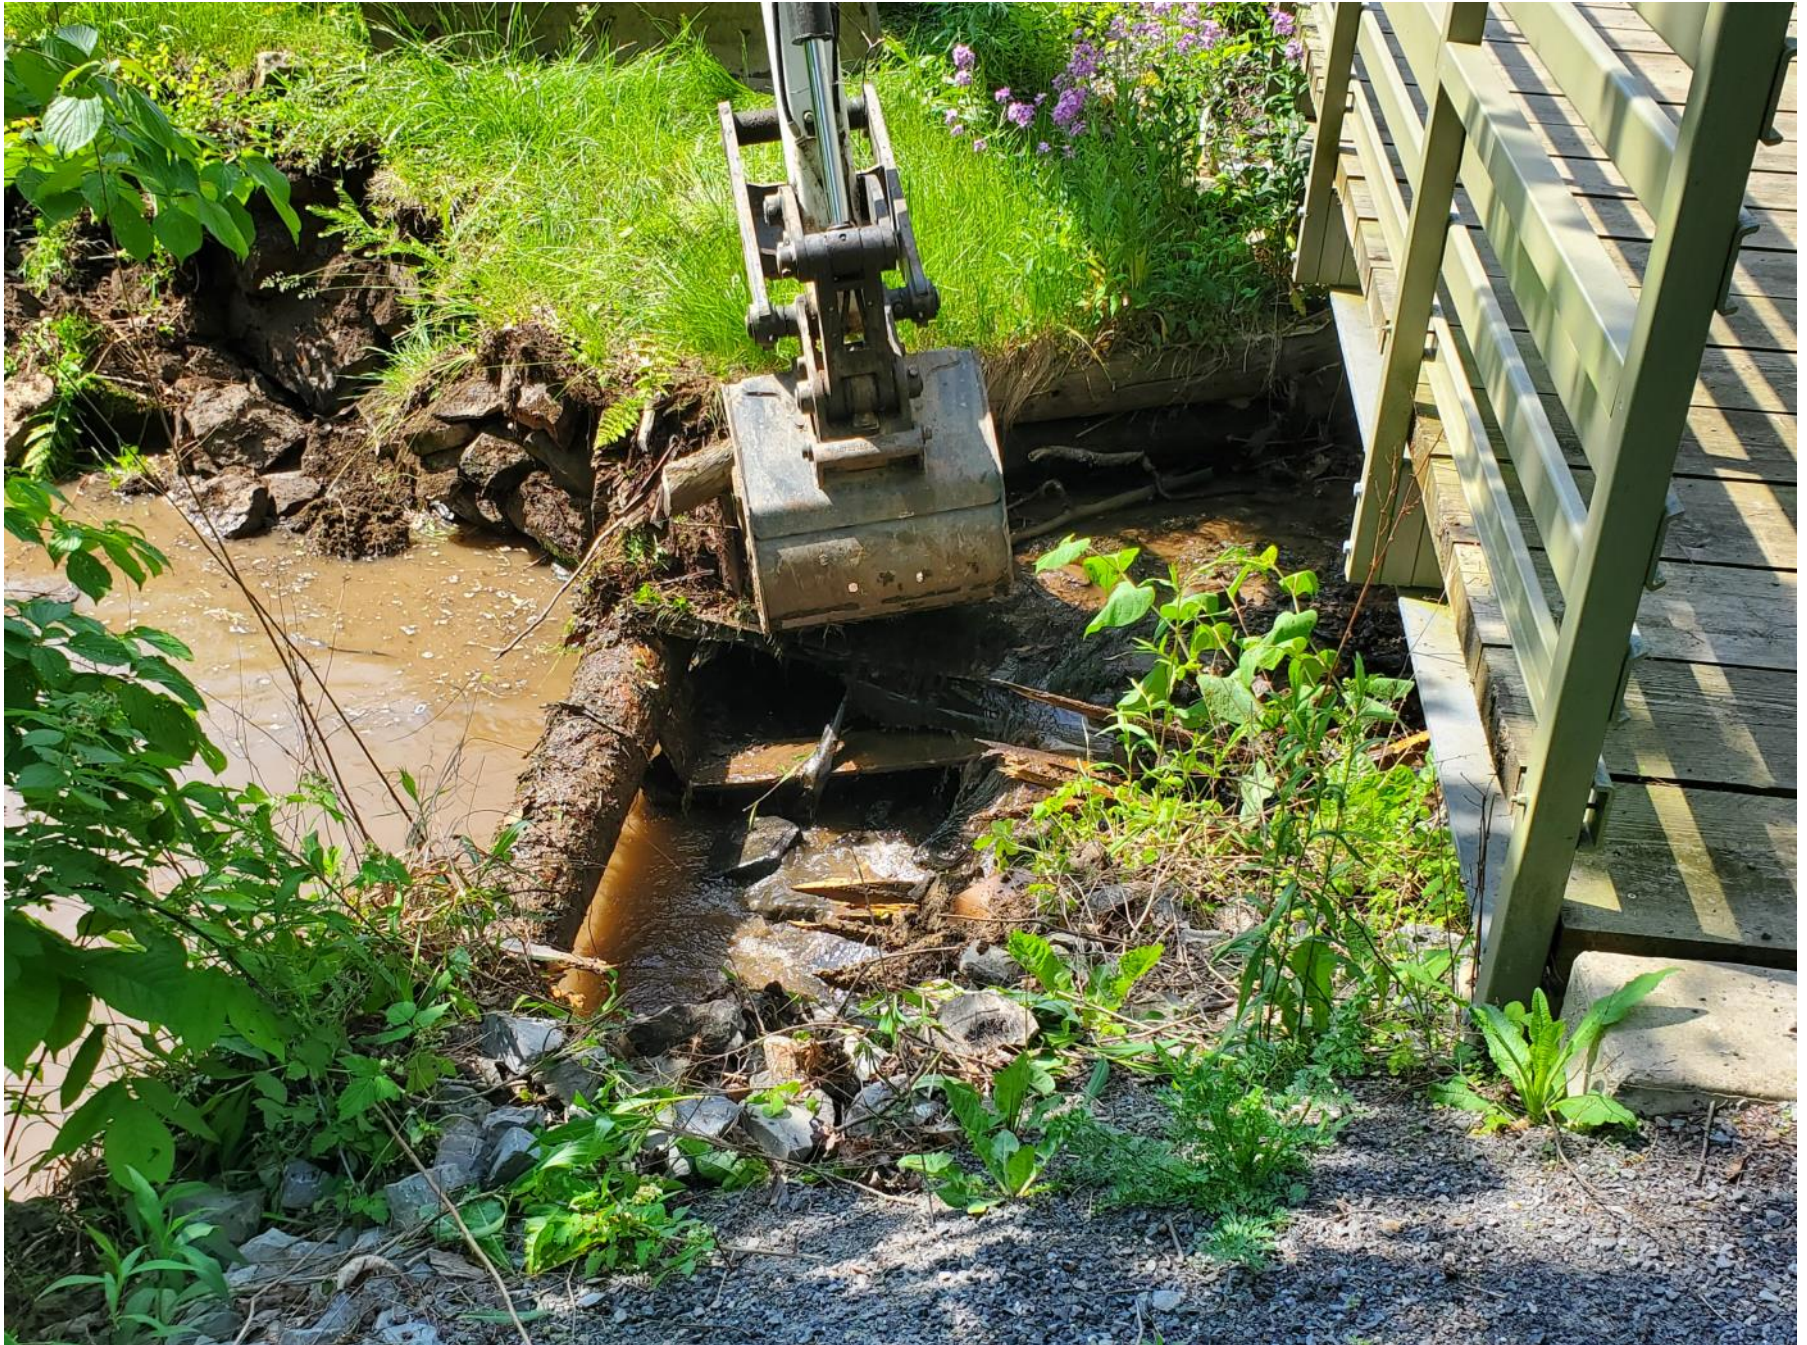
Removing structure 3—6/1/22

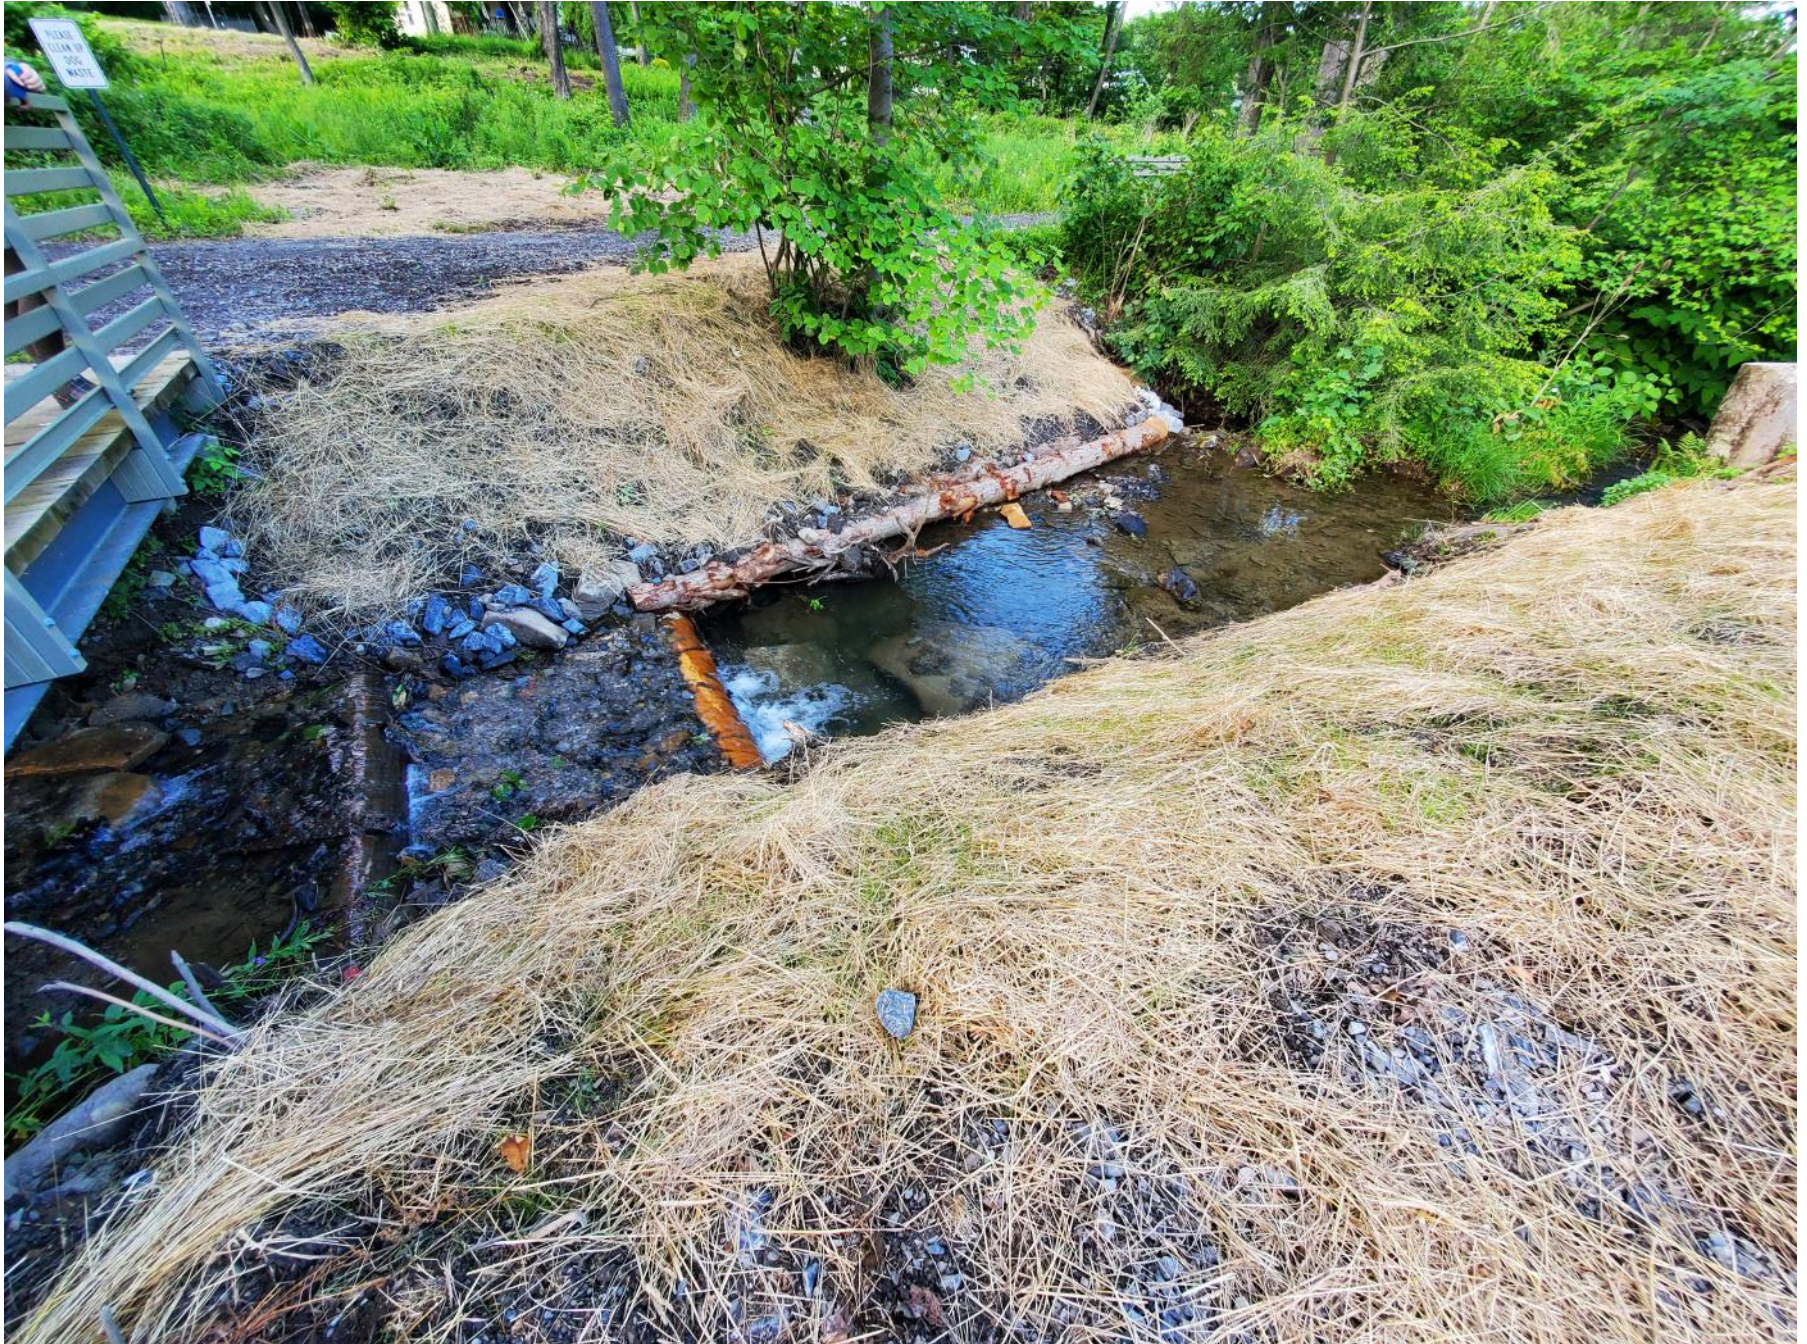
Structure 3 one week after construction and final stabilization—6/9/22

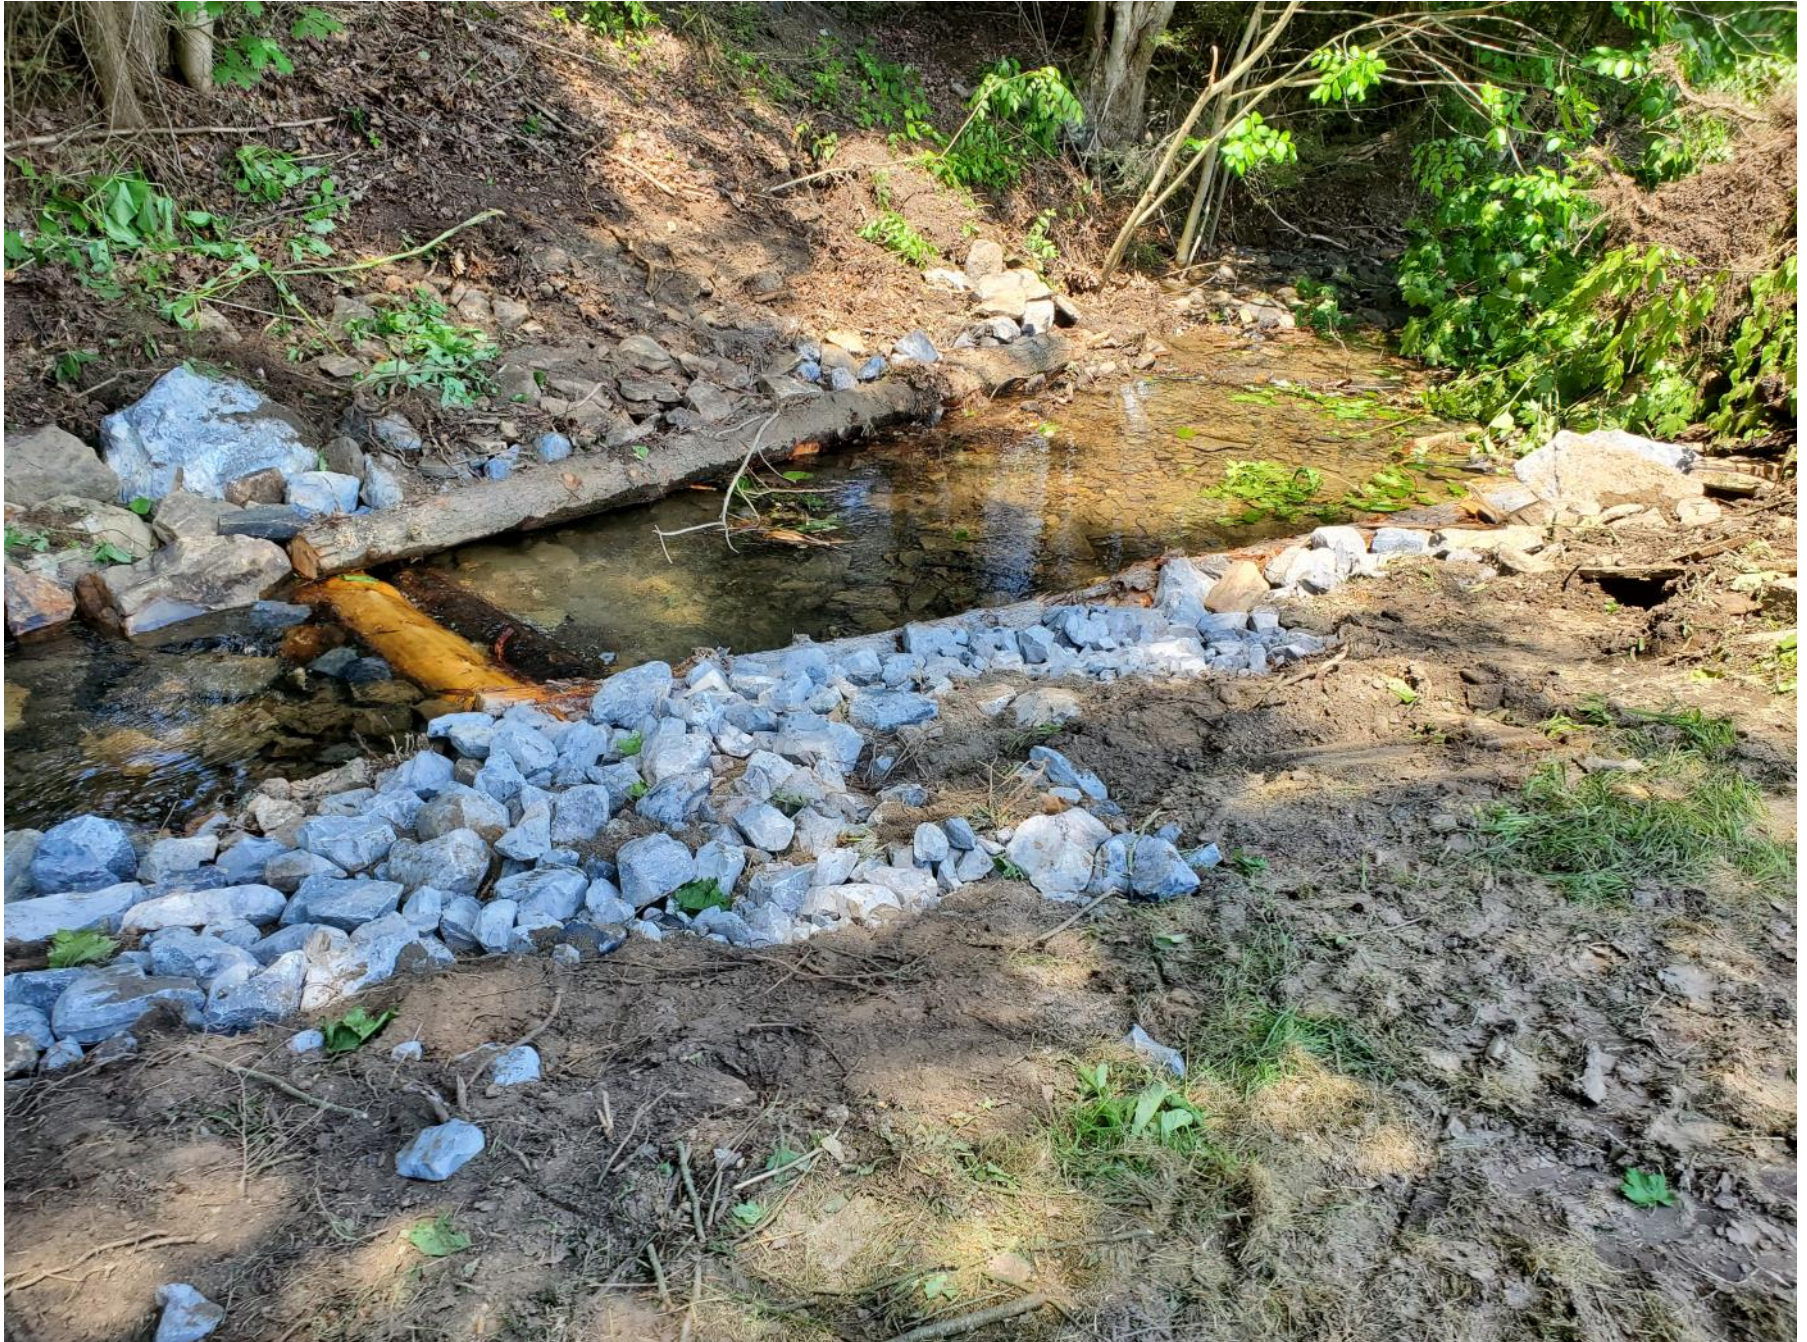
Structure 1 just after construction and right before final stabilization—6/1/22

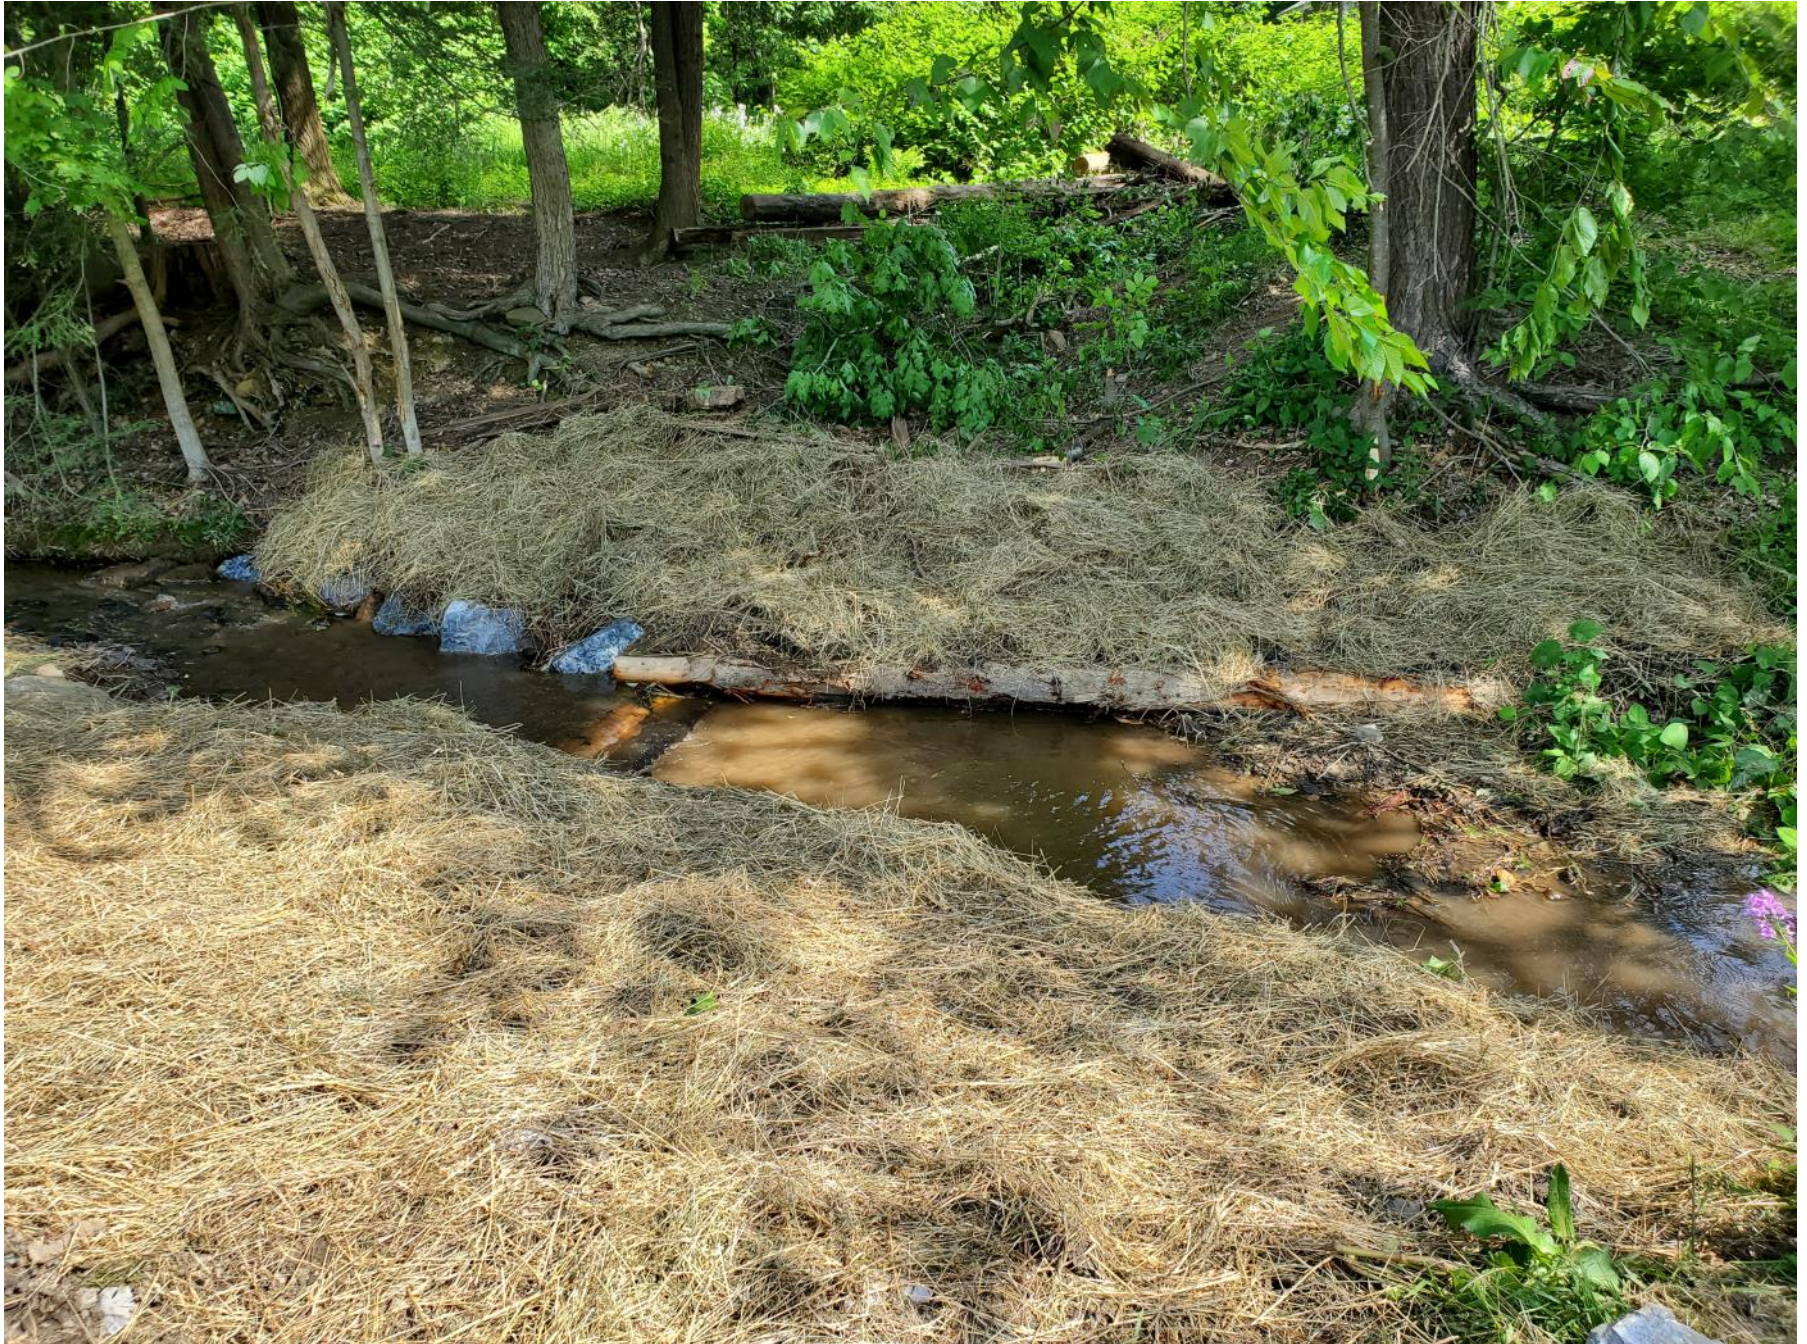
Structure 2 just after construction and final stabilization—6/1/22
