Coldwater Heritage Partnership Final Report

Stream Name: Little Pine Creek

Project Title: Little Pine Creek State Park Streambank Stabilization

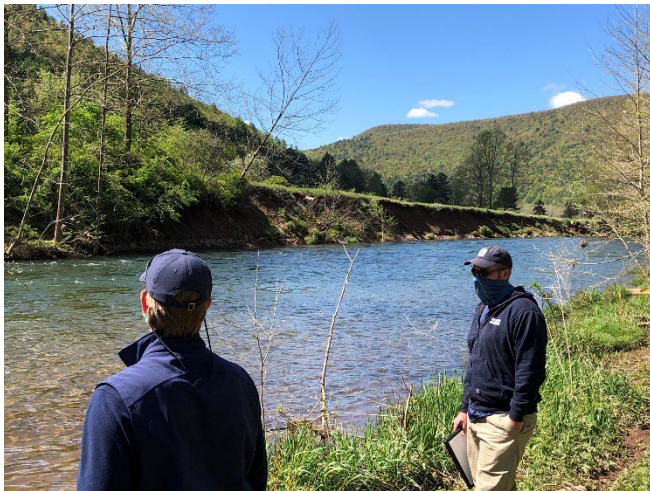
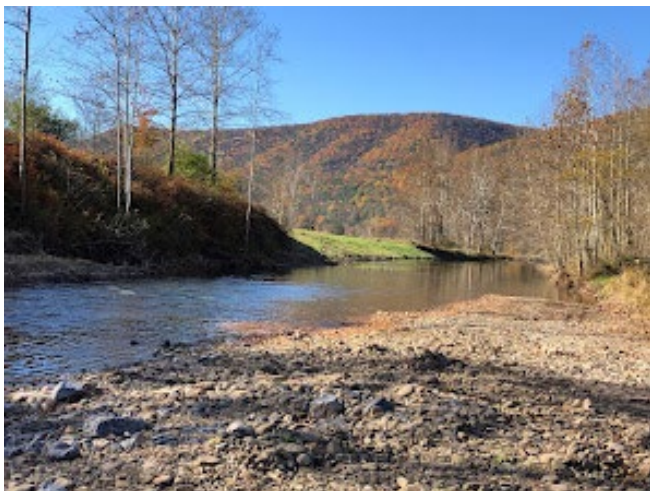
Before and after photos of the project site(s) taken from the same vantage point.

The before and after photos above show part of the improved condition. The streambank has been sloped back to slow high water, the toe of the slope is stabilized (hard to see actual structures), and the slope is vegetated.

During the first 2 weeks of September a crew of Pennsylvania Fish and Boat Commission's stream habitat staff worked with a private contractor at Little Pine State Park to install structures and slope the stream banks back. The project is intended to stop further erosion along the streambank and to provide better opportunities for high water to flow up and out of the banks.

- 2 modified mud sills
- 10 rootwads
- 1 sawtooth modified mud sill
- 15 random boulders
- 24 live stakes (Willow)
