# CUSH CREEK COLDWATER CONSERVATION PLAN

Western Pennsylvania Conservancy

This Coldwater Conservation Plan (CCP) for the Cush Creek Watershed reports on watershed assessment activities completed by WPC in 2021 & 2022. The objective of this plan is to summarize the methods and results of the assessment as well as identify and prioritize potential actions which may be taken to further conservation of the native & wild trout resources within the drainage.

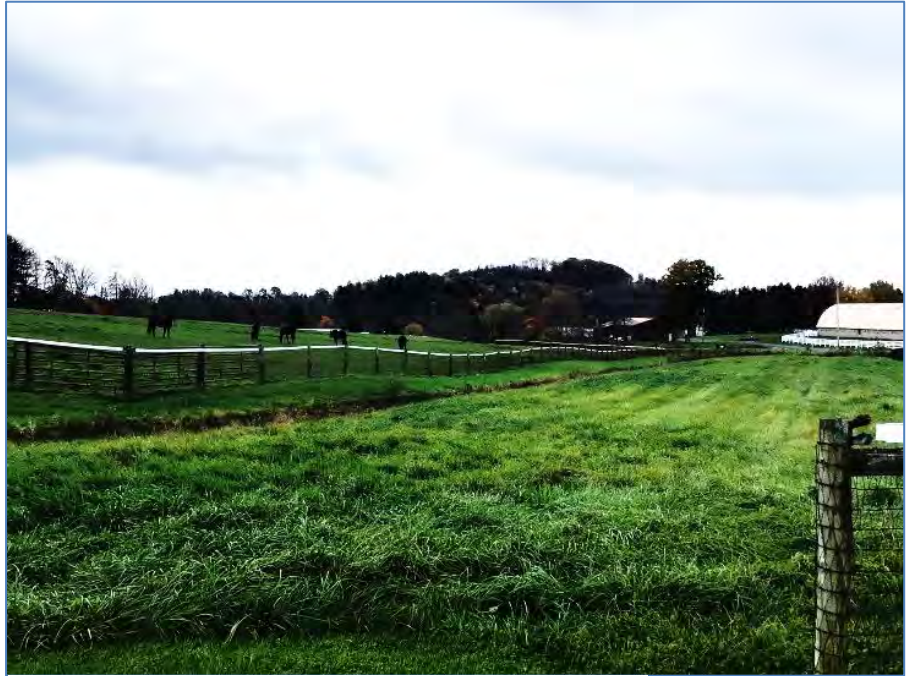
The mainstem of Cush Creek has been encroached upon throughout its reach. The headwaters of the stream fall within one of the most developed areas in the watershed, the village of Hillsdale. The source of Cush Creek flows out of a manmade pond. Residential development and its associated impacts encroach upon Cush Creek for more than a mile. Here Cush Creek has been channelized, deforested, and “cleaned out.” The stream channel is significantly narrower than forested sections upstream and downstream of this reach. Bank erosion is prevalent and there is minimal, oftentimes no, riparian vegetation. Instream habitat is expected to be significantly degraded. Tributaries that enter Cush Creek here are subject to the same challenges, including one stream which has been confined to a long culvert pipe for several hundred feet. This area is also a concentration of agriculture, with row crops, hayland, horse pasture and dairy cattle all in close proximity to the waterway.

FIGURE 4 - HORSE PASTURE IN HEADWATERS

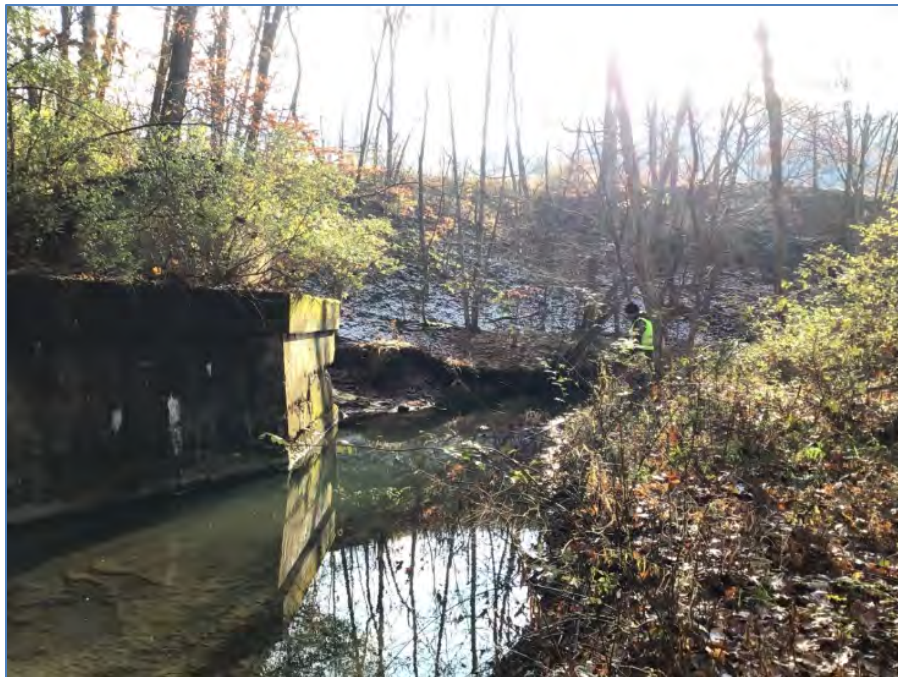
Cush Creek passes under a bridge in the village of Arcadia and signs of the watershed's coal mining legacy begin to appear. Spoil lined streambanks, the remnants of an old bridge, and a modified stream channel are evidence of the impact coal extraction has had upon these reaches. While the majority of abandoned mine lands are along the tributaries, six DEP Abandoned Mine Land Inventory (AMLI) polygons lie in close proximity to the mainstem. Cush Creek crosses back under PA 286 through this reach and will remain on the eastern side of the major route for the remainder of its course. It is here, downstream of Hooverhurst, where the larger tributaries to Cush Creek begin to enter the mainstem.

**FIGURE 6 - COAL MINE BRIDGE ON CUSH CREEK DOWNSTREAM OF ARCADIA**

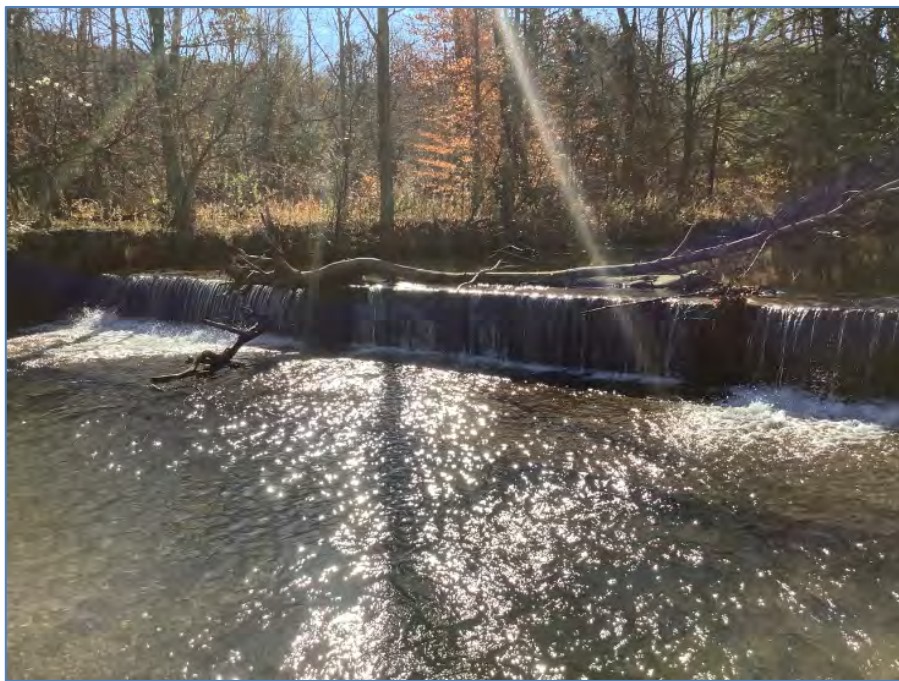
**FIGURE 7 - DAM ON MAINSTEM CUSH CREEK NEAR GLEN CAMPBELL**

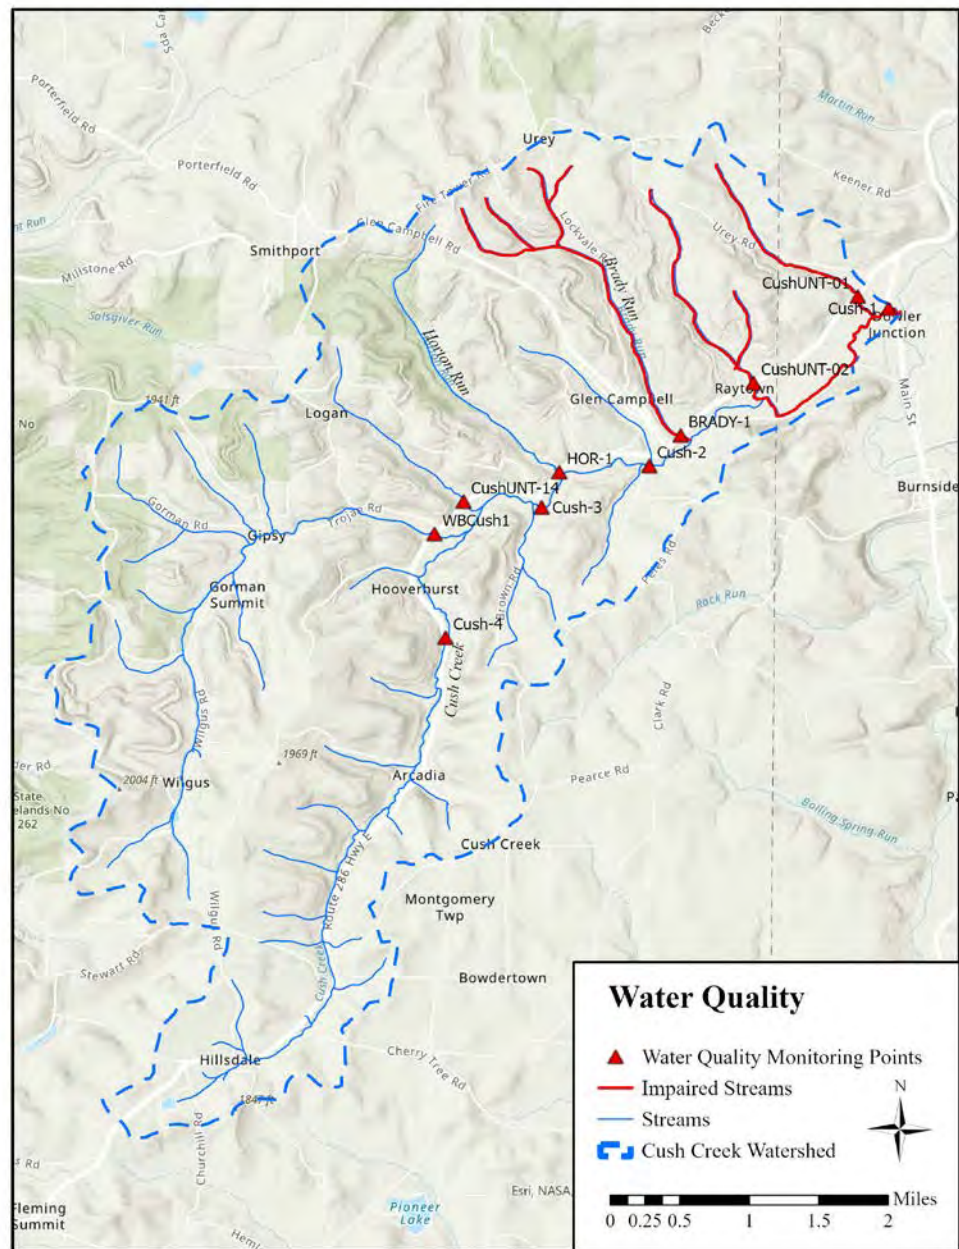
FIGURE 10 – WATER QUALITY SITES

Ten sampling sites were selected: four on Cush Creek mainstem and six on major tributaries (Figure 10). Tributary sites were sampled on UNT 27101, UNT 27102, Brady Run, Horton Run, UNT 27114 and UNT 27115 (West Branch Cush Creek), listed in order from closest to the mouth of Cush Creek to the headwaters. Sites were sampled in October and November 2021.

The data for all the monitoring sites was reviewed and summarized. Table 4 lists the data information that was collected on water quality. Much of the information showed expected trends and water quality fluctuations, but there were some areas where results varied. Some of these variations can be explained through weather events and other knowns about the surrounding area; however, there are some areas where without further monitoring, an explanation about the results cannot be done with any amount of certainty. Future efforts should include continued analysis of the current data while expanding the dataset through more monitoring.

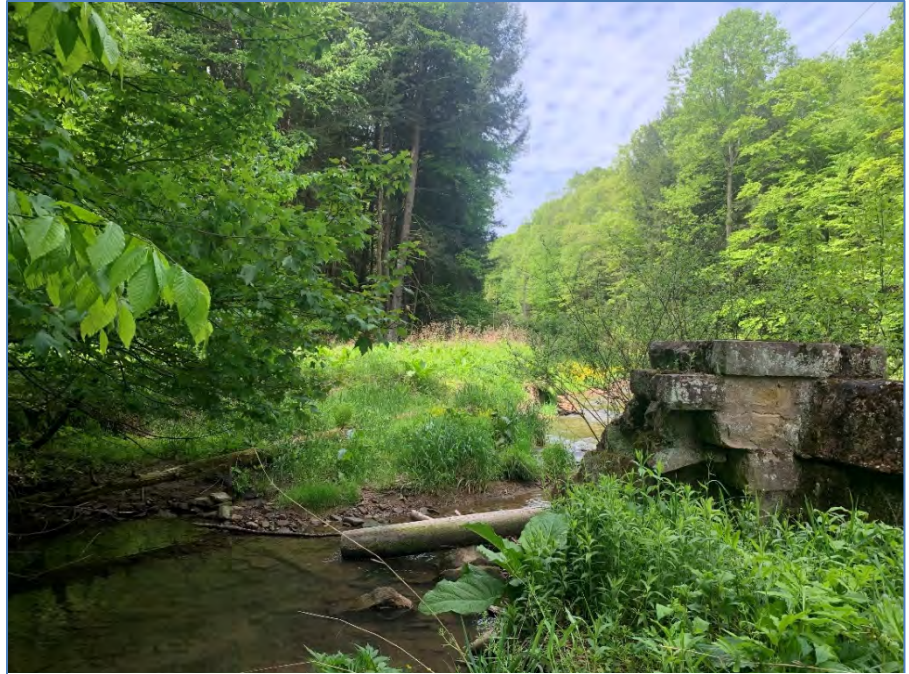
Additional concerns with aquatic organism passage lie in the dams that bisect the mainstem of Cush Creek, greatly reducing and possibly eliminating movement for all but the most robust species. Another dam, while no longer standing constricts Cush Creek through some of its best habitat (Figure 15).

FIGURE 15 - OLD DAM ON CUSH CREEK WHICH CONSTRICTS THE STREAM

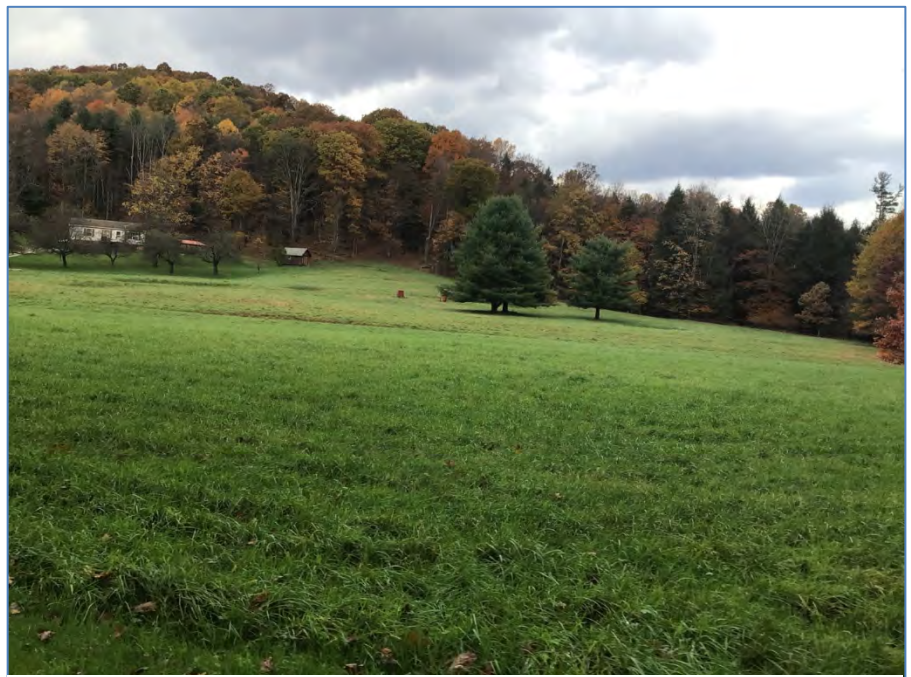
The establishment of forested riparian buffers is an essential component of water quality protection and the planting of trees in un-forested streamside areas is a recommended BMP for the Cush creek watershed. The establishment of native trees and shrubs along waterways is critical for the control of sedimentation and erosion, as well as being important habitat for both aquatic and terrestrial wildlife. WPC utilized several methods to determine opportunities for riparian buffer outreach. That data on buffer gaps can, such as the open area shown in Figure 16 can be referenced for riparian restoration.

FIGURE 16 – MINIMAL RIPARIAN VEGETATION IN CUSH CREEK HEADWATERS
