COLDWATER CONSERVATION PLAN

Clear Creek; Callen, Pine, and Leeper Runs

Jefferson County, Pennsylvania

Final September 2018

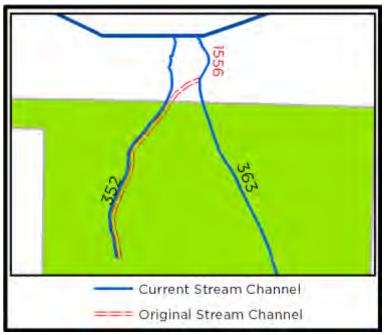
In the instance of Segment 1556, it no longer exists as a unique segment between two confluences. Pine Run flows directly into the Clarion River, without making a confluence with the unnamed tributary to the west. See the inset to the left for the originally mapped stream channels as well as on the ground observations.

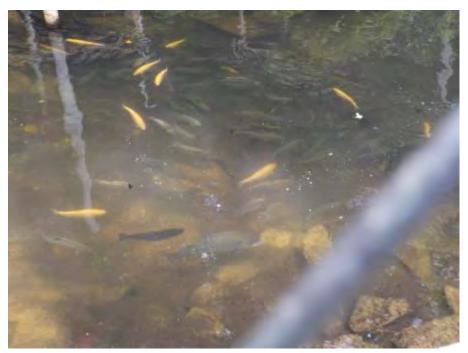
1561: Native brook trout were observed in many stream segments, and are considered to inhabit the entire watershed. The trout above are not wild, but a mix of brook, brown, rainbow, and golden rainbow trout raised by the Heath Township Sportsmen's Club. They are stocked in Clear Creek and Callen Run in April and May during the height of Pennsylvania's Trout Season.

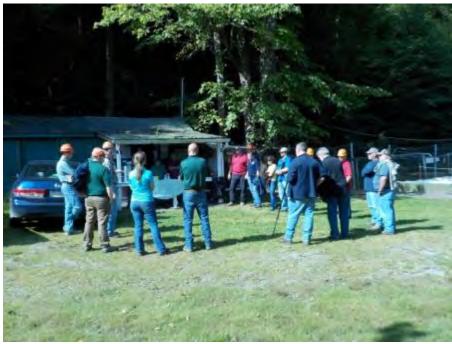
1561: Meeting on 08/30/2017 with stakeholders interested in the dam on Callen Run at Heath Pump Station.

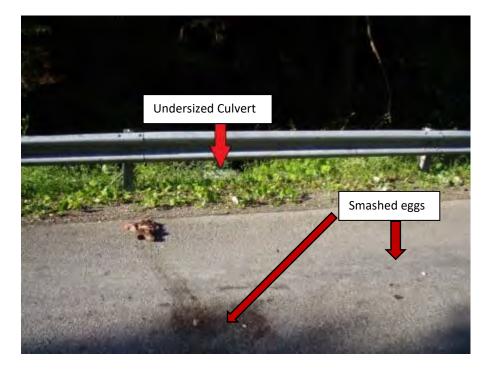
As in the case of segment 570, the culvert crossing under Shaffer Road is undersized, putting the stream and roadway at risk. This structure should be replaced with a larger one, be it a squashed pipe, bottomless arch, or bridge. Structure type and installation will vary by site based on the stream, landowner, and roadway needs, as well as available funding. The structure should be sized to one hundred and twenty percent (120%) of the stream's current bankfull width that is out of the "zone of influence" of the existing crossing structure. A substrate/bedload mix comparable to that present naturally in the stream channel should be used to simulate it through the crossing. Floodplains should be built inside the crossing structure to facilitate higher flows expected to be associated with climate change trends (thus reducing future maintenance), as well as assist non-fish species in utilizing the waterway for travel. The photo below, taken in the East Branch Tionesta Creek drainage in McKean County, poignantly illustrates the importance of a properly sized crossing structure. Had she been able to traverse the stream and floodplain through the culvert, the smashed, gravid female snapping turtle would not have been hit by a vehicle. She, as well as the eggs she was carrying, represent a rare source of energy traveling upstream. Not only has the culvert impacted the turtle population, but the energy cycle of the entire ecosystem.

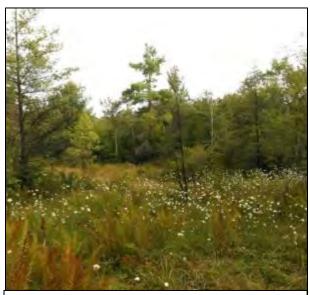
490: Wetlands like this one at the top of Callen Run will become increasingly important as hydrologic cycles change in the coming century.
