Letort Spring Run Coldwater Conservation Plan Route 34 to Interstate-81

Plan Prepared by: Cumberland Valley Trout Unlimited

Cumberland County Conservation District

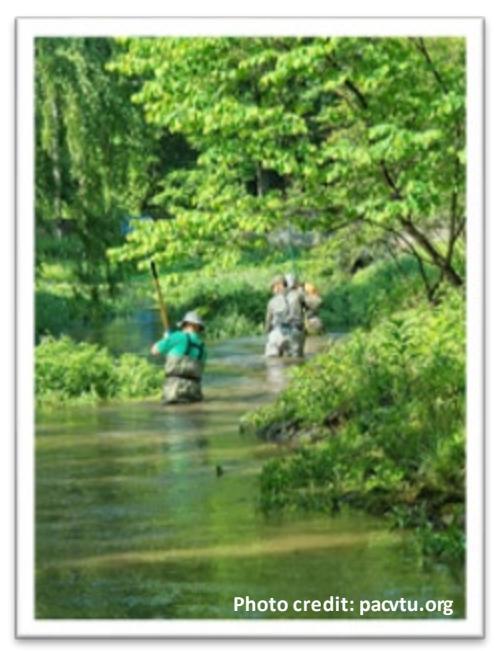
**Figure 1:** CVTU's Feet In The Stream (FITS) crew working to expose gravel substrate and remove reed canary grass.

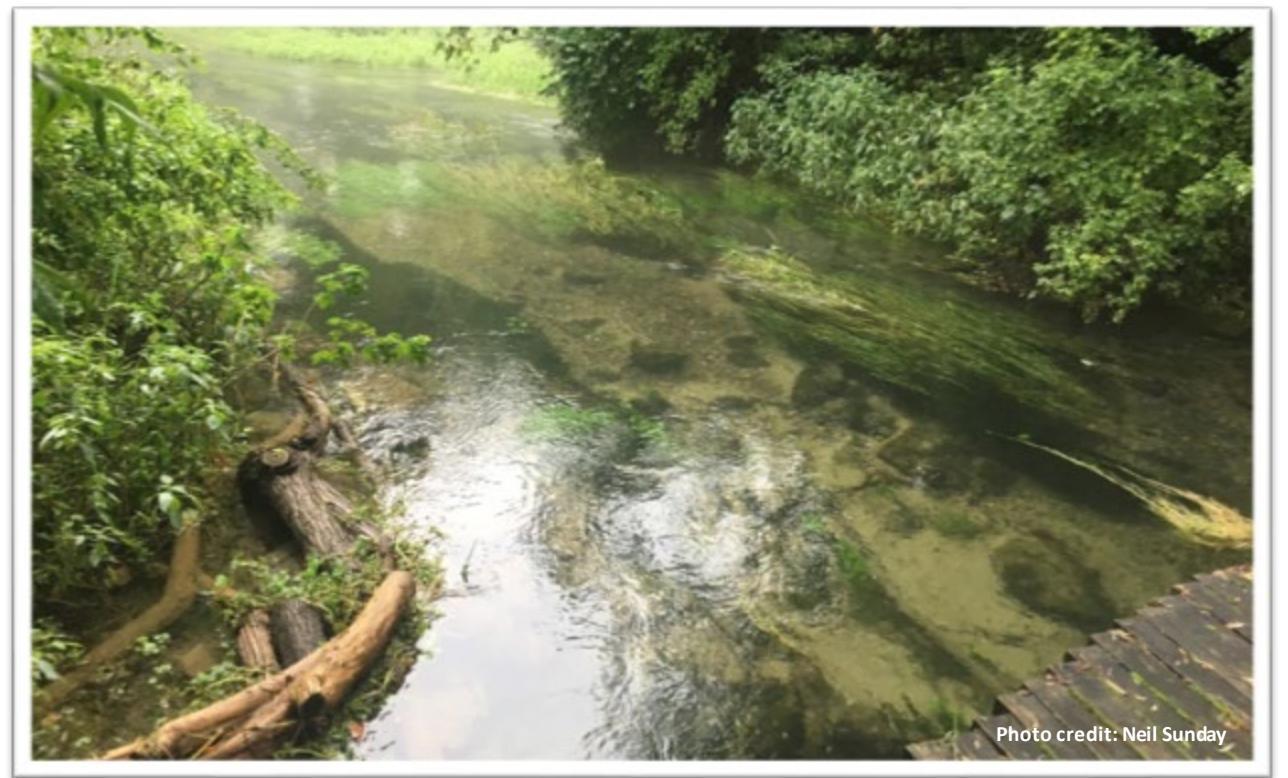
**Figure 2:** View looking downstream from Bonny Brook parking a rea footbridge showing exposed gravel in the thalweg of the stream with watercress and elode a providing cover for fish.

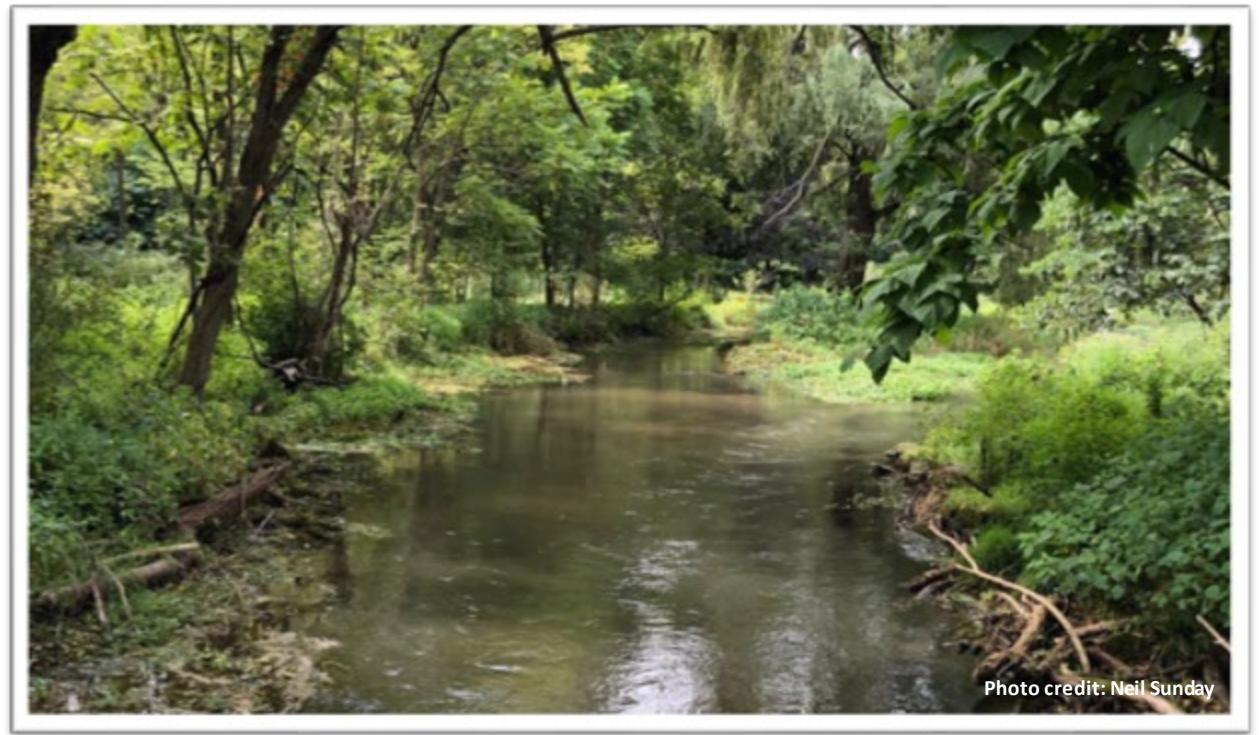
Figure 5: View of the Letort from the footbridge near parking area looking upstream at Bonny Brook Road.

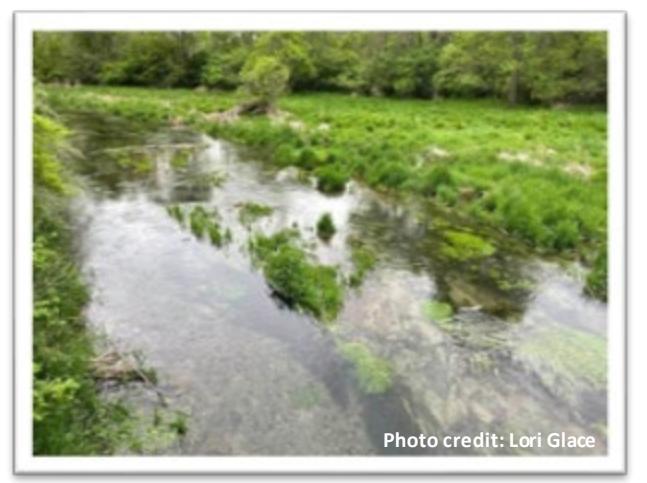
The East Branch was formerly a watercress farm and most of this stream channel has been manipulated through the years through channelization and diversion into cress beds. This section has excessive sedimentation, overall

Figure 15: Upstream of Railroad Bridge on Letort Nature Trail.

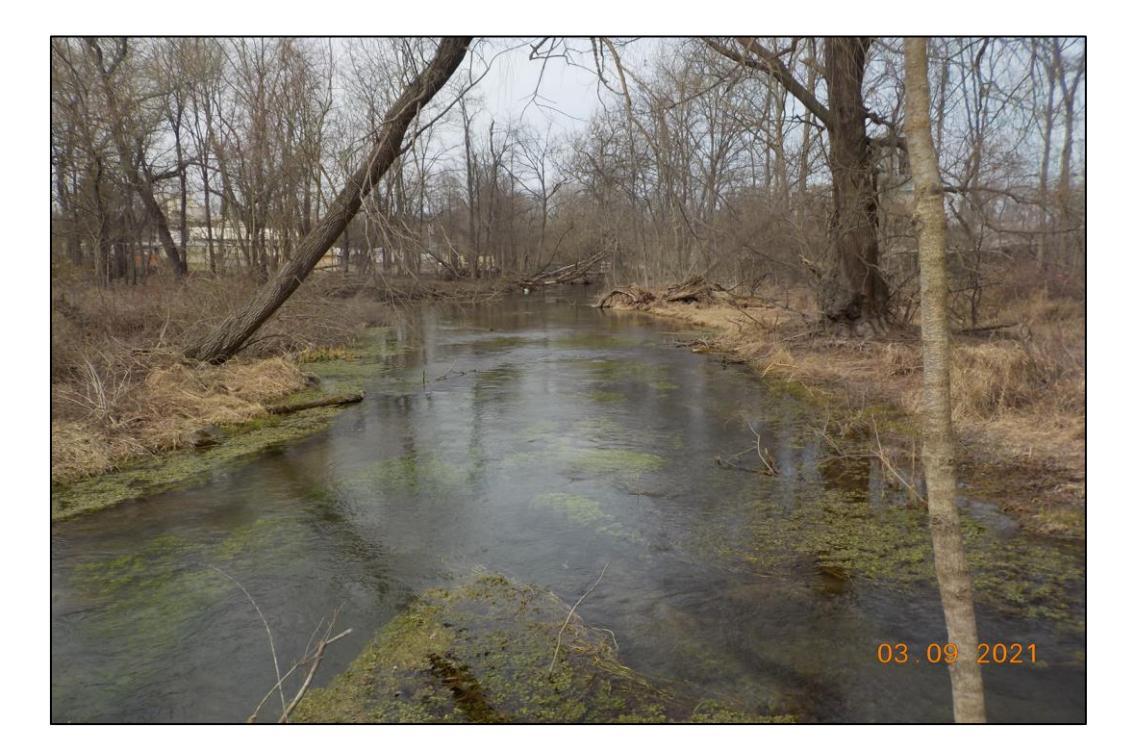
This reach starts at the confluence of both branches and continues to the Letort Rail Trail bridge downstream from the Union Quarry property (Figure 1). In spite of the quarry activity and narrowed riparian corridor through the quarry property the upper and lower sections of this reach contain numerous deep channels through the vegetated beds. Bank stability is good even through the quarry stretch where vegetation and tree roots prevent erosion and keep the stream banks in place. Evidence of erosion is minimal and limited to small areas at bridge crossings.

Figure 1. Main Letort Spring Run, Reach 1, looking downstream from the confluence of the East Branch on the right and the Bonny Brook Branch on the left.

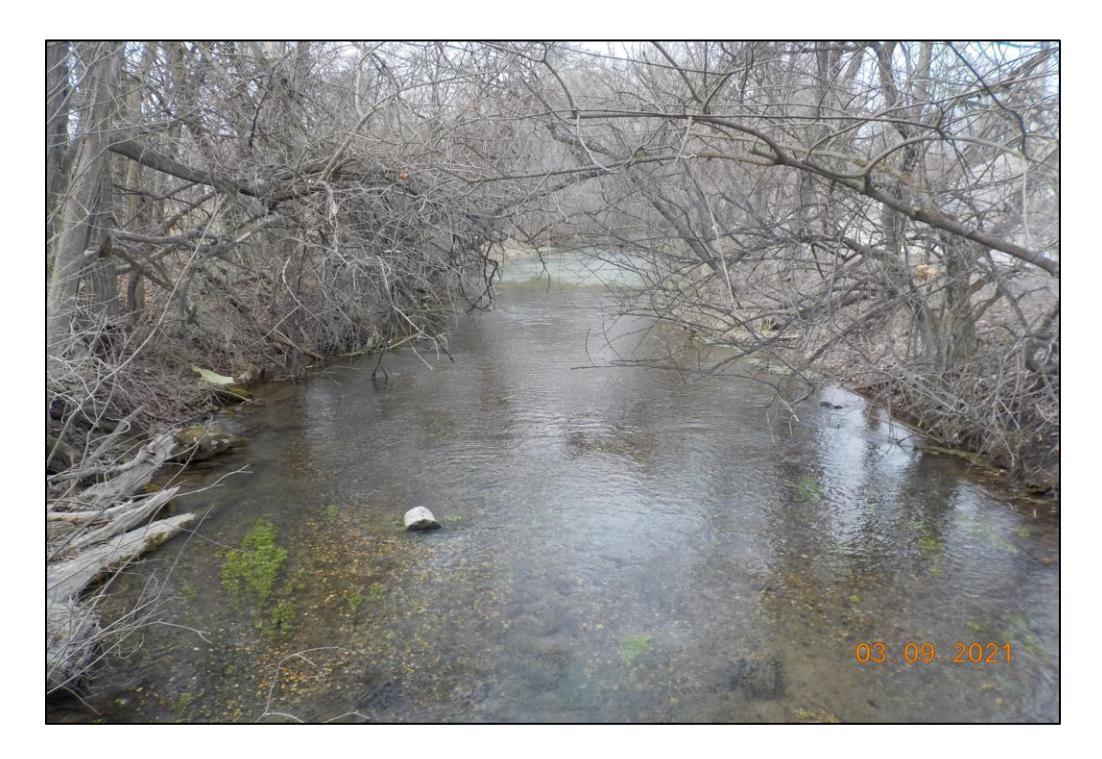
The substrate is a good mix of sediment, vegetated beds, and an extensive stretch of gravel which provides good spawning habitat (Figure 2). Apparently the gravel was dumped in the stream years ago to provide spawning habitat for trout.

Figure 2. Main Letort Spring Run, Reach 1, looking downstream from the most upstream Union Quarries bridge.

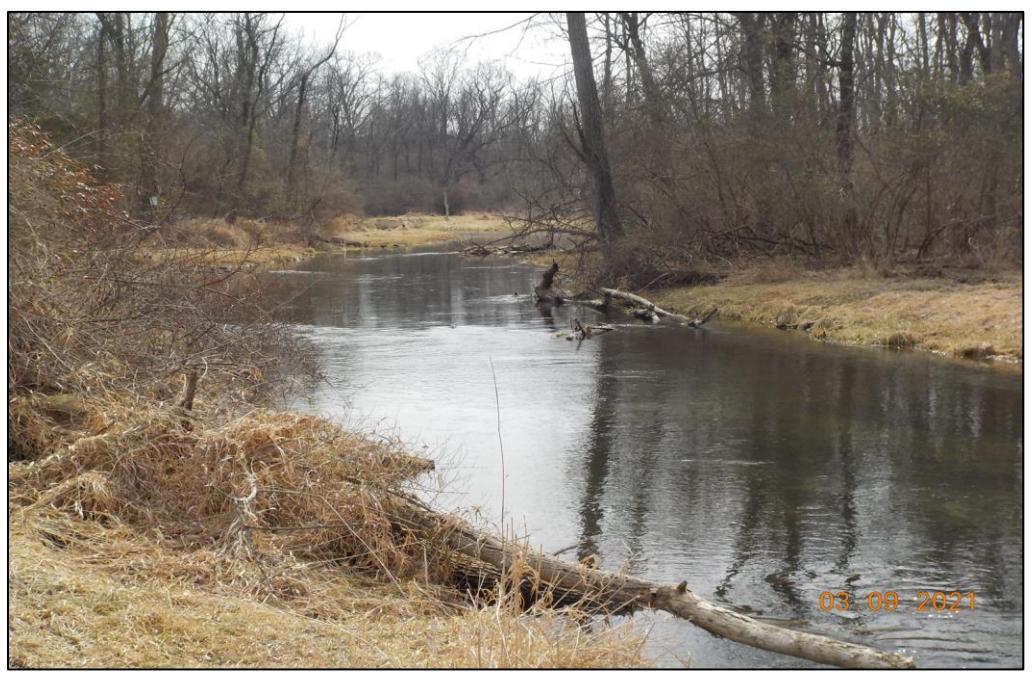
Further downstream (Figure 5) where the Letort flows past the Cumberland Valley Chapter of Trout Unlimited's property (Vince's Meadow) pockets of vegetation are present allowing for the formation of deeper, scoured channels between the vegetated areas. The vegetation provides cover for fish and substrate for macroinvertebrate colonization.

Figure 5. Main Letort Spring Run, Reach 2, looking upstream at the reach bordering the property owned by the Cumberland Valley Chapter of Trout Unlimited (Vince's Meadow).

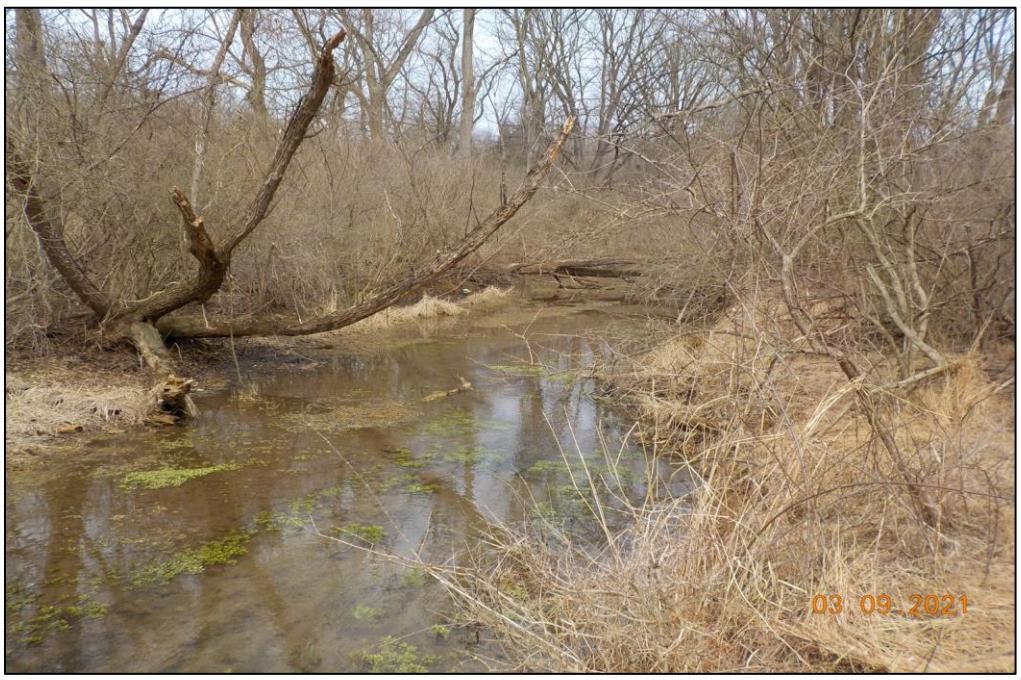
The lower portion of this reach receives some spring input from a smaller spring on the Capone property and allows for the establishment of some vegetated areas (Figure 7). Overall though, the entire reach lacks depth, clean substrate, and favorable habitat precluding the establishment of a healthy fish and macroinvertebrate community.

Figure 7. Bonny Brook Branch of Letort Spring Run, Reach 1, looking downstream.

Due to dry weather conditions prior to this survey channel flow status was low since this portion of the Letort lacks input from larger springs. The eroded stream banks indicate that the stream level through this reach is at least a foot higher during major storm events. It appears that the high sediment load is due to erosion from agricultural areas upstream from Rt. 34 and eroding stream banks along this reach.

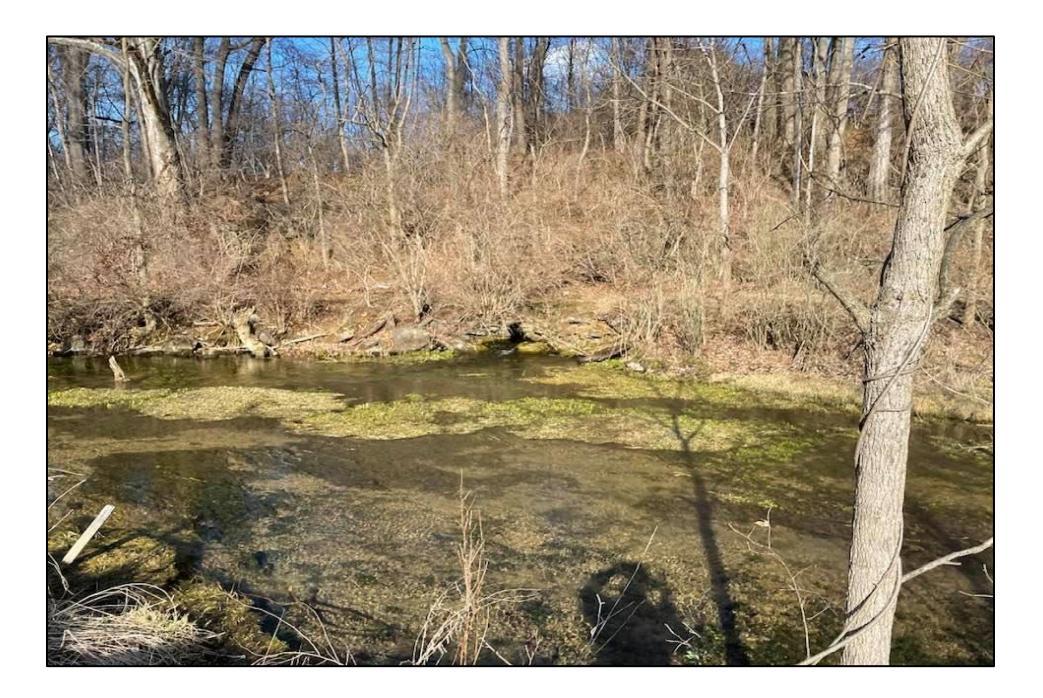
This reach begins with two large spring outflows (Figure 8) along the east border of the Capone property (former B&W Quality Growers watercress farm) and ends downstream from Bonnybrook Road at the confluence with the unnamed tributary (East Branch). Most notable about the stretch of stream immediately below the springs is the clean gravel substrate. This is most likely what most of the Letort looked like prior to development and farming in the watershed.

Figure 8. Bonny Brook Branch, Letort Spring Run, Reach 2, showing one of the two major spring outflows located on the eastern border of the Capone property. Note the clean gravel substrate.

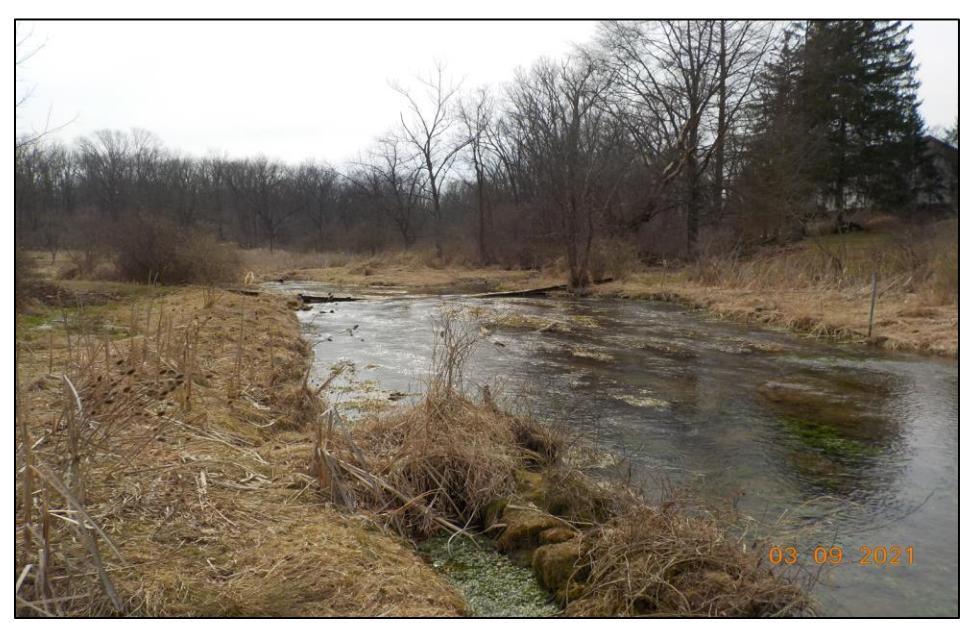
The large volume of flow from those springs provides this section of the Letort with optimal channel flow although at least half of the reach is shallow due to the width of the stream (Figure 9).

Figure 9. Bonny Brook Branch, Letort Spring Run, Reach 2, looking upstream. Location is immediately below the confluence of Reach 1 and major spring outflows located on the Capone property.

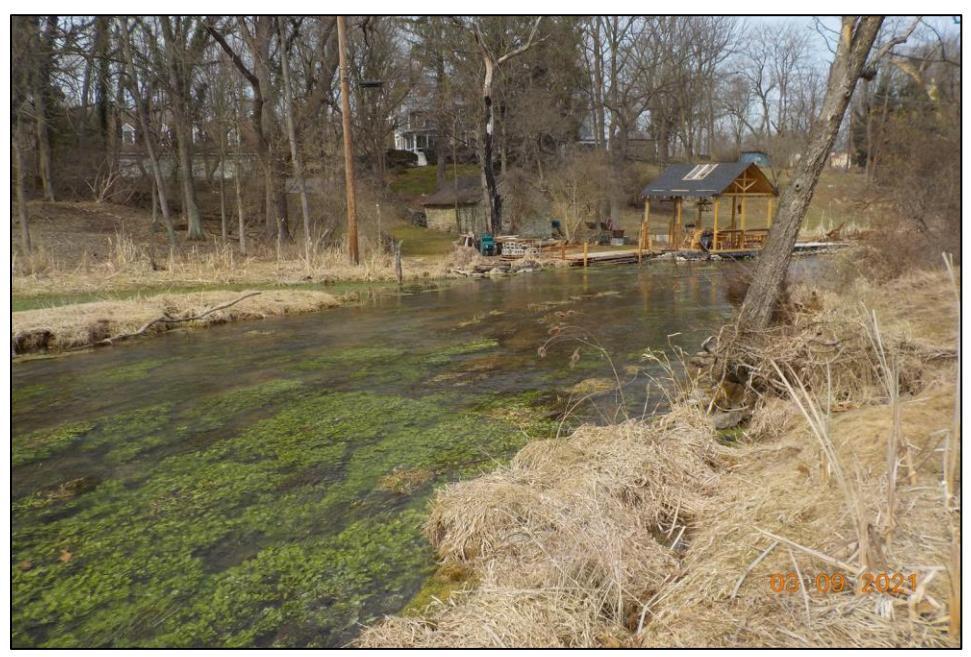
Habitat and depth improve in those areas where the stream is narrower. Such is the case along the Luciano property (Figure 10) where the narrowing of the channel has led to increased water velocity which in turn allows for the flushing of sediment and reduced plant growth. Clean gravel areas are also prevalent which provides excellent habitat for fish spawning and macroinvertebrate colonization.

Figure 10. Bonny Brook Branch, Letort Spring Run, Reach 2, looking downstream towards Luciano property.

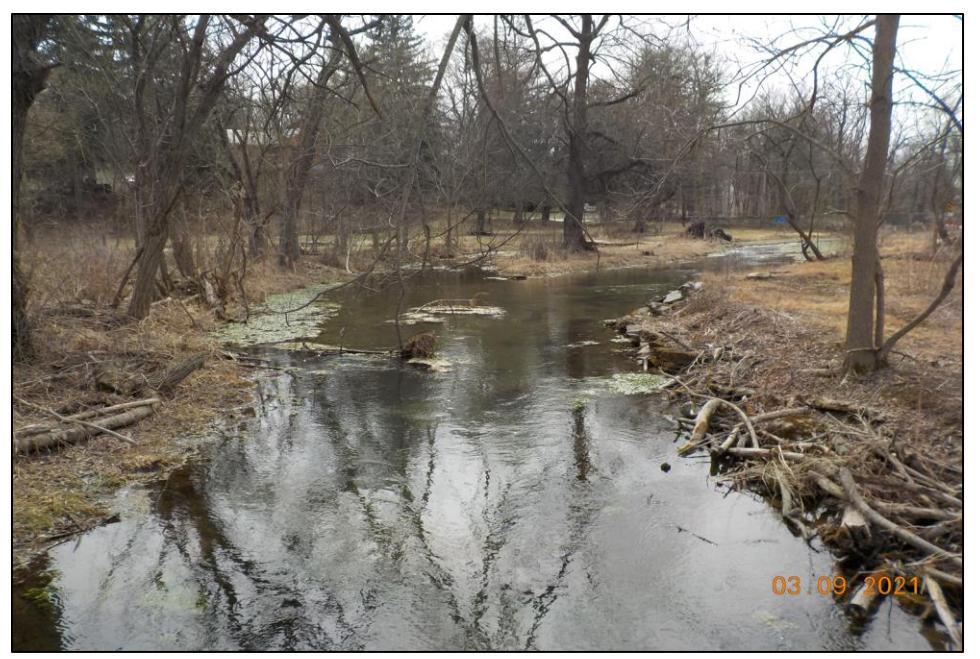
The lower end of Reach 2 between Bonnybrook Road and the confluence with the East Branch is narrower (Figure 12). Deeper channels are prevalent between the vegetated beds providing excellent fish habitat.

Figure 12. Bonny Brook Branch, Letort Spring Run, Reach 2, looking upstream towards Bonnybrook Road.

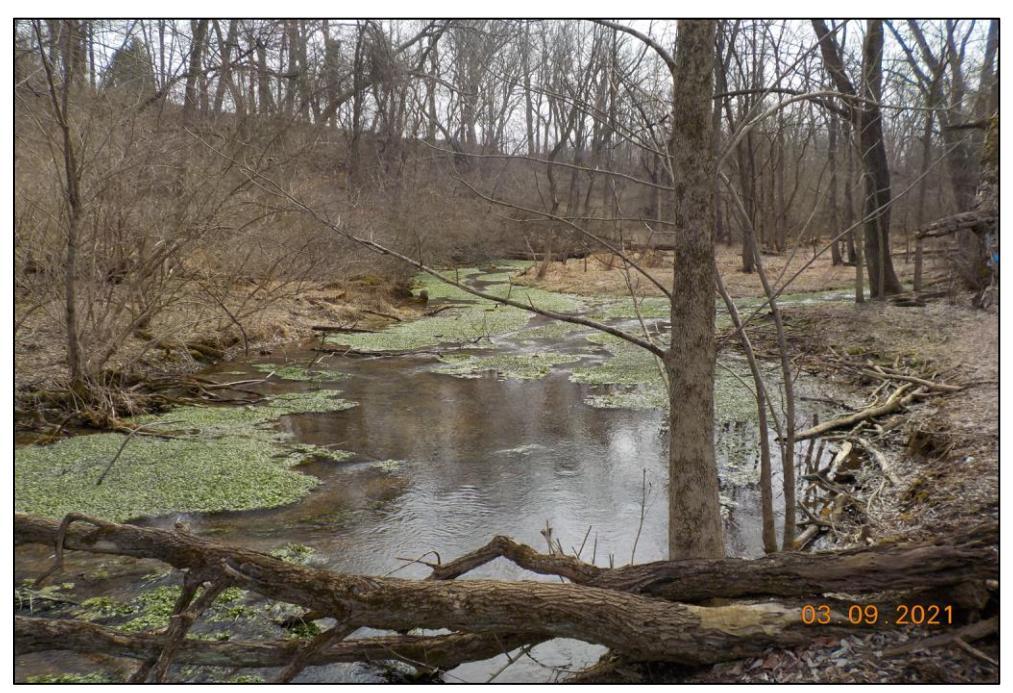
This reach starts on the southeast side of Spring Garden Street where the stream emerges from two large spring areas (Figure 13). From there it flows under Spring Garden Street and on to the property

Figure 13. East Branch, Letort Spring Run, Reach, looking upstream from Spring Garden Street.

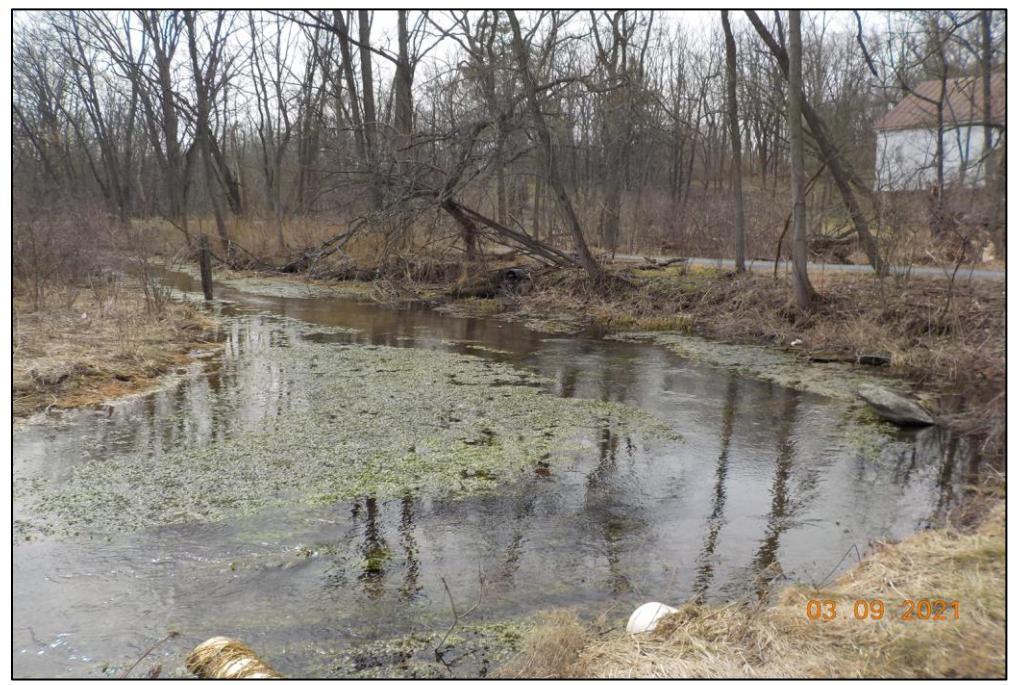
owned by the Central Pennsylvania Conservancy (CPC) which was the former B&W Quality Growers watercress farm. This reach ends at the road culvert at the upstream border of the former watercress farm (Figure 14). Major stream channel modifications and land use changes have occurred below that location due to activities at the former watercress growing facility.

Figure 14. East Branch, Letort Spring Run, Reach 1, looking upstream from the upper end of former watercress beds on property owned by Central Pennsylvania Conservancy.

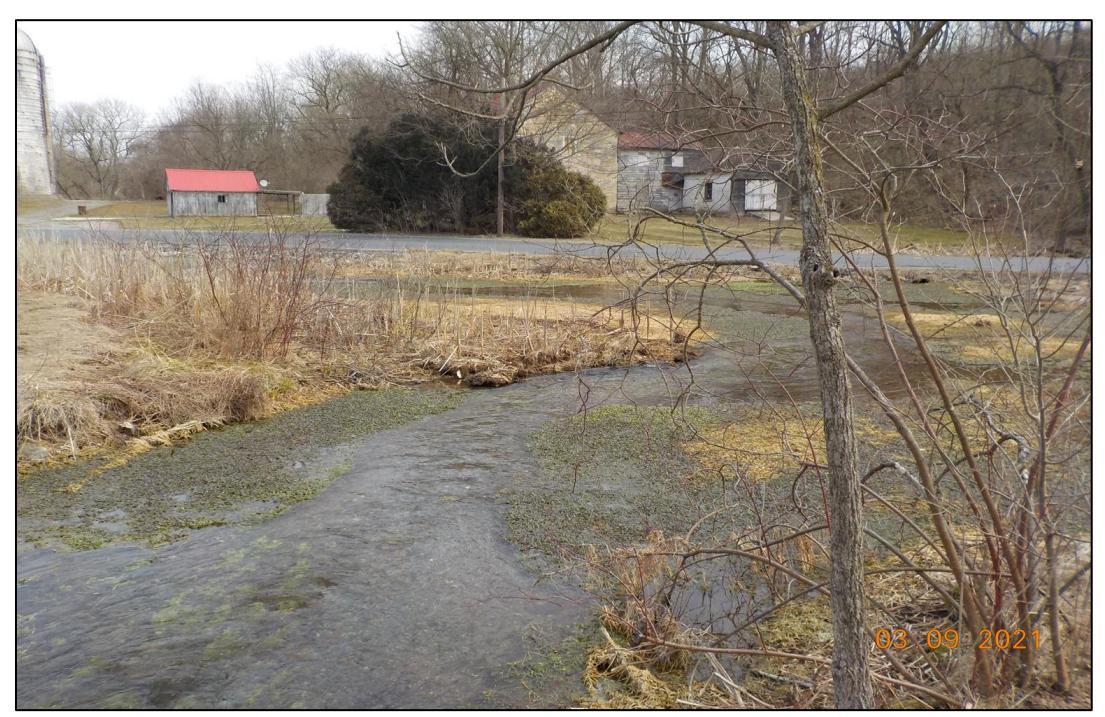
Evidently the original stream channel ran through the present location of the Meadows beds but was diverted east and then along Spring Garden Street (Figure 15) where it flows north-northwest as a channelized stretch between Spring Garden Street and a shale-filled road between the stream and the cress beds. It flows along Spring Garden Street for approximately 350 meters (1148 feet) and then makes an unnatural 90-degree turn to the southwest and flows under the next road culvert separating the upper and lower farm areas which is the lower border of Reach 2.

Figure 15. East Branch, Letort Spring Run, Reach 2, looking downstream from road culvert at upper end of former watercress beds. Spring Garden Street is in the background.

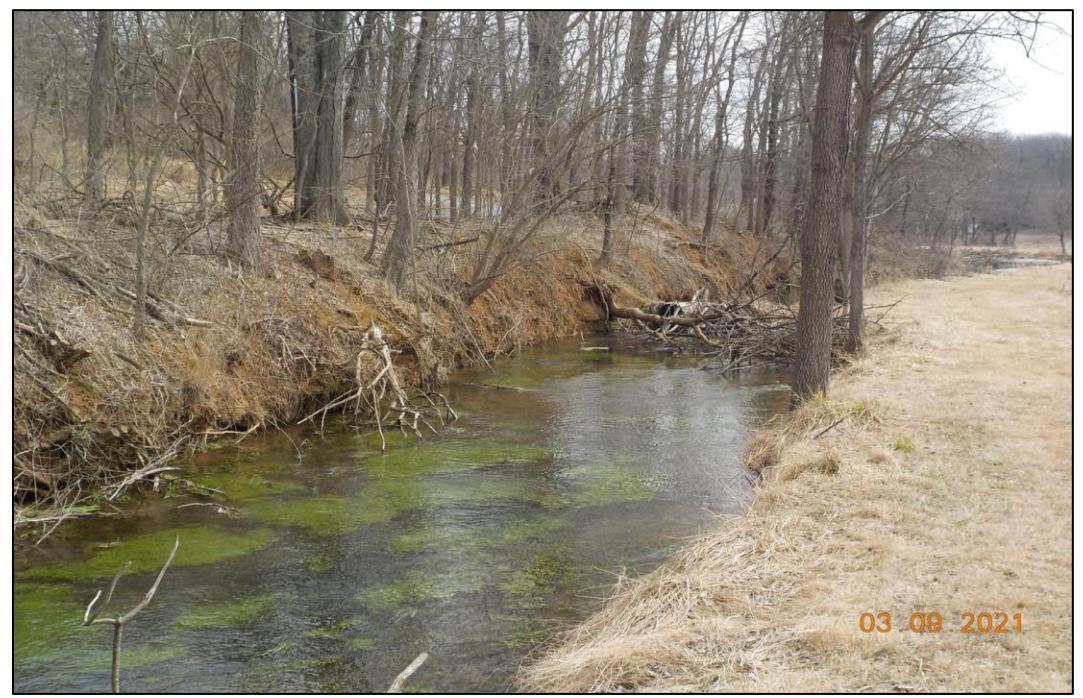
As the stream flows along Spring Garden Street (Figure 16) it picks up additional flow from two springs. Channel flow status along this reach is optimal and the majority of the reach is deep. The deeper water, vegetation, and occasional large woody debris all combine to create good fish habitat. Substrate composition is fairly good with numerous areas of clean gravel for macroinvertebrate colonization but sediment deposition is present over 50% of the reach. It appears that the major source of sediment along this reach is coming from erosion off the steep stream bank bordering Spring Garden Street. Overall, the condition of the stream banks is marginal along both sides of the stream. The riparian vegetative zone rated poorly due to the short distance between the stream and Spring Garden Street on one side and the shale-fill road and cress beds on the opposite side.

Figure 16. East Branch, Letort Spring Run, Reach 2, looking upstream from property owned by Central Pennsylvania Conservancy. Spring Garden Street is above the steep bank on the left.

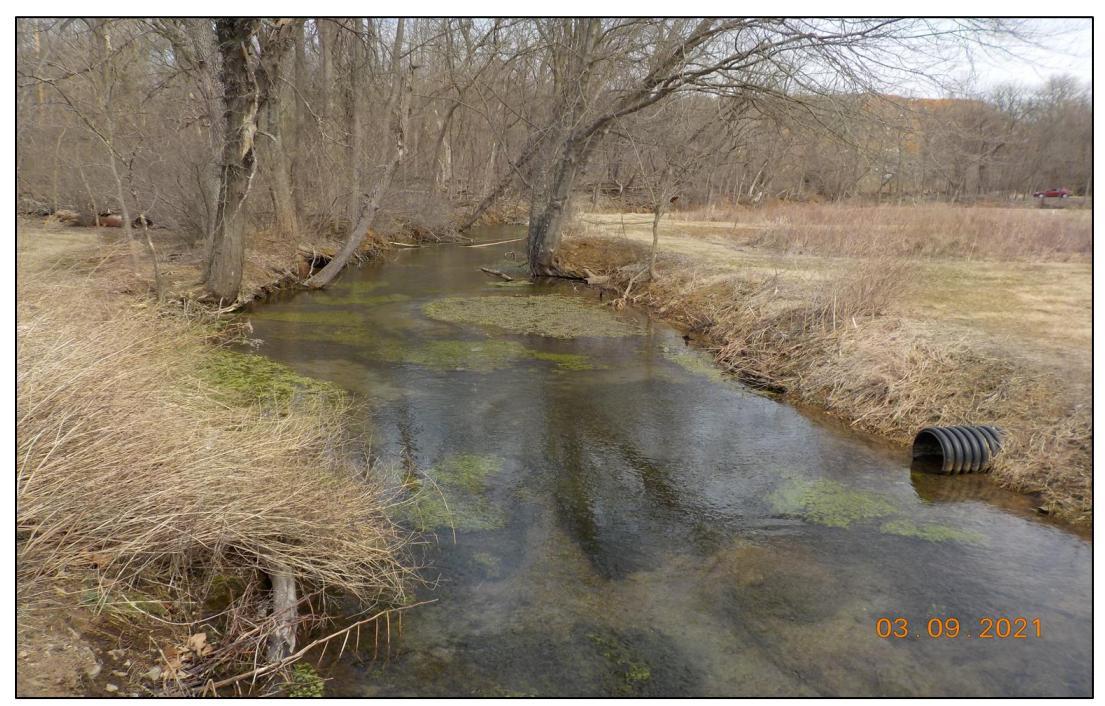
After the stream makes the 90-degree turn it flows along the lower end of the Meadows cressbeds where the former discharges from the cressbeds are located (Figure 17). These discharge pipes were a source of sediment when the cress farm was in operation. When the farm was active the workers would walk through the beds stirring up sediment while harvesting the watercress by cutting the tops off the plants. This would typically occur 4 to 5 times a growing season. The Pennsylvania Department of Environmental Resources (now DEP) began regulating the farm after the May, 1981 fish kill due to their extensive use of pesticides. B&W Quality Growers was further instructed to install filter fabric above the discharge pipes at the lower end of the beds. This resulted in a reduction in sediment leaving the beds but did not eliminate it. The water that was discharged from the beds were also a source of nutrient and pesticide contamination.

Figure 17. East Branch, Letort Spring Run, Reach 2, looking upstream from road culvert separating the former upper (Meadows) and lower (Bonny Brook) cressbeds.

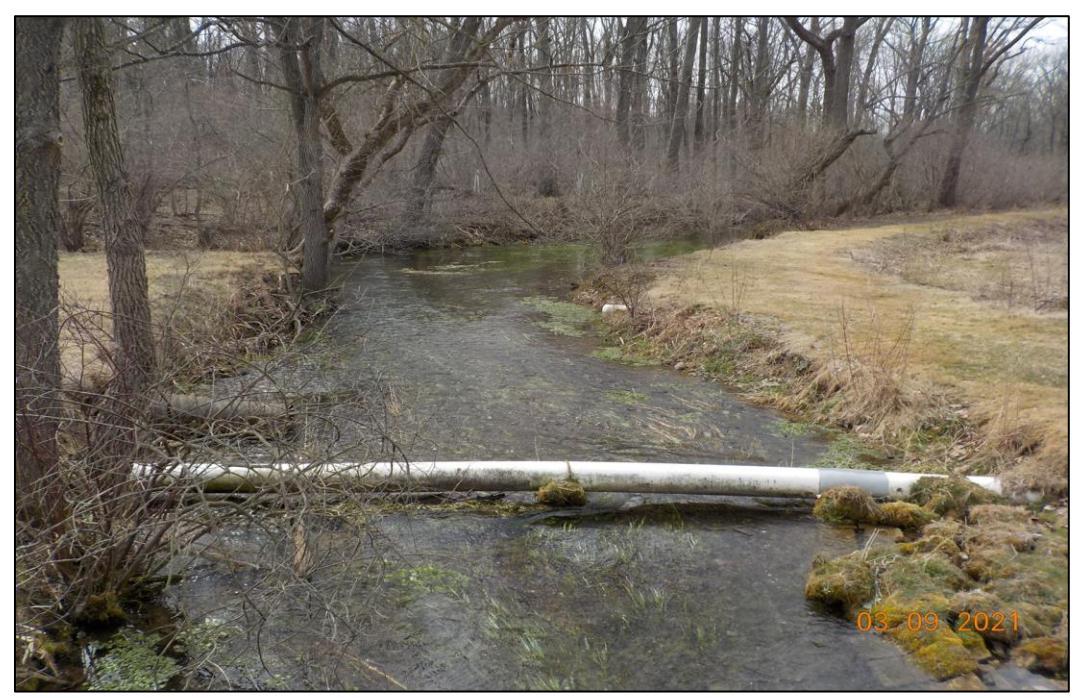
This reach begins at the road culvert separating the upper and lower sections of the former watercress farm and ends at Letort Rail Trail bridge. Most of the reach flows between the Letort Rail trail and a earthen roadbed separating it from the former Bonny Brook section of the old cress farm (Figure 18).

Figure 18. East Branch, Letort Spring Run, Reach 3, looking downstream from road culvert separating the former upper (Meadows) and lower (Bonny Brook) cressbeds. PVC pipe was formerly used to divert water from cressbed to a block trout holding area in order to observe the potential effects of the discharge on the fish.

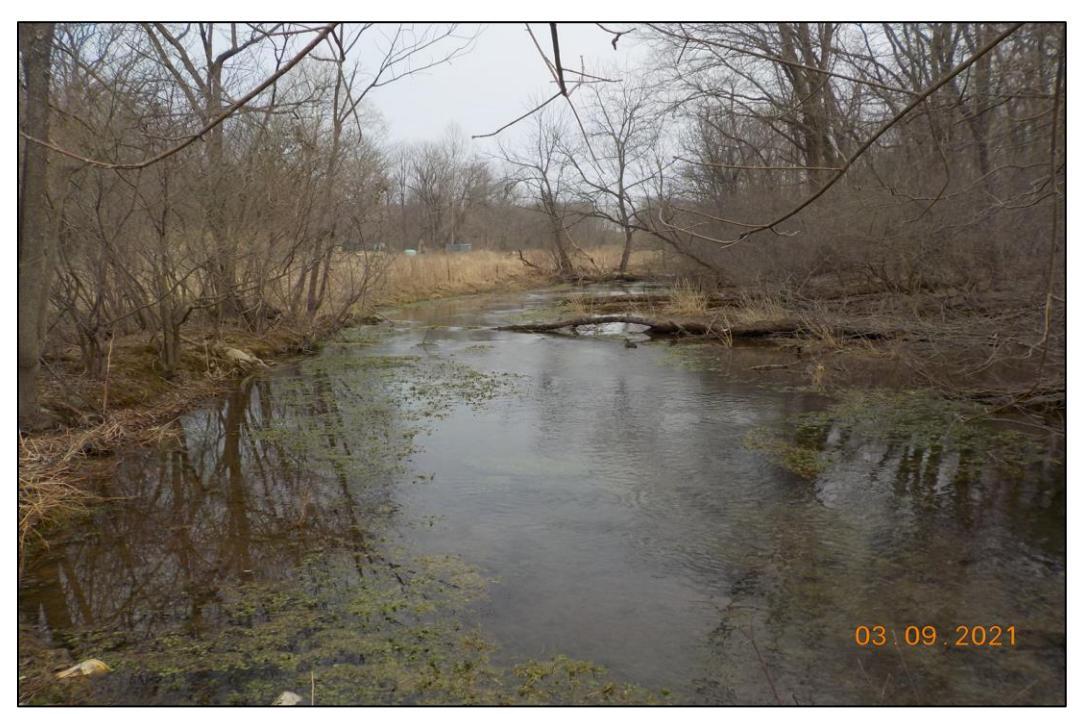
The reach tends to be shallower overall compared to Reach 2. This is mostly due to increased sedimentation that has occurred over the years from the discharge exiting the cressbeds. The retention of sediment in this reach was further exacerbated by the presence of two small dams that were installed to raise the water level for diversion into the Bonny Brook cressbeds. This has led to the widening and filling in of a large section of this reach (Figure 19). Overall, sediment deposition affects upwards to 80 percent of this section. Thick beds of vegetation are also present. During the summer thick growths of filamentous algae also plague this section of the stream. While in operation the farm would drip-feed fertilizer into the cressbeds possibly leaving a high nutrient residual in the accumulated sediment.

Figure 19. East Branch, Letort Spring Run, Reach 3, looking upstream from former dam structure utilized to raise water level and divert flow into former cressbeds.

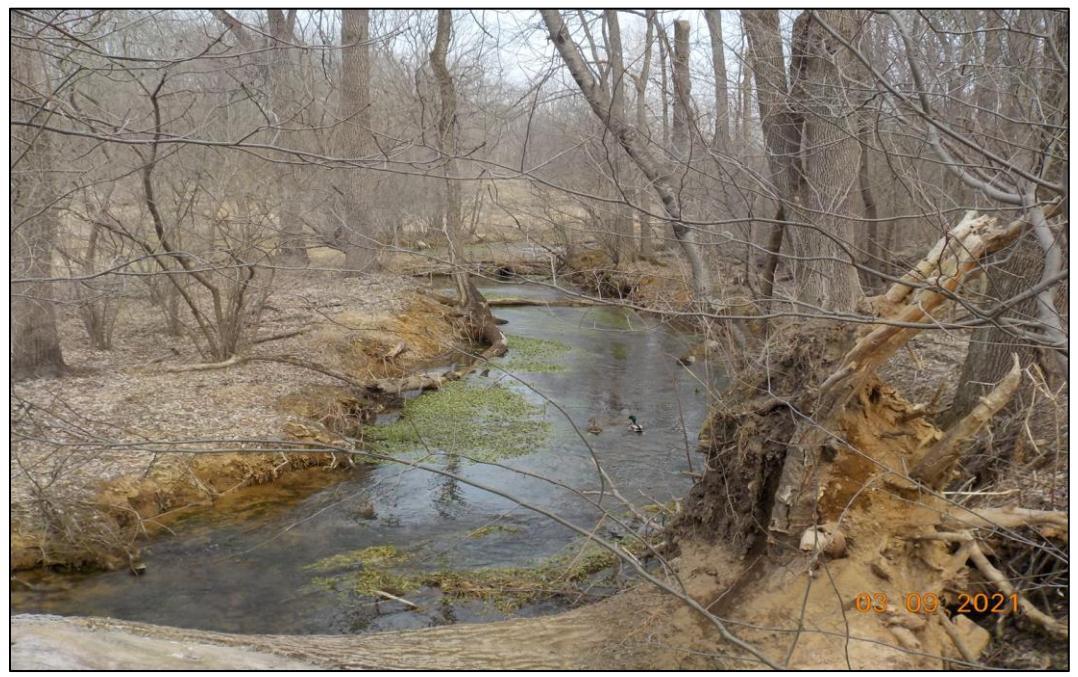
Downstream from the lower impounded stretch the stream narrows and the flow velocity increases which has led to the flushing of some of the sediment and exposing of some areas of gravel. This section is mostly shallow with good habitat for smaller fish and macroinvertebrates (Figure 20).

Figure 20. East Branch, Letort Spring Run, Reach 3, looking downstream. Letort Rail Trail is on the left side of the stream.

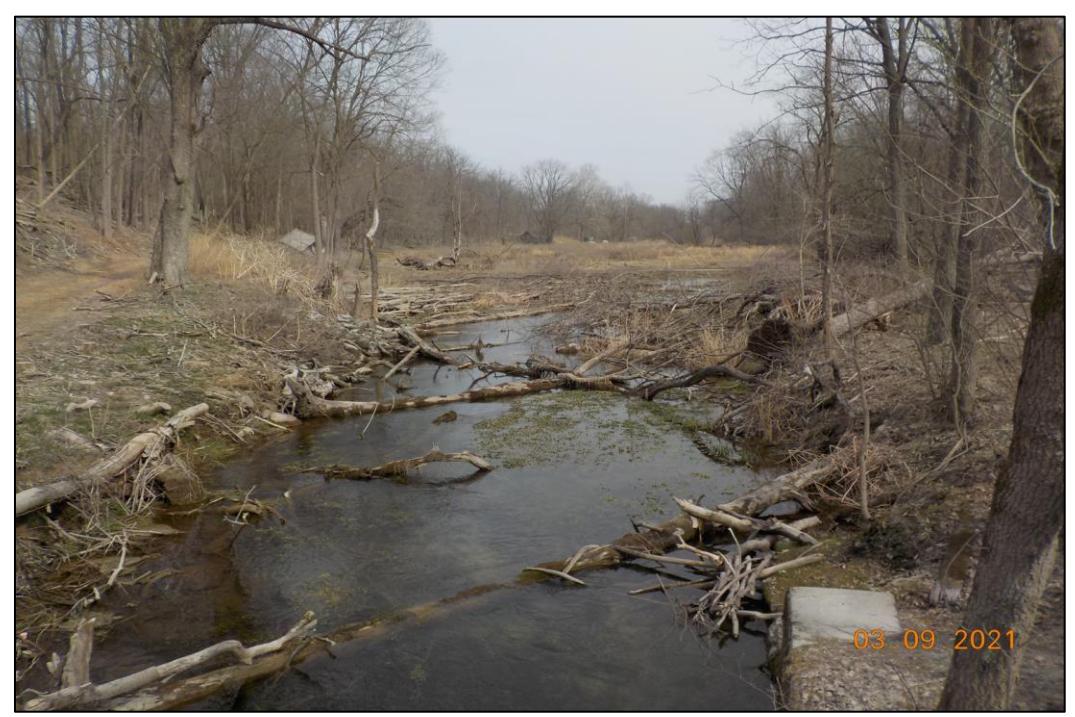
On the date of this investigation the lower section of Reach 3 was flowing over its banks into a wetland area below the former watercress beds (Figure 21). Bare stream banks and numerous downed trees give the stretch a poor appearance although the large woody-debris in the stream and deep channel provides excellent cover for fish.

Figure 21. East Branch, Letort Spring Run, Reach 3, looking upstream from Letort Rail Trail bridge towards former watercress farm.

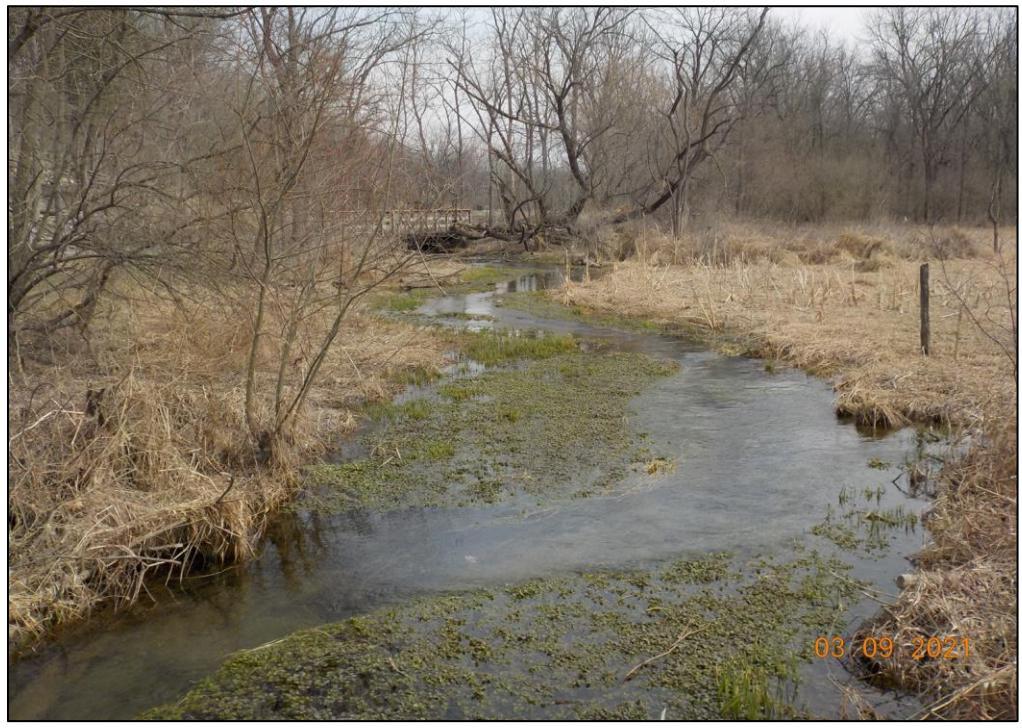
This reach begins at the Letort Rail Trail bridge and ends at the confluence with the main Letort or the Bonny Brook branch. The reach was not included as part of Reach 3 because of the major differences that exist upstream and downstream from the bridge. Below the bridge the stream meanders through a marsh/meadow type of habitat at least to the next downstream bridge (Figure 22). The channel is narrow and deep with areas of exposed gravel. The deep water and beds of vegetation provide excellent habitat for fish. The presence of exposed gravel and rocks provides better habitat for macroinvertebrates. The condition of the banks and bank vegetative protection is optimal with no signs of erosion. The only channel alteration is at the location of the two bridge crossings. The two parameters that lowered the score for this reach were sediment deposition and riparian zone width caused by the thick beds of watercress that trap sediment and the presence of a gravel roadway that infringes on the riparian zone.

Figure 22. East Branch, Letort Spring Run, Reach 4, looking downstream from Letort Rail Trail bridge.
