Farnsworth Branch COLDWATER CONSERVATION PLAN Warren County

July 2021

Warren County Conservation District

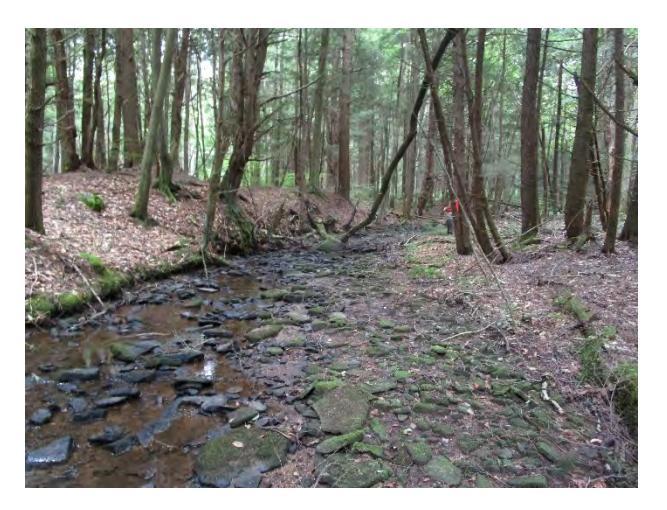
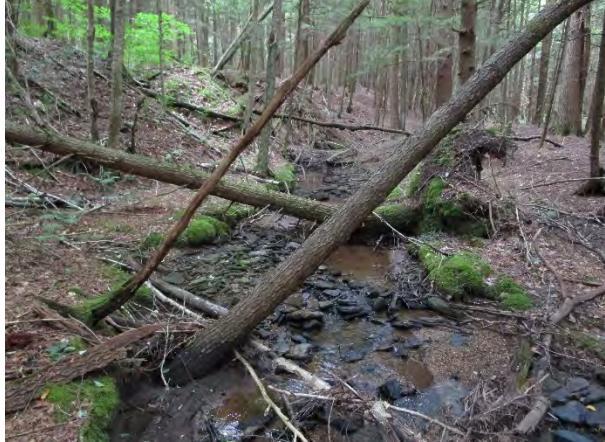
N 41.74493, W 79.12815
N 41.735011, W 79.138710

<u>Recommendation</u>: Good candidate for large wood (accessible floodplain, side channels) Large wood could be added from bottom to N 41.735011, W 79.138710.

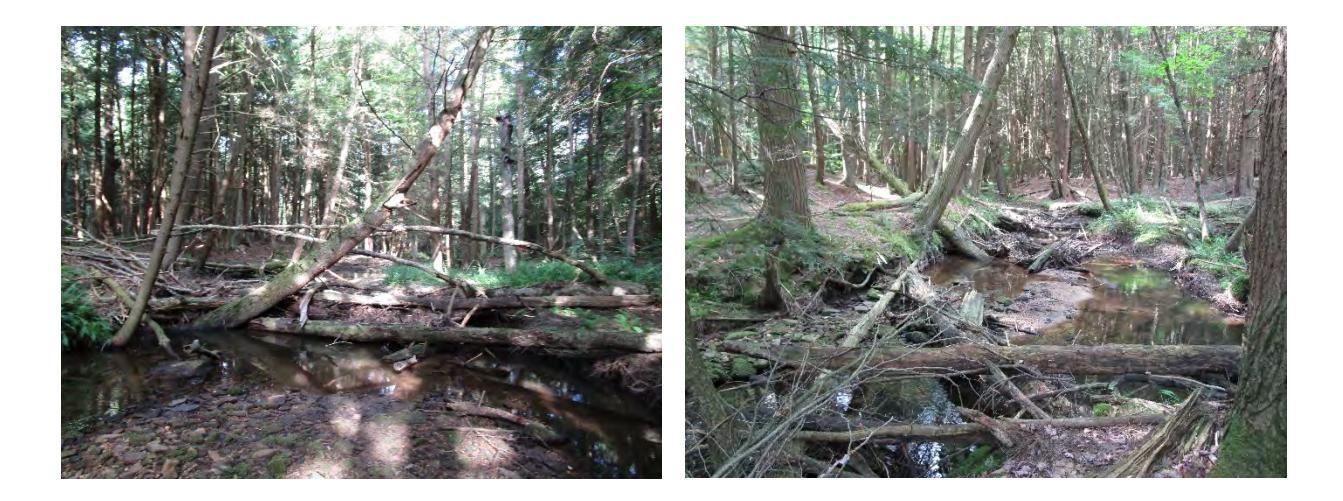
N 41.7121, W 79.1673

<u>Recommendation</u>: Opportunities to enhance existing log jams, possible opportunities to install streambank stabilization/fish habitat structures.
