**Tubmill Trout Club Unlimited, 2021 Stream Habitat Improvement Project  
Coldwater Conservation Implementation Report- Henry Neiport Phase-I**

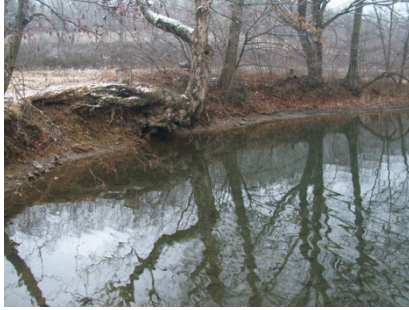
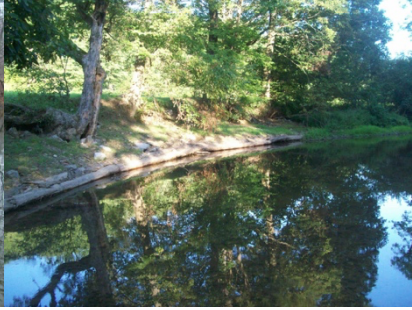
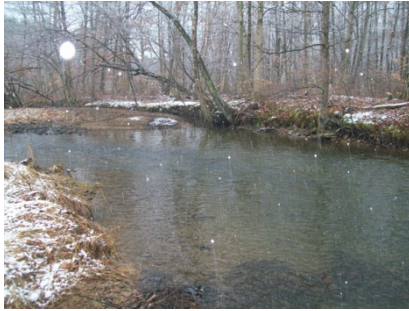
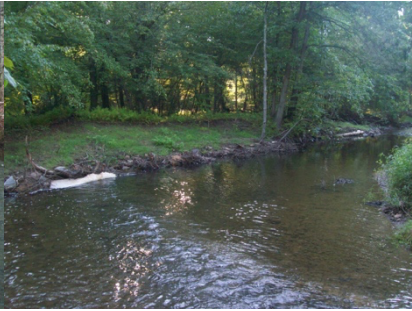
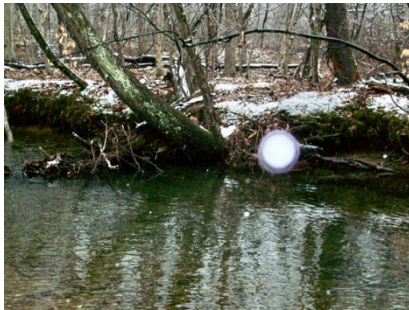
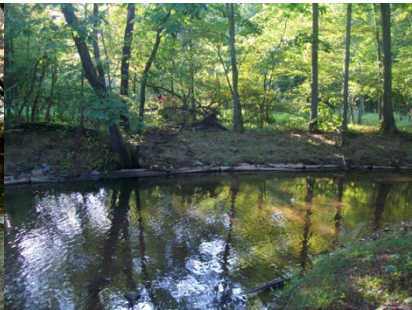
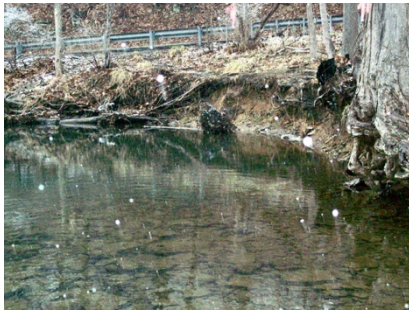
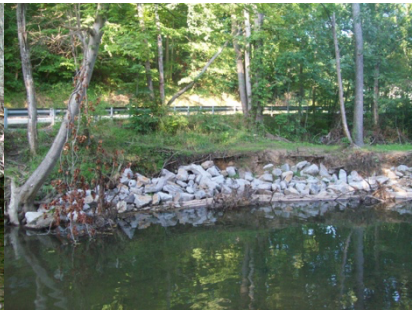
Before and after construction photos.

- Number of linear feet/acres improved; 1000 feet of stream channel, 1200 feet of stream banks.
- Number of structures placed, if applicable; 2-Log Framed Cross Vanes, 2 – Log Framed stone deflectors, 3 – Single Log deflectors, 4 – Modified Mudsill and root ball insertions. 25-30 Random Boulder placement
