**Clear Creek Habitat Improvement Phase I
Western Pennsylvania Conservancy
Coldwater Conservation Implementation Project**

Project summary

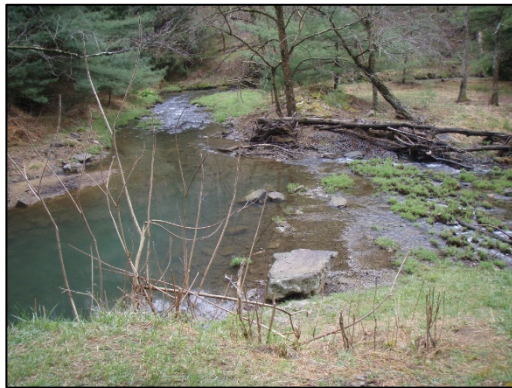
Gabion baskets across the main channel of Clear Creek (to the right), formed a low-head dam, explaining the vegetation growth across the channel.

Project partners, after extensive research, could not locate drawings, schematics, or permits to better understand the scope and depth of the gabion structures installed in Clear Creek at this location. Upon removal of the gabions, their full depth and volume made apparent that they had formed a dam structure. The gabion dam may have been installed to divert flood flows to the side channel, away from maintenance buildings at the park that are downstream along the mainstem

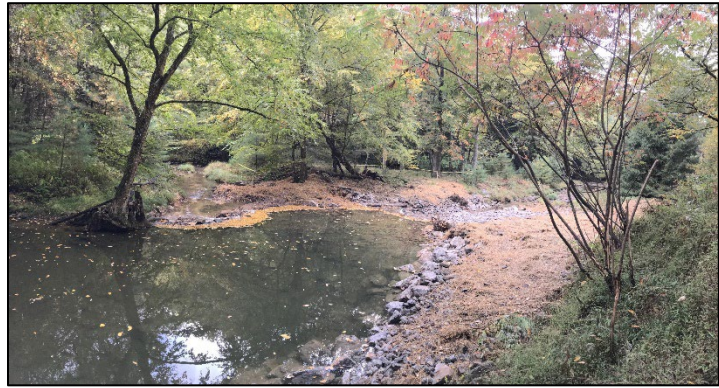
After work was completed on Phase I in 2020, a temporary grade control rock dam had to be constructed at the entrance to the side channel to maintain flow in both channels until additional construction could be completed on Phase II in 2021.

At the end of construction of Phase I in 2020, large boulders and key-piece sized stone were used to temporarily hold the elevation at the entrance to the side channel. This was necessary to temporarily establish a stable grade control at the entrance to the side channel until Phase II construction could occur in 2021 to restore a section of that side channel, improve the structures constructed in 2020, and construct additional habitat structures on the main channel.

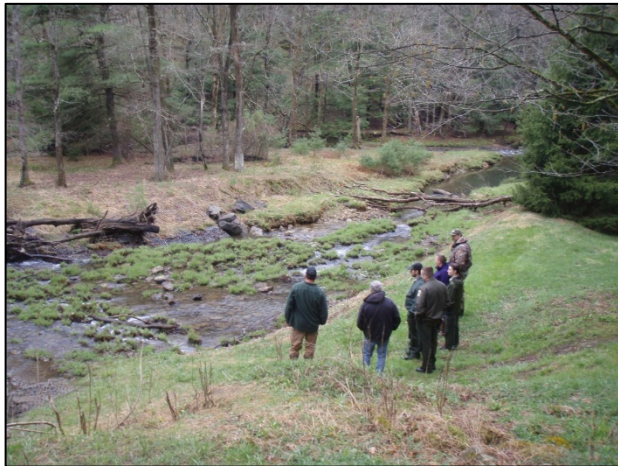
Clear Creek main channel before restoration

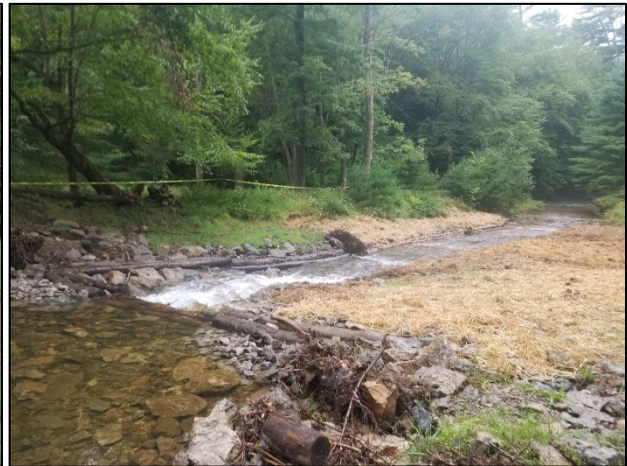
Final Clear Creek main channel after Phase I & II

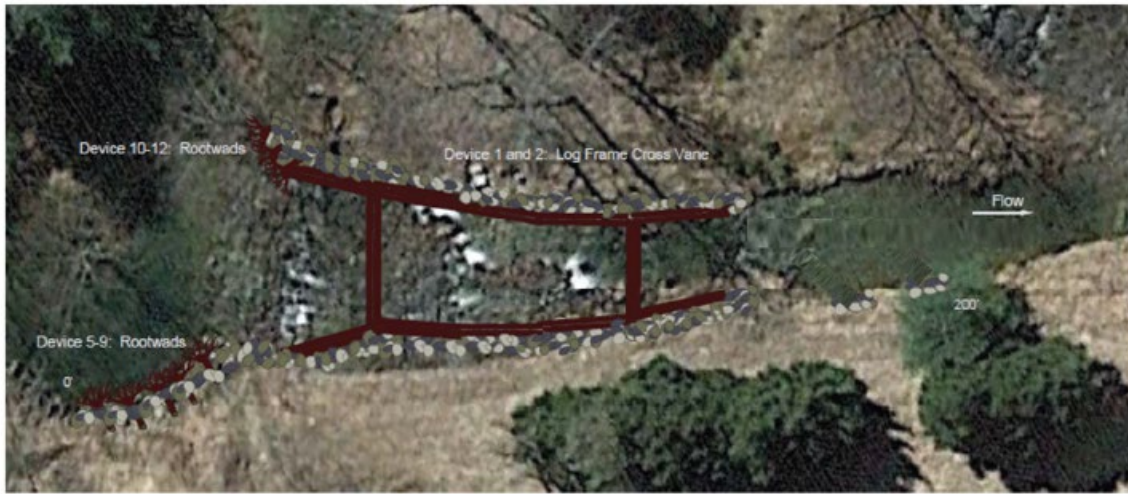
Clear Creek Phase I

Linear: 160'
Square: 770'

Clear Creek, Jefferson County			
Clear Creek State Park			
DCNR, WPC			
Fish Habitat Improvement Plan			
Stream Section Habitat Management Division			
Pennsylvania Fish & Boat Commission			
Project No.	10473	Project Name	Clear Creek
Stream Name	Clear Creek	Section	01-10-2017
Scale	1" = 100'	Date	01-10-2017
